# 2002 Annual Compliance Report Ambrosia Lake, New Mexico, Disposal Site

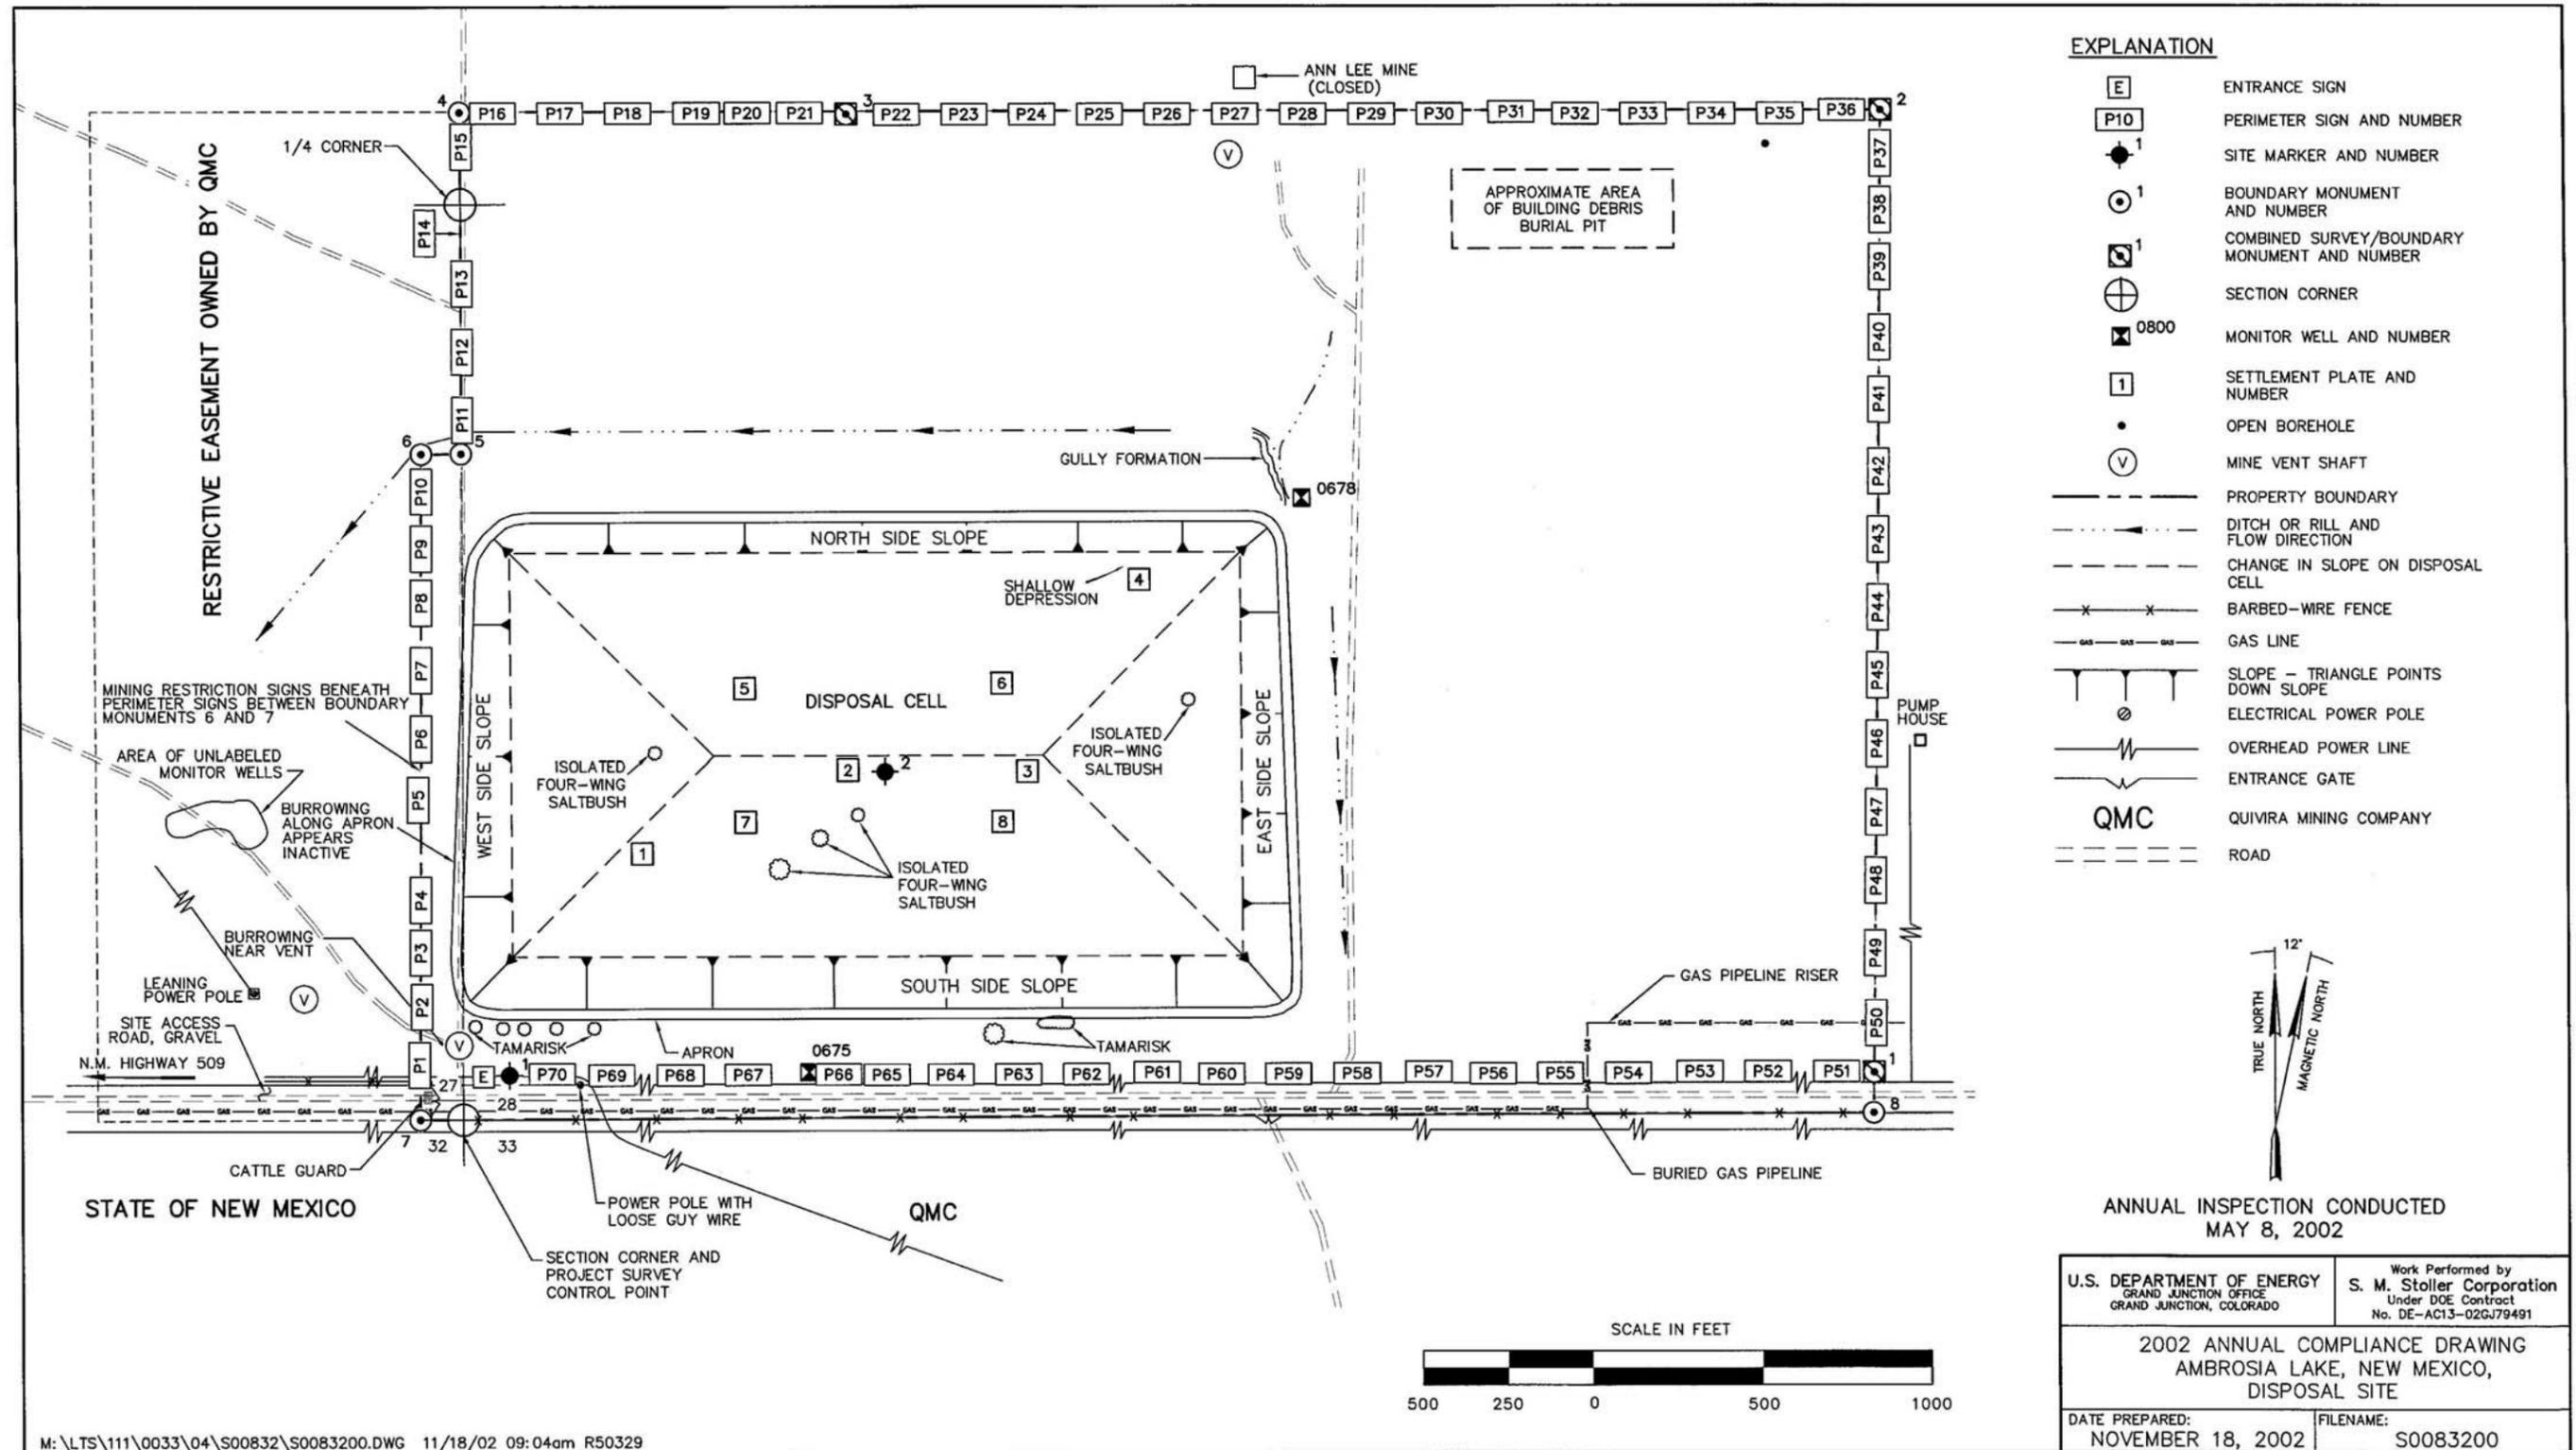
Figure 1-1. 2002 Annual Compliance Drawing for the Ambrosia Lake, New Mexico, Disposal Site

The site, north of Grants, New Mexico, was inspected on May 8, 2002. Results of the inspection are described below. Features mentioned in this report are shown on Figure 1–1. Numbers in the left margin of this report refer to items summarized in the Executive Summary table.
