2002 Annual Compliance Report Burrell, Pennsylvania, Disposal Site

Compliance Summary

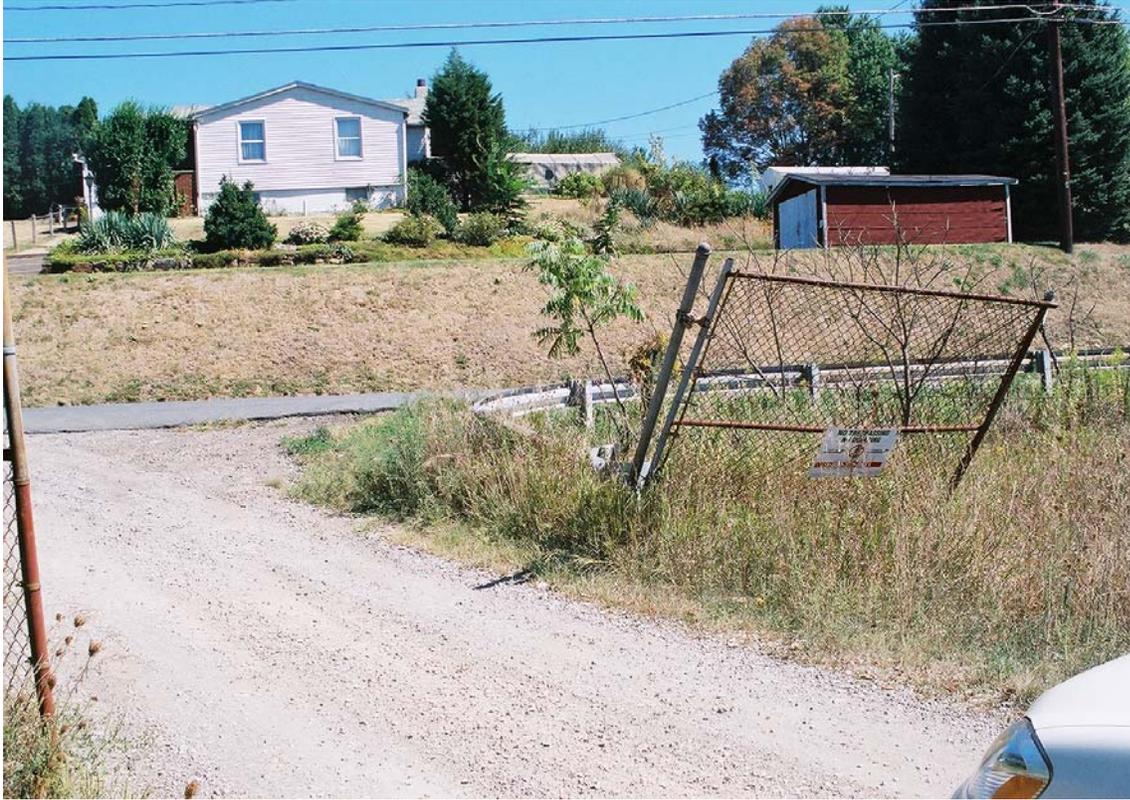
DOE has tried to prevent use of its access road by keeping the gate locked and installing a guardrail along Strangford Road. However, on every site visit since 2000 the gate has been found open. Inspectors found the gate damaged and derelict in 2002 (PL-1 and PL-2).

PL-1. Damaged east gatepost at Strangford Road.

2B The access gate will likely be an ongoing maintenance problem and access control has been ignored by local residents. Also, limiting access to the site at Strangford Road does not enhance site protectiveness or security. Therefore, DOE will seek U.S. Nuclear Regulatory Commission concurrence in removing the gate at Strangford Road.

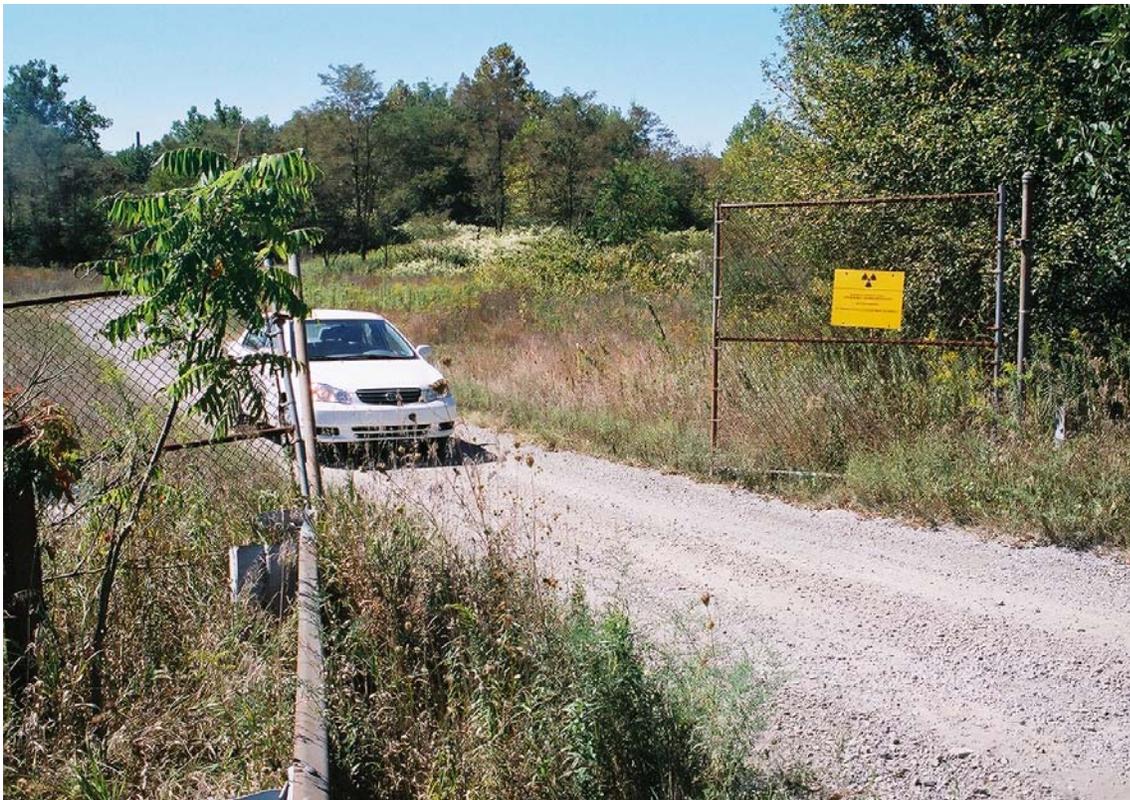
PL-2. Damaged west gatepost at Strangford Road.

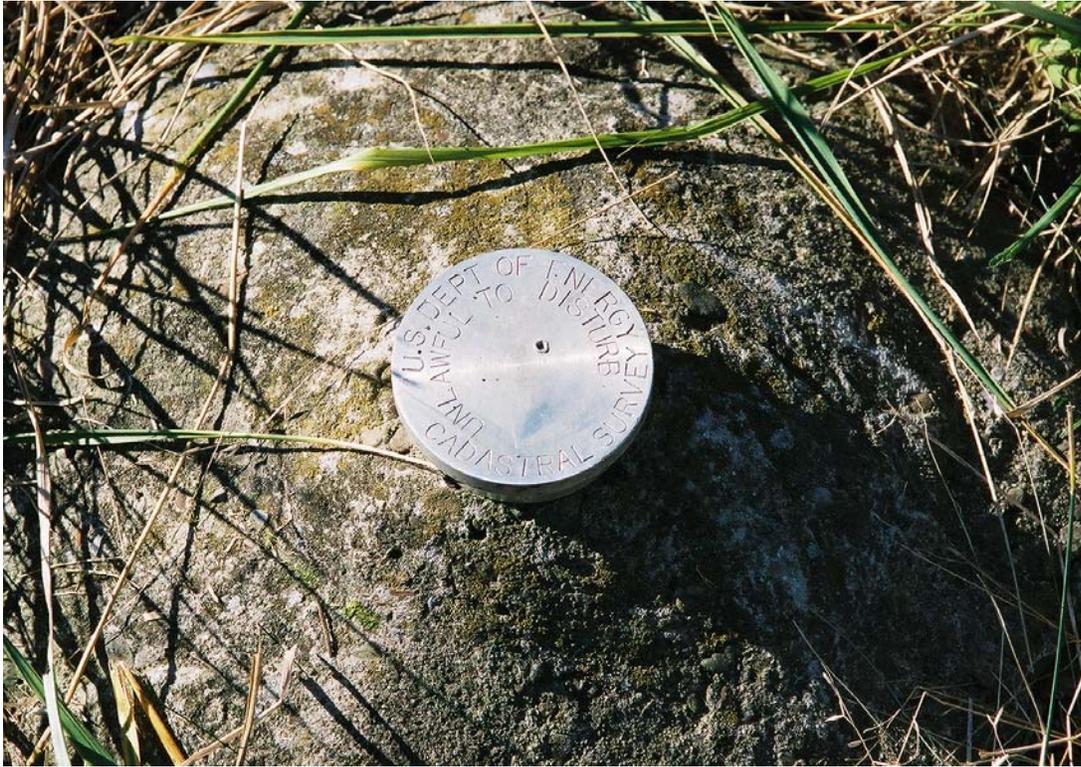
2D The site has three survey monuments (SM-100, SM-101, and SM-102) and seven boundary monuments (BM-1 through BM-7). Because of dense vegetation, inspectors could not locate survey monument SM-1 or boundary monument BM-4. Remaining markers and monuments were undisturbed and in excellent condition. The cap on boundary monument BM-7, found sheared off in 2001, was replaced in December 2001 (PL-3).

PL-3. New cap on boundary monument BM-7.

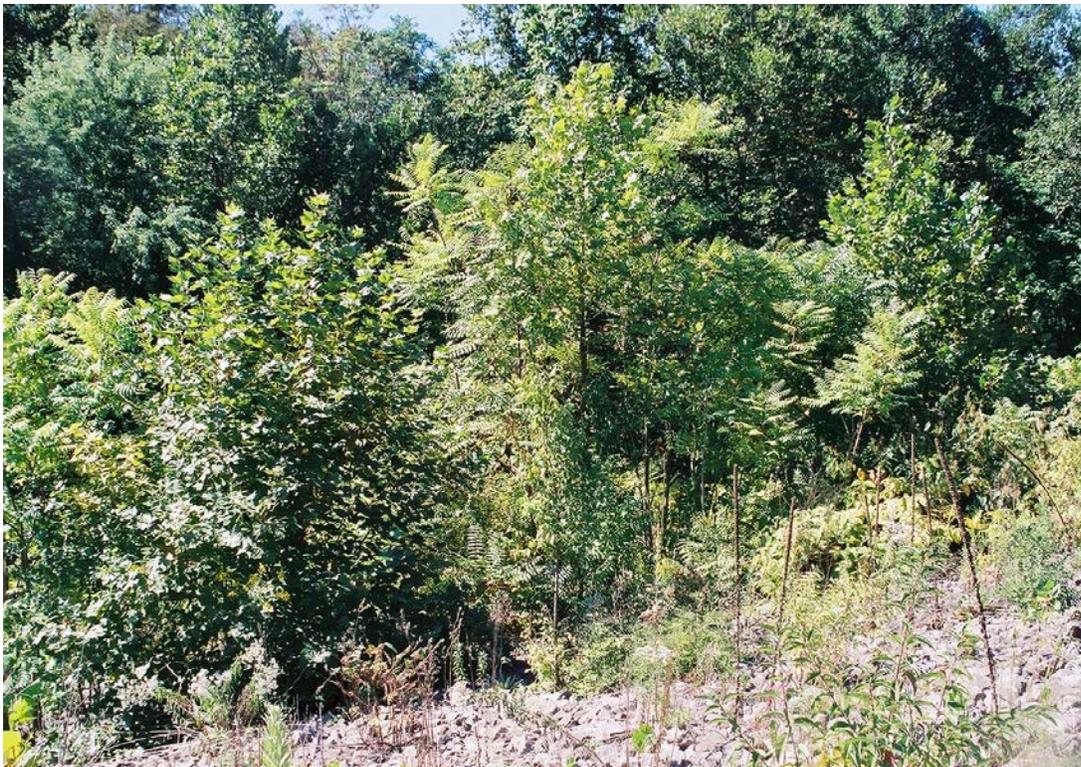
Trees and shrubs continue to establish in the riprap (PL-4). In the past, this vegetation was aggressively controlled with massive applications of herbicide. A study that evaluated risks posed by encroachment of plants on the disposal cell demonstrated that the plants will not degrade the long-term performance of the cell and may improve performance by reducing moisture in the cover through evapotranspiration.

PL-4. Vegetation growth on south toe of disposal cell.

The revised Long-Term Surveillance Plan allows the vegetation to grow on the disposal cell without further intervention; such growth will not increase risk to public health, safety, or the environment. In their concurrence in the revised Long-Term Surveillance Plan, the U.S. Nuclear Regulatory Commission suggested that DOE reevaluate the effects of vegetation on cover performance in 10 or 20 years to confirm performance parameters and predictions.
