# 2002 Annual Compliance Report Maybell, Colorado, Disposal Site

## Compliance Summary

### 1.0 Annual Inspection and Report

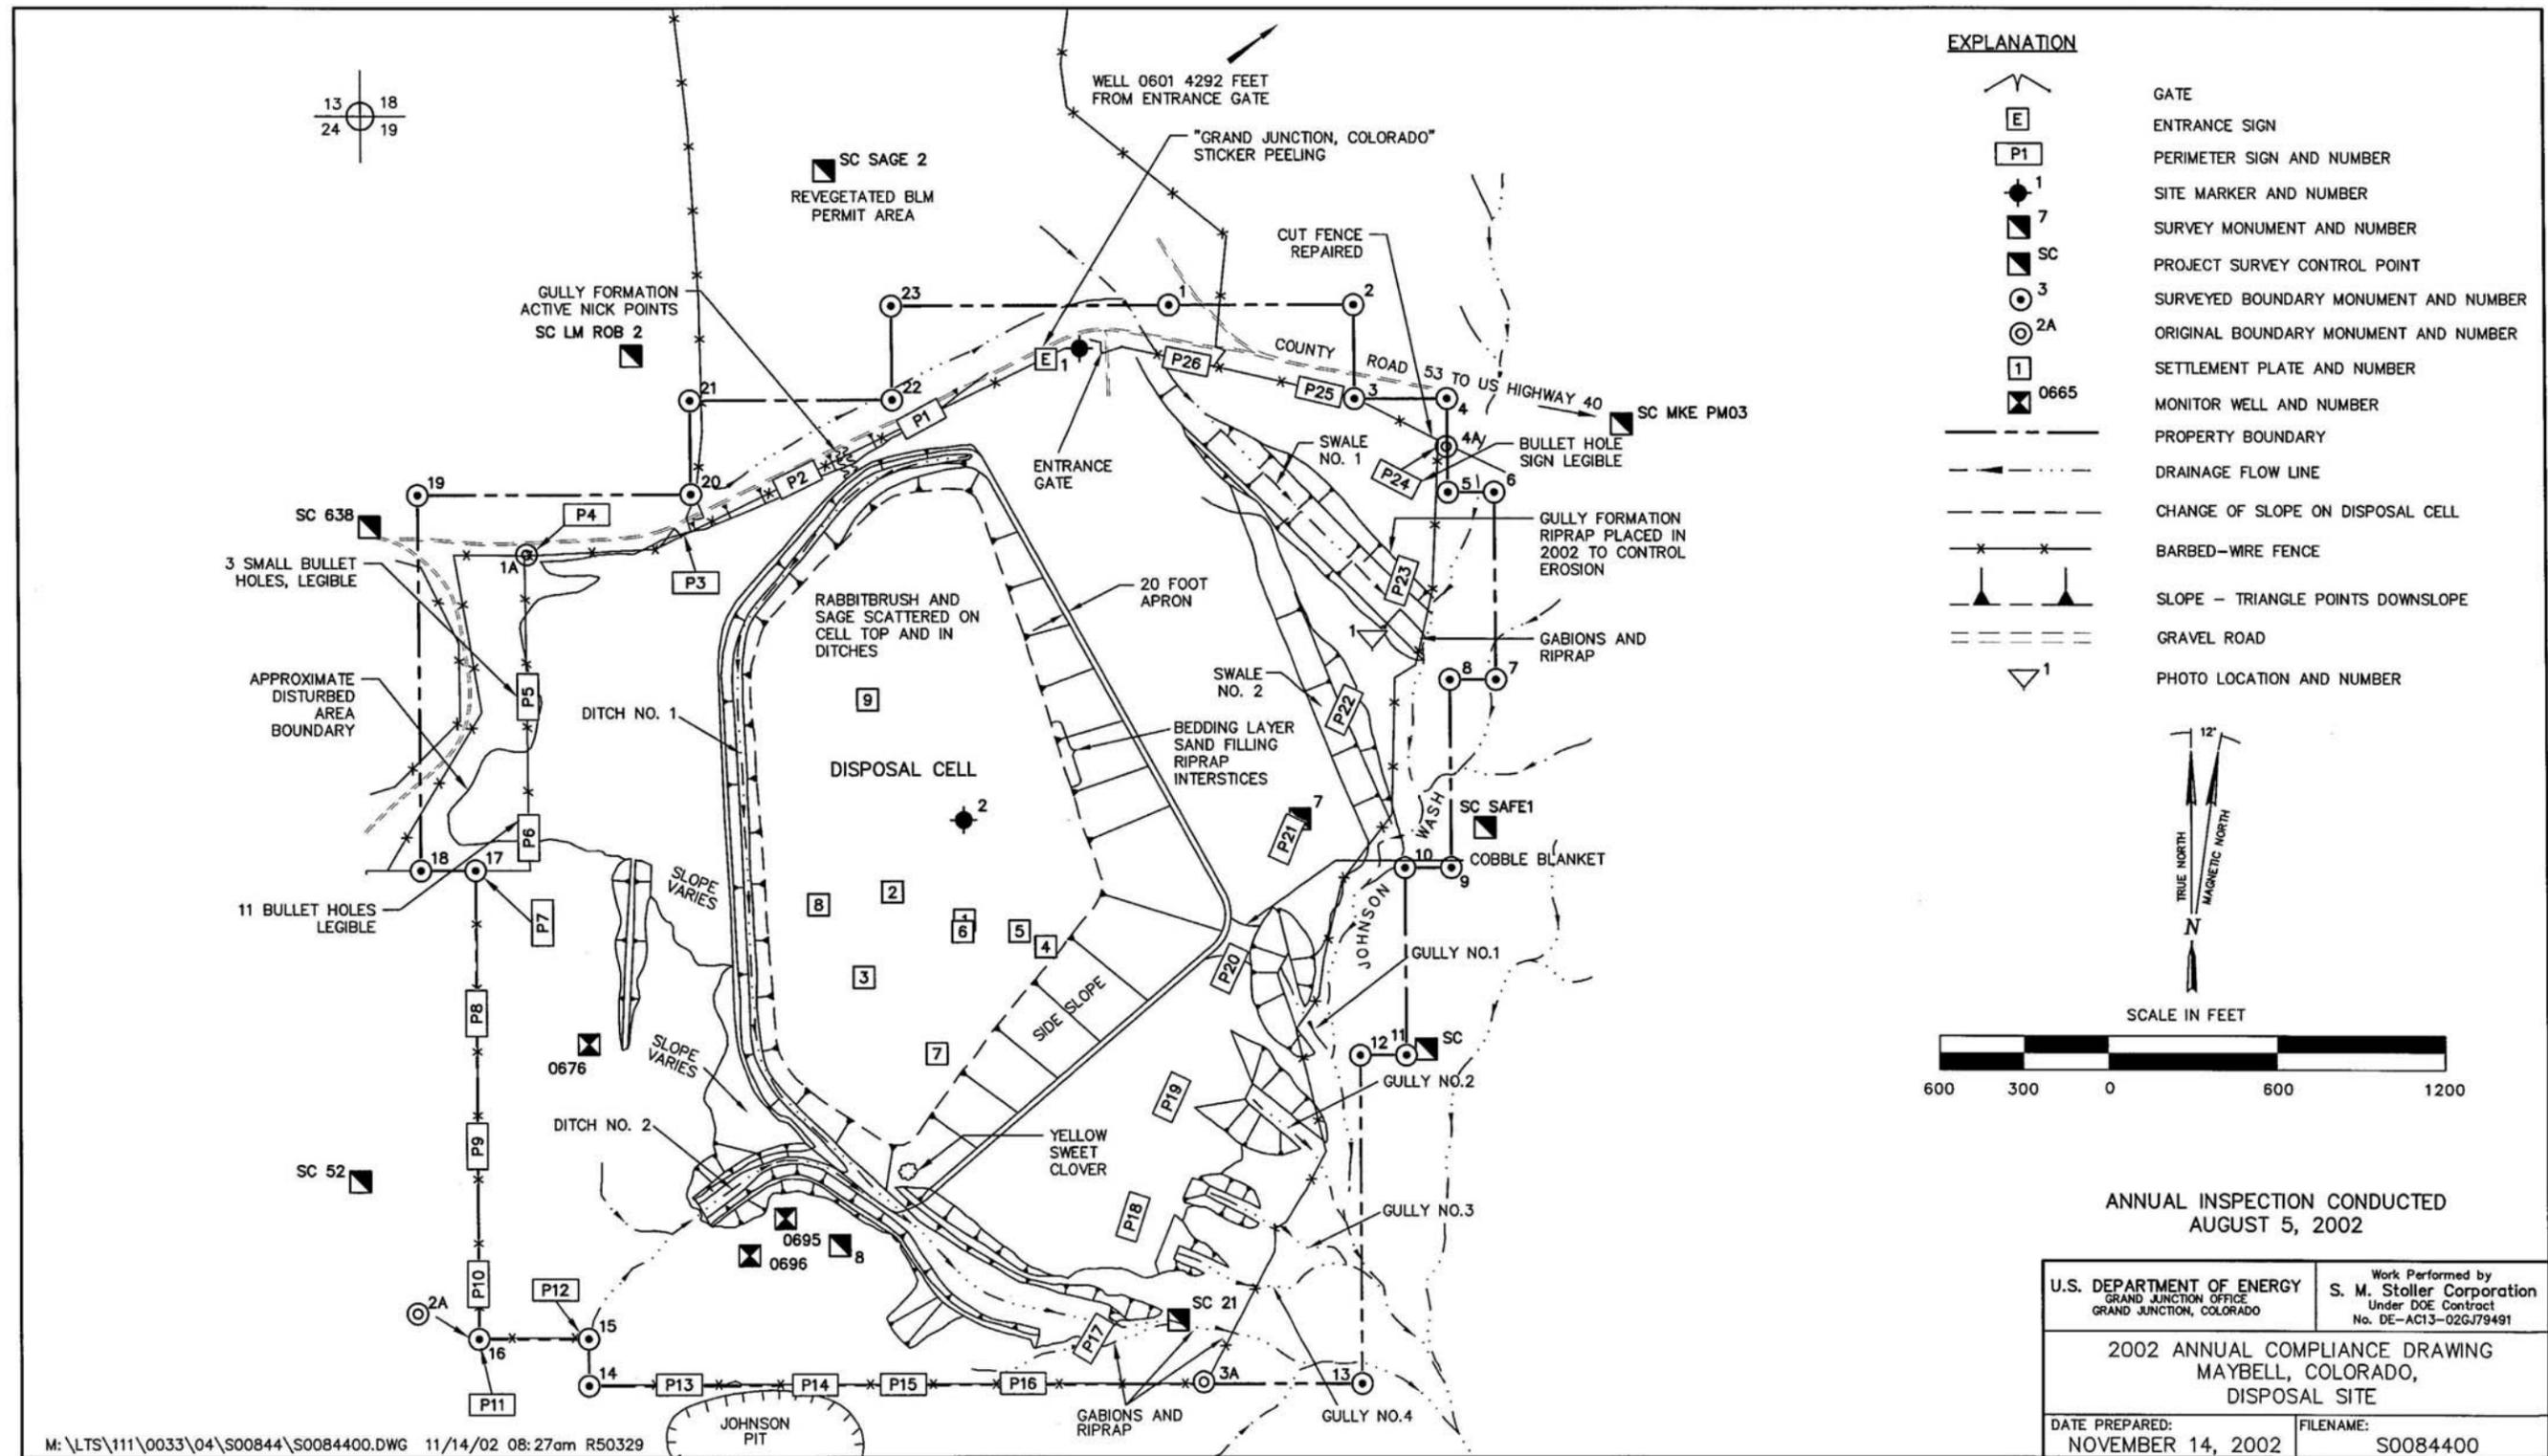
Figure 11-1. 2002 Annual Compliance Drawing for the Maybell, Colorado, Disposal Site

11C At the time of the 2002 inspection, four boundary monuments (shown as BM-1A through BM-4A on Figure 11-1) were present along the property boundary. Only one boundary monument (BM-2A) is at a corner, and one (BM-1A) is at a fence corner but not on the property boundary. This configuration was at variance with Uranium Mill Tailings Remedial Action Project specifications that require boundary monuments at actual property corners. Therefore, the property was resurveyed in September 2002 based on real estate records, and 23 new boundary monuments were installed—BM-1 at a section line and the remainder (BM-2 through BM-23) on property corners. The resurveyed property boundary and all 27 boundary monuments are shown on Figure 11-1.

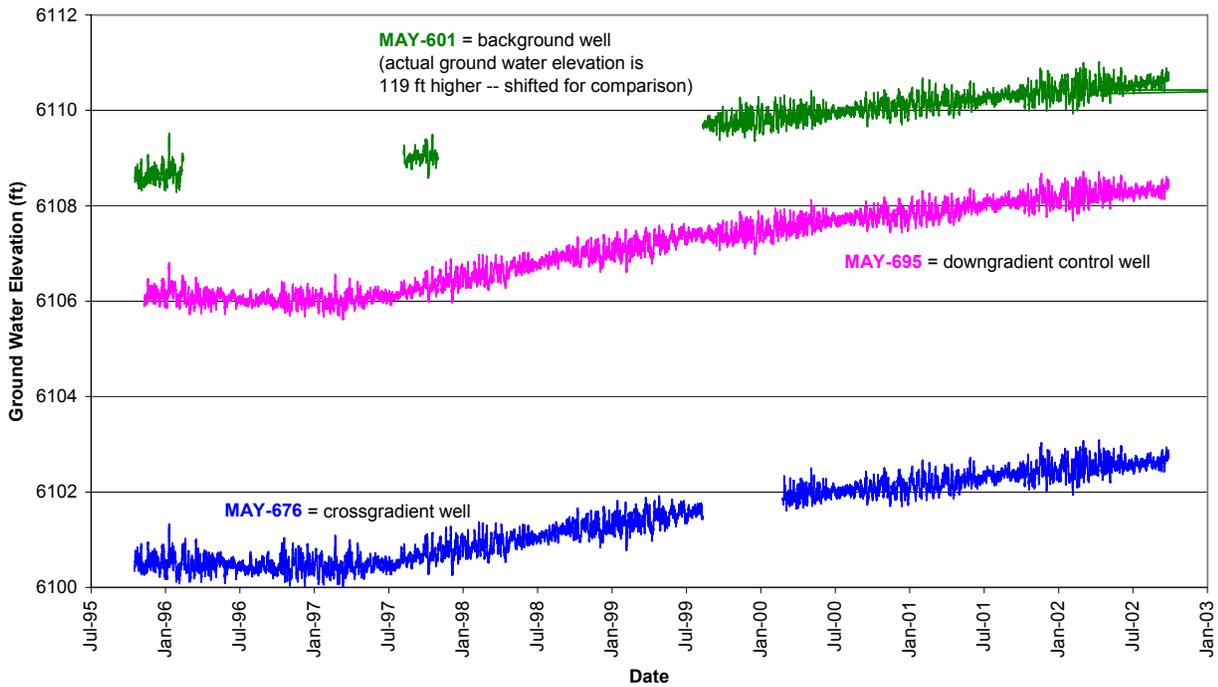
Figure 11–2. Water Level Measurements at the Maybell, Colorado, Disposal Site

Water levels are monitored by data loggers installed in each well. Data are downloaded quarterly. Water level measurements through October 3, 2002, are shown in Figure 11-2. Breaks in two of the hydrographs are due to data logger malfunction. Measurements are not shown for backup monitor well 0696.

Water levels continue to rise at a similar rate in all wells. Data from background well 0601 indicate that rising water levels are regional and cannot be related to any local effect around the disposal cell. A regional rise in water level can reasonably be attributed to long-term precipitation patterns.

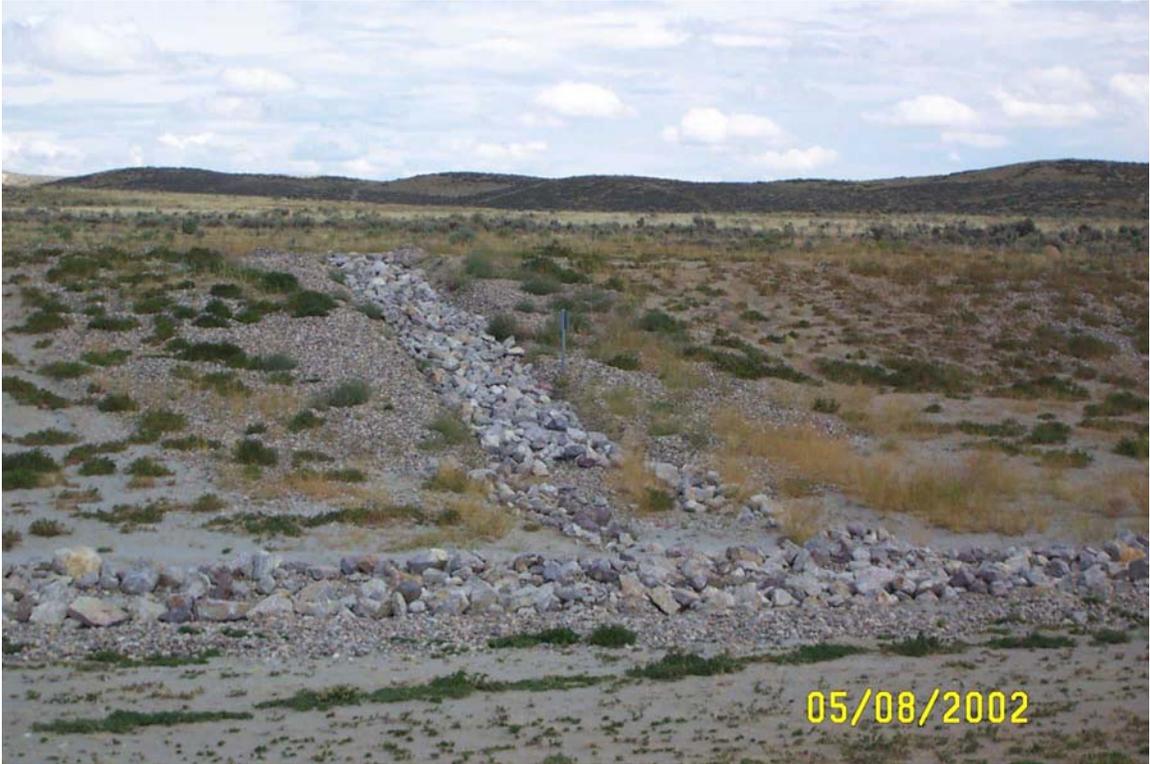
- 11F The outfalls below the four numbered gullies north of the Ditch Number 1 appeared to be stable. Additional erosion had occurred where the riprap was placed in previous years on the north bank of Swale Number 1, and more riprap was placed in the Swale Number 1 outlet and on the north bank in spring 2002 (PL-1). These locations were self-armoring and may stabilize.

*PL-1. Erosion protection rock installed on the north side of Swale Number 1.*

A portion of fence near boundary monument BM-4A was repaired. Additional riprap was placed in Swale Number 1.
