2002 Annual Compliance Report Rifle, Colorado, Disposal Site

Figure 14-1. 2002 Annual Compliance Drawing for the Rifle, Colorado, Disposal Site

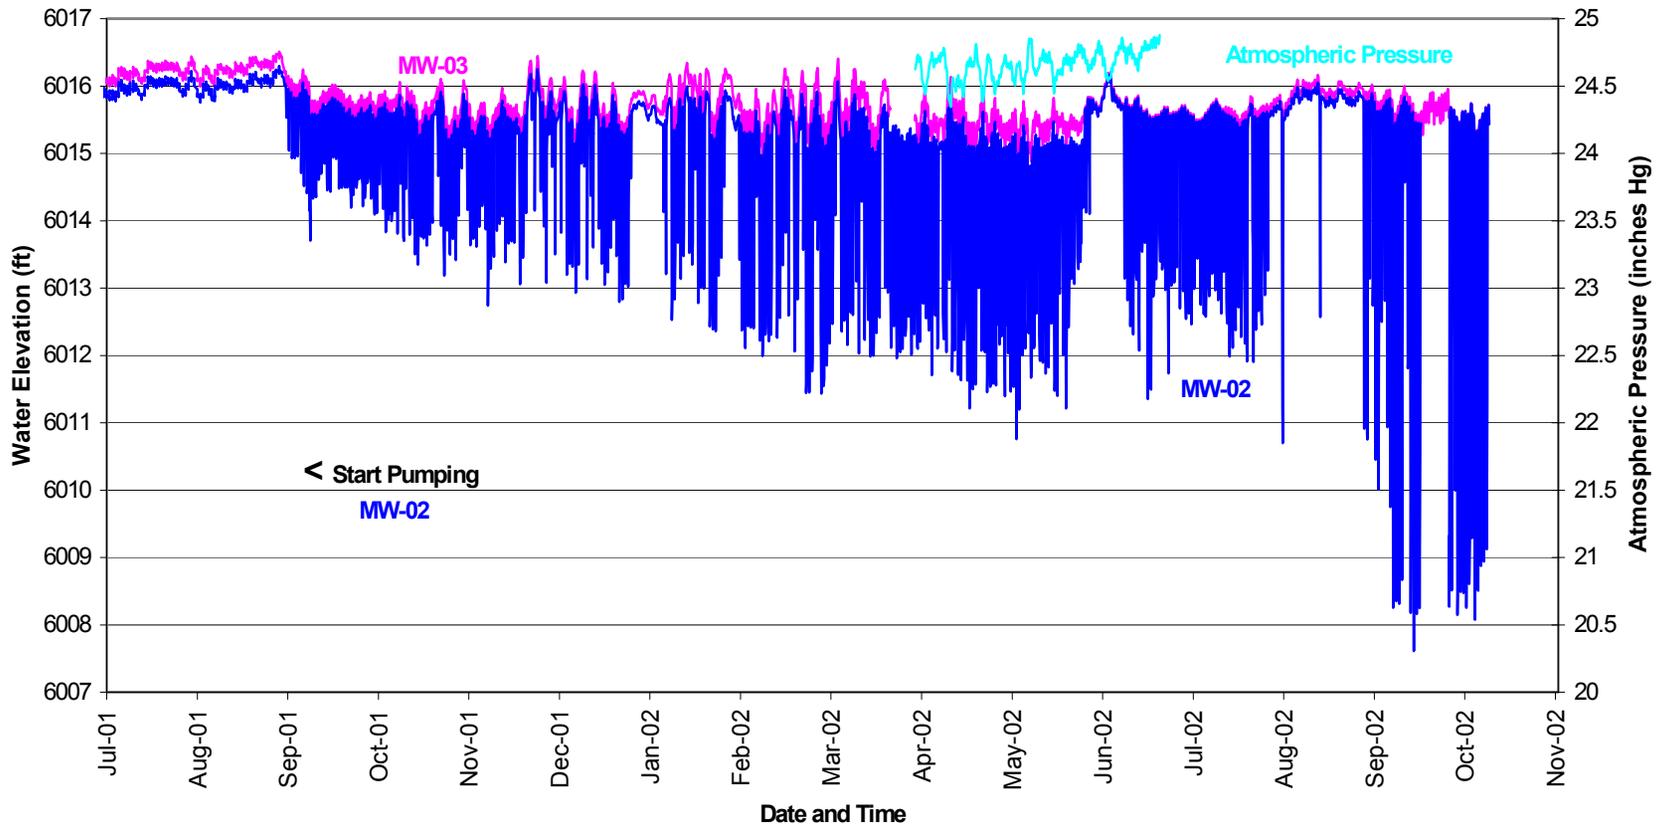
Figure 14-2. Water Levels in Standpipes MW-02 and MW-03 at the Rifle, Colorado, Disposal Site

When average water levels (as calculated using linear regression) in MW-02 approached the action level in August 2001, DOE installed a pump in this standpipe, constructed an evaporation pond, and began pumping from the standpipe to the pond. Since then, a total of 488,000 gallons of water have been extracted from the disposal cell, and water levels have slowly decreased as shown by datalogger measurements (Figure 14-2). The discharge rate from the solar-powered pump is approximately 5 gallons per minute during periods of operation. The oscillation in the datalogger trace for MW-02 in Figure 14-2 represents drawdown in the standpipe during pumping, and recovery of the water level when pumping ceases. The minor irregularities in the datalogger lines shown on the graph (most obvious in MW-03) are related to variations in atmospheric pressure (as shown during the period of measurement from April through June 2002), with elevated atmospheric pressure causing depressed water levels. The increase in elevations in late May 2002 for MW-02 is a result of a resurvey of the measuring point and adjustment of the datalogger readings.

DOE intends to remove enough water from the disposal cell to lower water levels in the standpipes to below the 6,014-foot elevation. At that time, pumping will be stopped, and water levels will be monitored to ensure they remain at or below that elevation. If water levels again rise, pumping will resume. DOE will monitor water levels with dataloggers and will adjust the frequency of downloading and manual water level checks on the basis of water level trends.

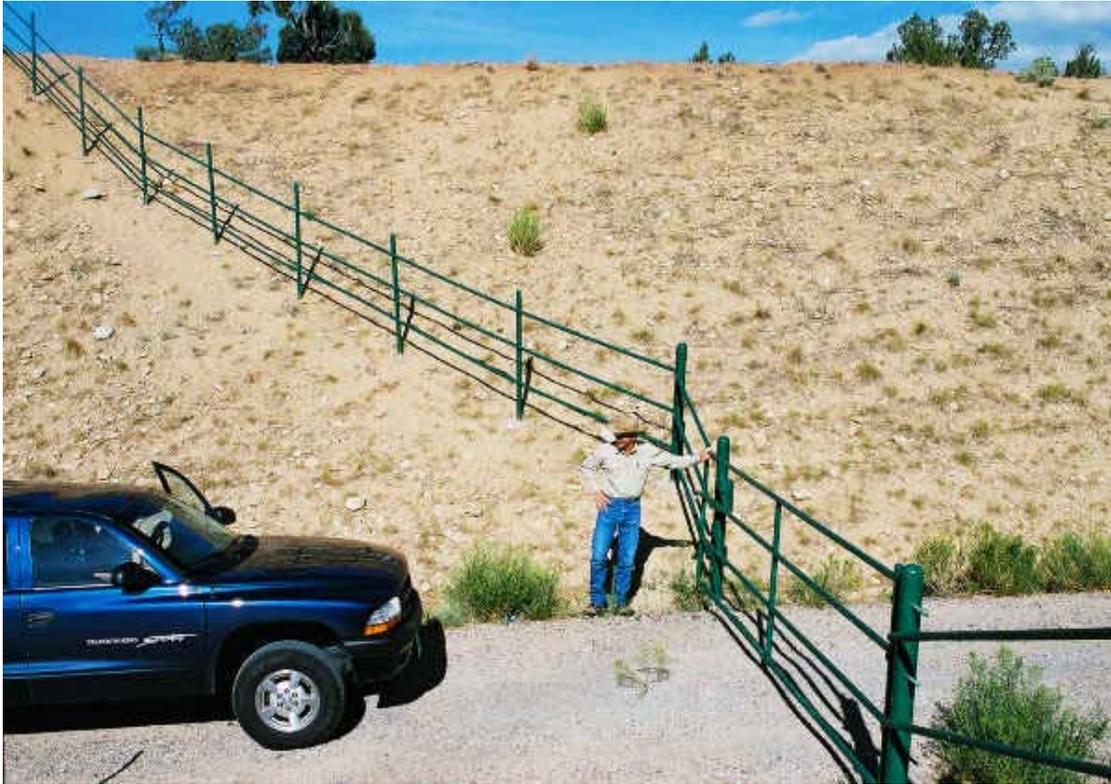
14A **Access Road, Gates, Fence, and Signs**—The site is reached by driving north on an improved gravel road from State Highway 13. In 2002, a steel fence and swinging gate (PL-1) were installed where the access road passes through a road cut to limit access to the site and prevent vandalism to the cell dewatering pumping system and evaporation pond. The gate was locked and there was no evidence of trespass beyond the gate.

PL-1. New fence and gate across access road.

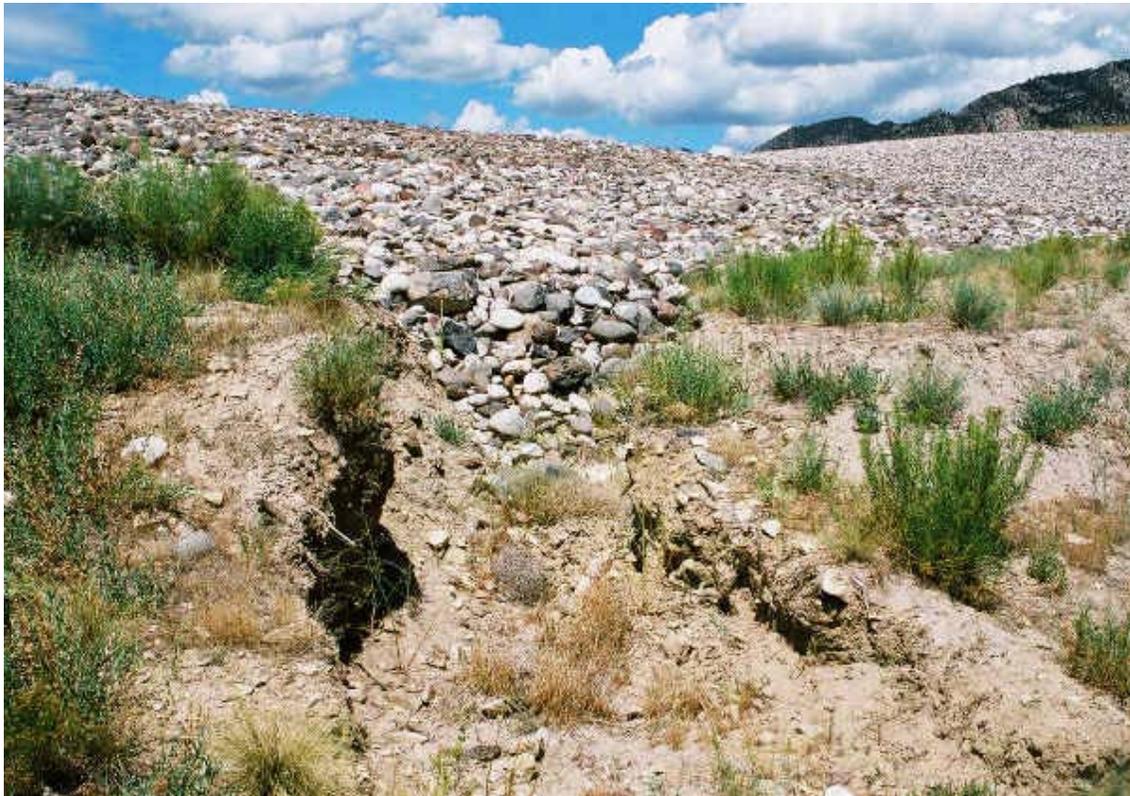
Minor erosion, anticipated in the design, has occurred in the channel at the outlet below the toe ditch (PL-2). Bedrock is now exposed at the outlet. Rock placed at the bottom of toe ditch outlet is dropping into the eroding channel and gradually forming an armor layer to inhibit erosion.

PL-2. Erosion at toe ditch outlet.

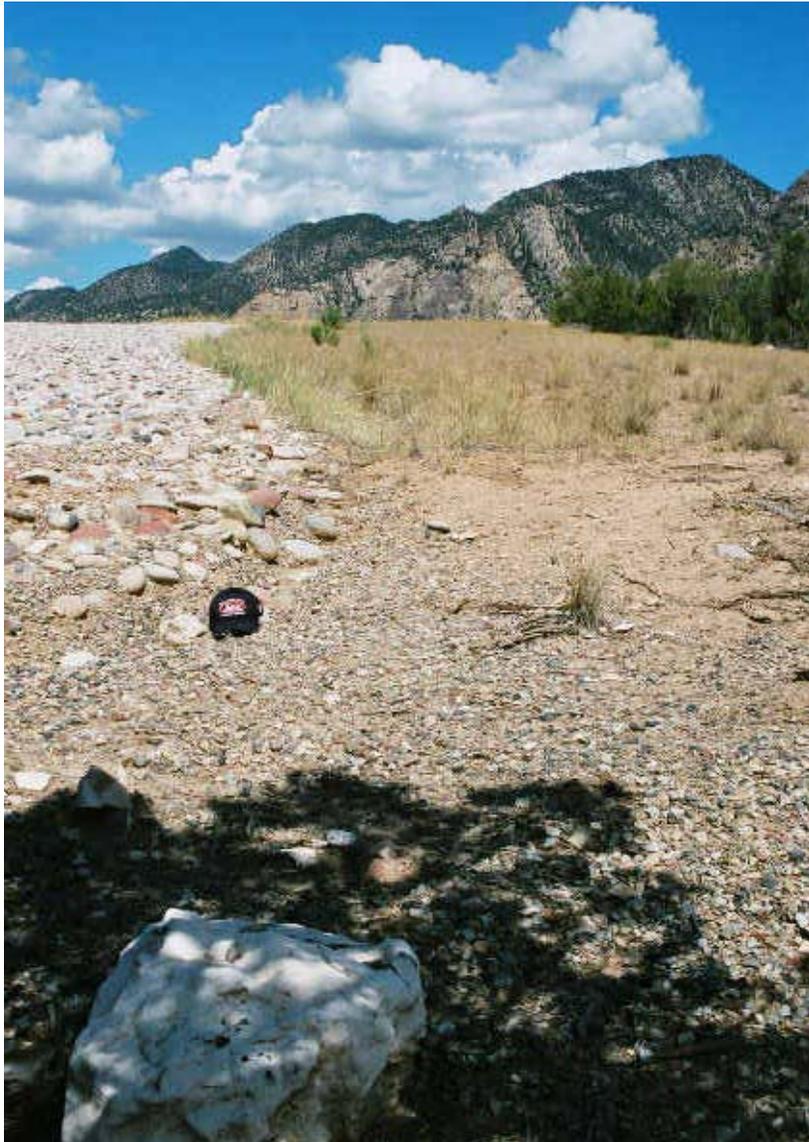
Rills noted during previous inspections in the vicinity of perimeter sign P13 appeared to be stable. However, the runoff collected by the rills travels downhill along the interface between the riprap and the adjacent reclaimed soil area. A small channel that currently averages about 1 foot wide and less than 1 foot deep has formed and has exposed some of the gravel bedding material (PL-3 and PL-4). The scoured channel extends approximately from perimeter sign P13 to boundary monument BM-3. This feature is not threatening the integrity of the disposal cell at this time, but DOE will continue to monitor it during subsequent site inspections.

PL-3. Developing channel near perimeter sign P13; upslope view.

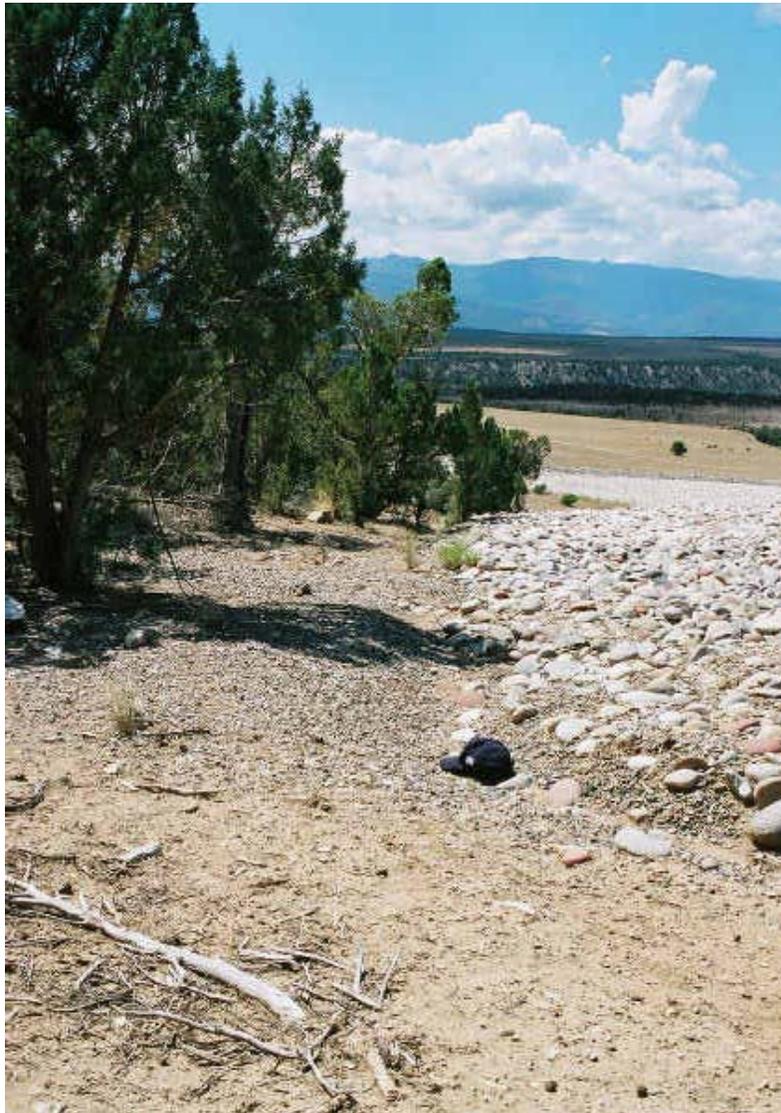
PL-4. Developing channel near perimeter sign P13; downslope view.
