2002 Annual Compliance Report Shiprock, New Mexico, Disposal Site

Compliance Summary

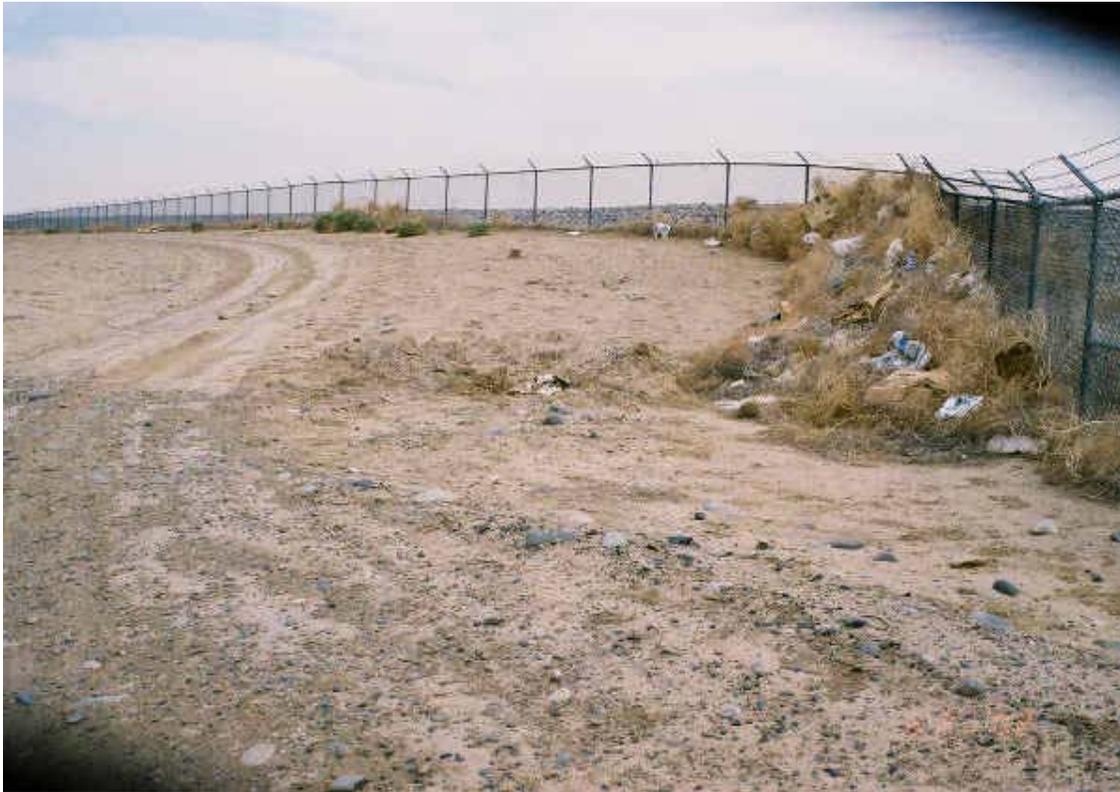
Tumbleweeds and windblown trash accumulate along upwind portions of the perimeter fence and must be removed every 2 or 3 years to mitigate potential fire hazards associated with the weeds and to maintain site appearance. During the June 2002 inspection, significant tumbleweed and trash accumulation was observed along the westernmost fence line near boundary monument BM-5 (PL-1) and near the main entrance gate near boundary monument BM-6.

PL-1. Trash and tumbleweed accumulation near boundary monument BM-5.

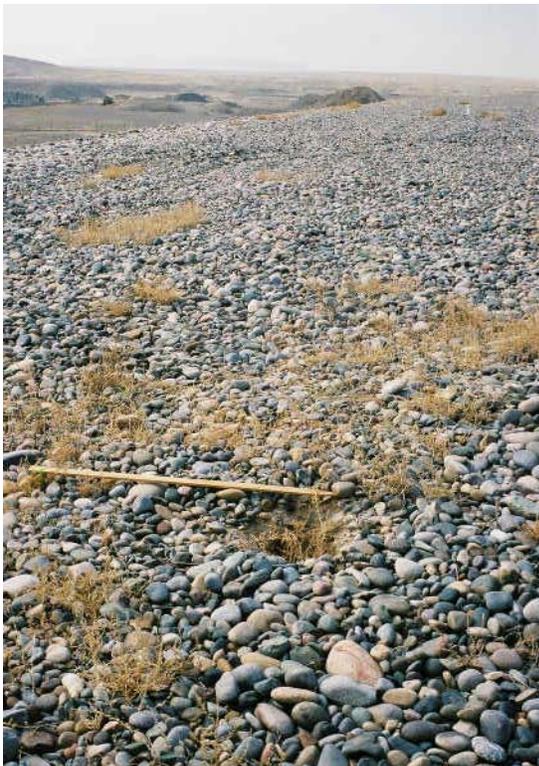
Inspectors observed locations on top of the disposal cell rock cover where the riprap had been pulled back and piezocones installed (PL-2). Vehicle tracks associated with this activity also were evident on top of the disposal cell. The piezocones had been removed by the time of the inspection, and the riprap was replaced after the inspection.

PL-2. Abandoned piezocone location on top of disposal cell cover.

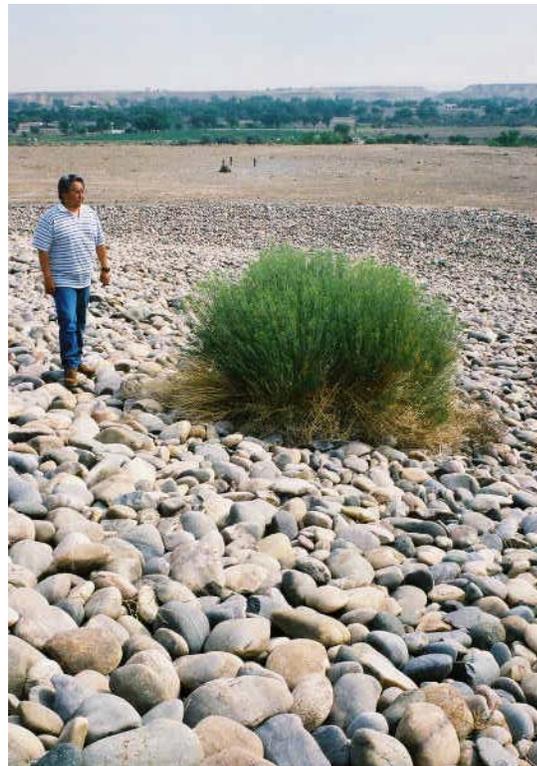
16C Significant vegetation growth has been noted during past inspections on the top and the east, northeast, and northwest side slopes. These areas were sprayed in June 2001 in a continuing effort to reduce the seed source and control future plant encroachment on the disposal cell. Although efforts to control annual weed species at this site have been successful, inspectors noted the population of woody shrubs growing in the storm water diversion channel continues to increase (PL-3). DOE will continue to monitor vegetation growth and will apply herbicide to the annual weeds and woody plants as they appear. No new tamarisk plants were observed in this transect.

PL-3. Rabbitbrush growing on NE side slope.
