2002 Annual Compliance Report Salt Lake City, Utah, Disposal Site

Compliance Summary

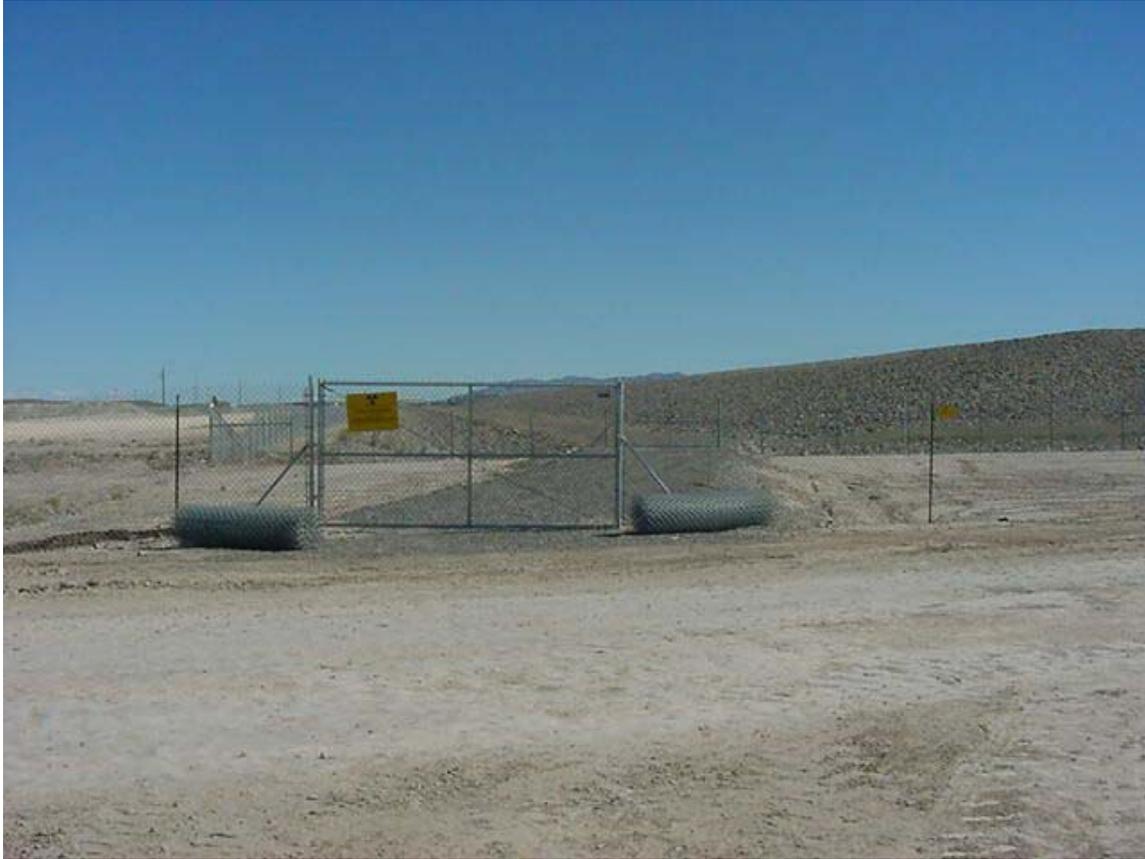
15B Envirocare installed new entrance gates through their fence and DOE’s fence at the southwest corner of the site. The DOE gate was locked and in excellent condition. The former entrance gate at the northwest corner of the site was locked and in good condition.

The entrance sign was relocated by Envirocare from the former entrance gate to the new entrance gate (PL-1). All perimeter signs were present and in good condition.

PL-1. New entrance gate and entrance sign on Envirocare's south fence.
