DOE/OR/21548-236
CONTRACT NO. DE-AC05-86OR21548

WSSRAP BUILDINGS CHARACTERIZATION - CHEMICAL CHARACTERIZATION REPORT

Weldon Spring Site Remedial Action Project
Weldon Spring, Missouri

OCTOBER 1991 **REV. 0**

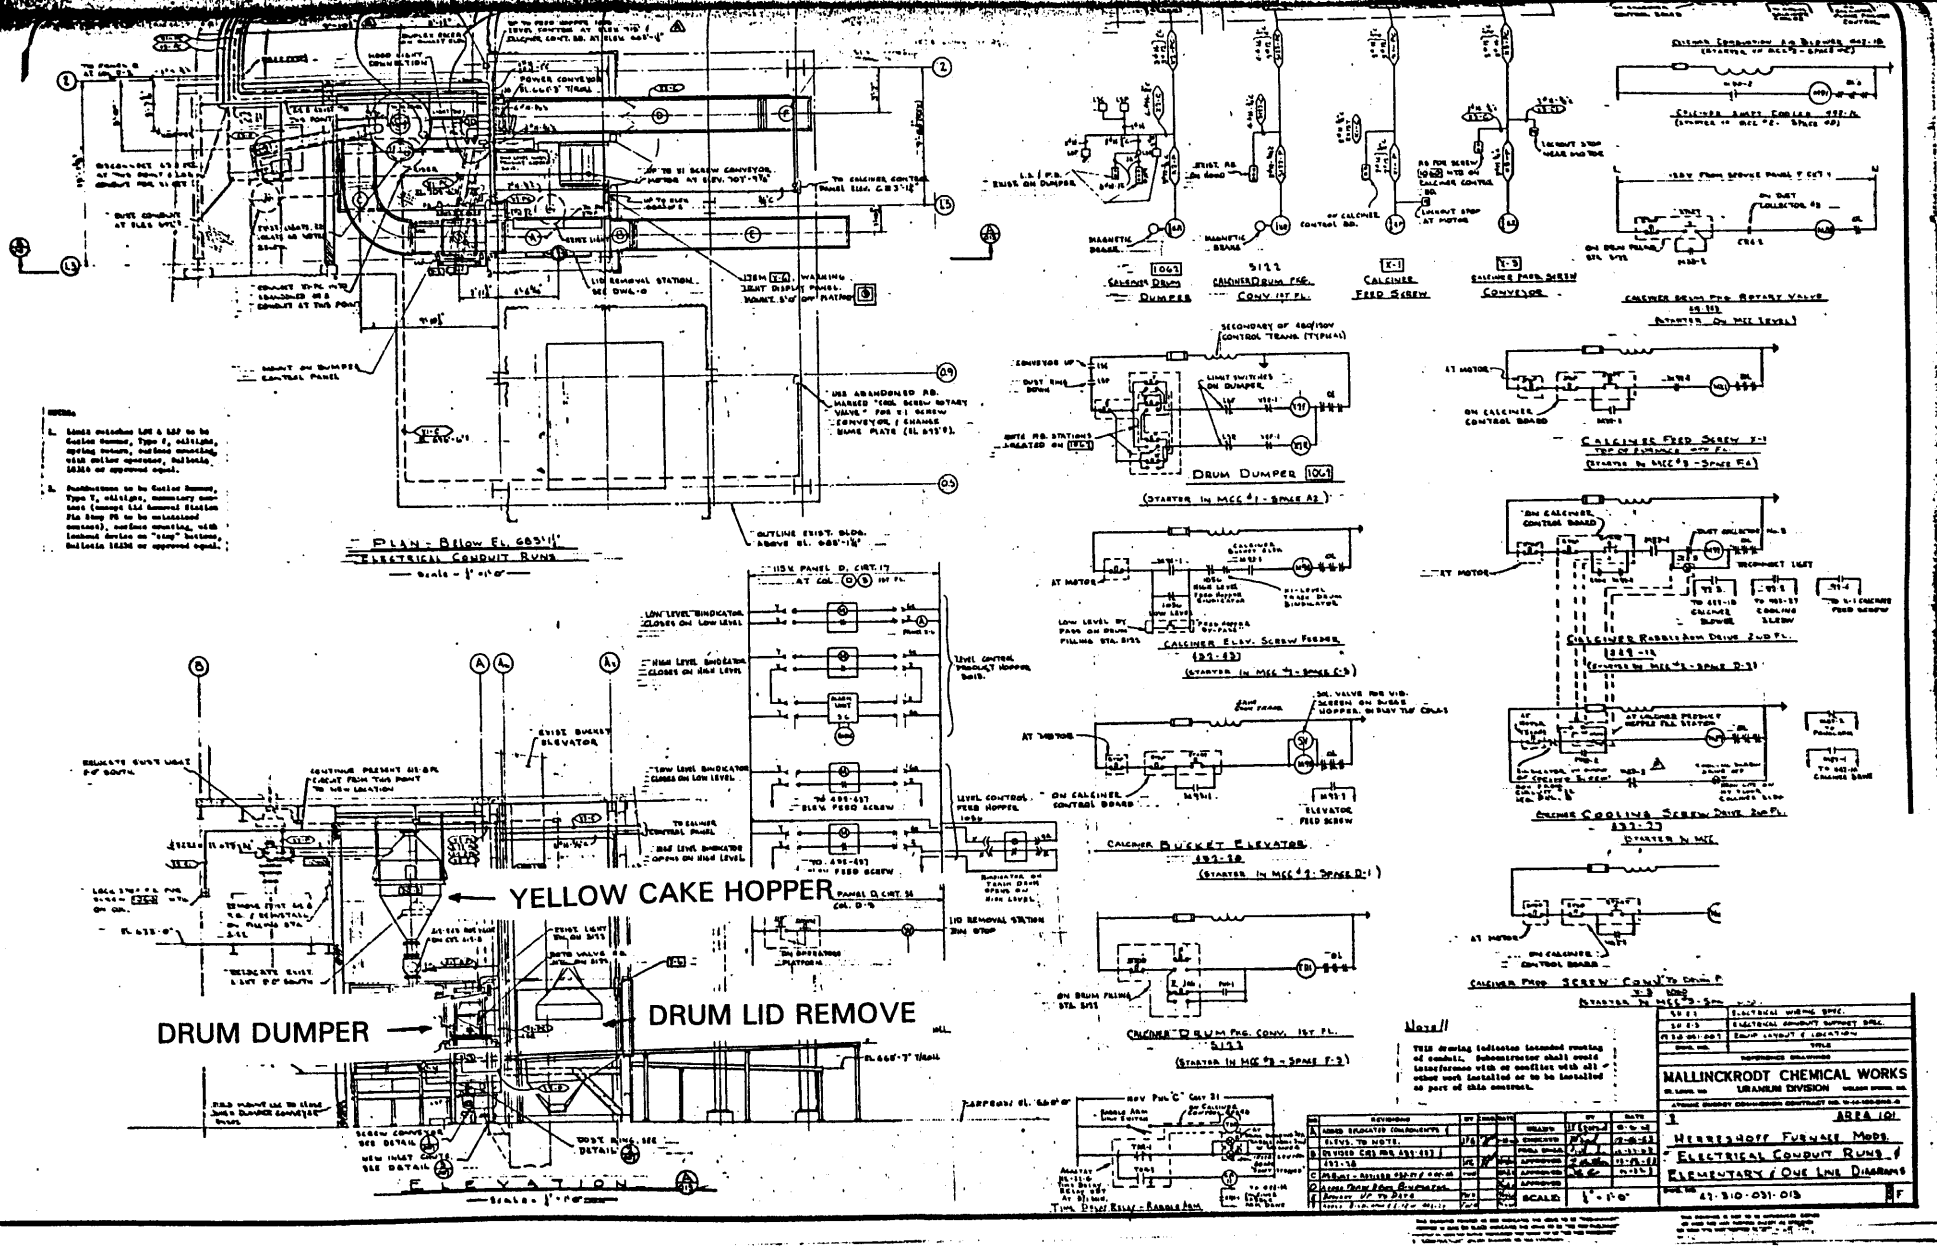
OBSERVATIONS/ANALYSIS: Resource Conservation Recovery Act (RCRA) hazardous waste residues are not present in this building. Residues of yellow cake and uranium oxides are present in the calciner, hoppers, drum lid removal and drum dumper systems, and the vacuum cleaning system. These residues are easily detected by field geiger counter, and will be removed, encapsulated, or contained to prevent future release to the environment. The level of polychlorinated biphenyls (PCBs) contamination in this building is under the 100 $\mu g/100\ cm^2$ action level.

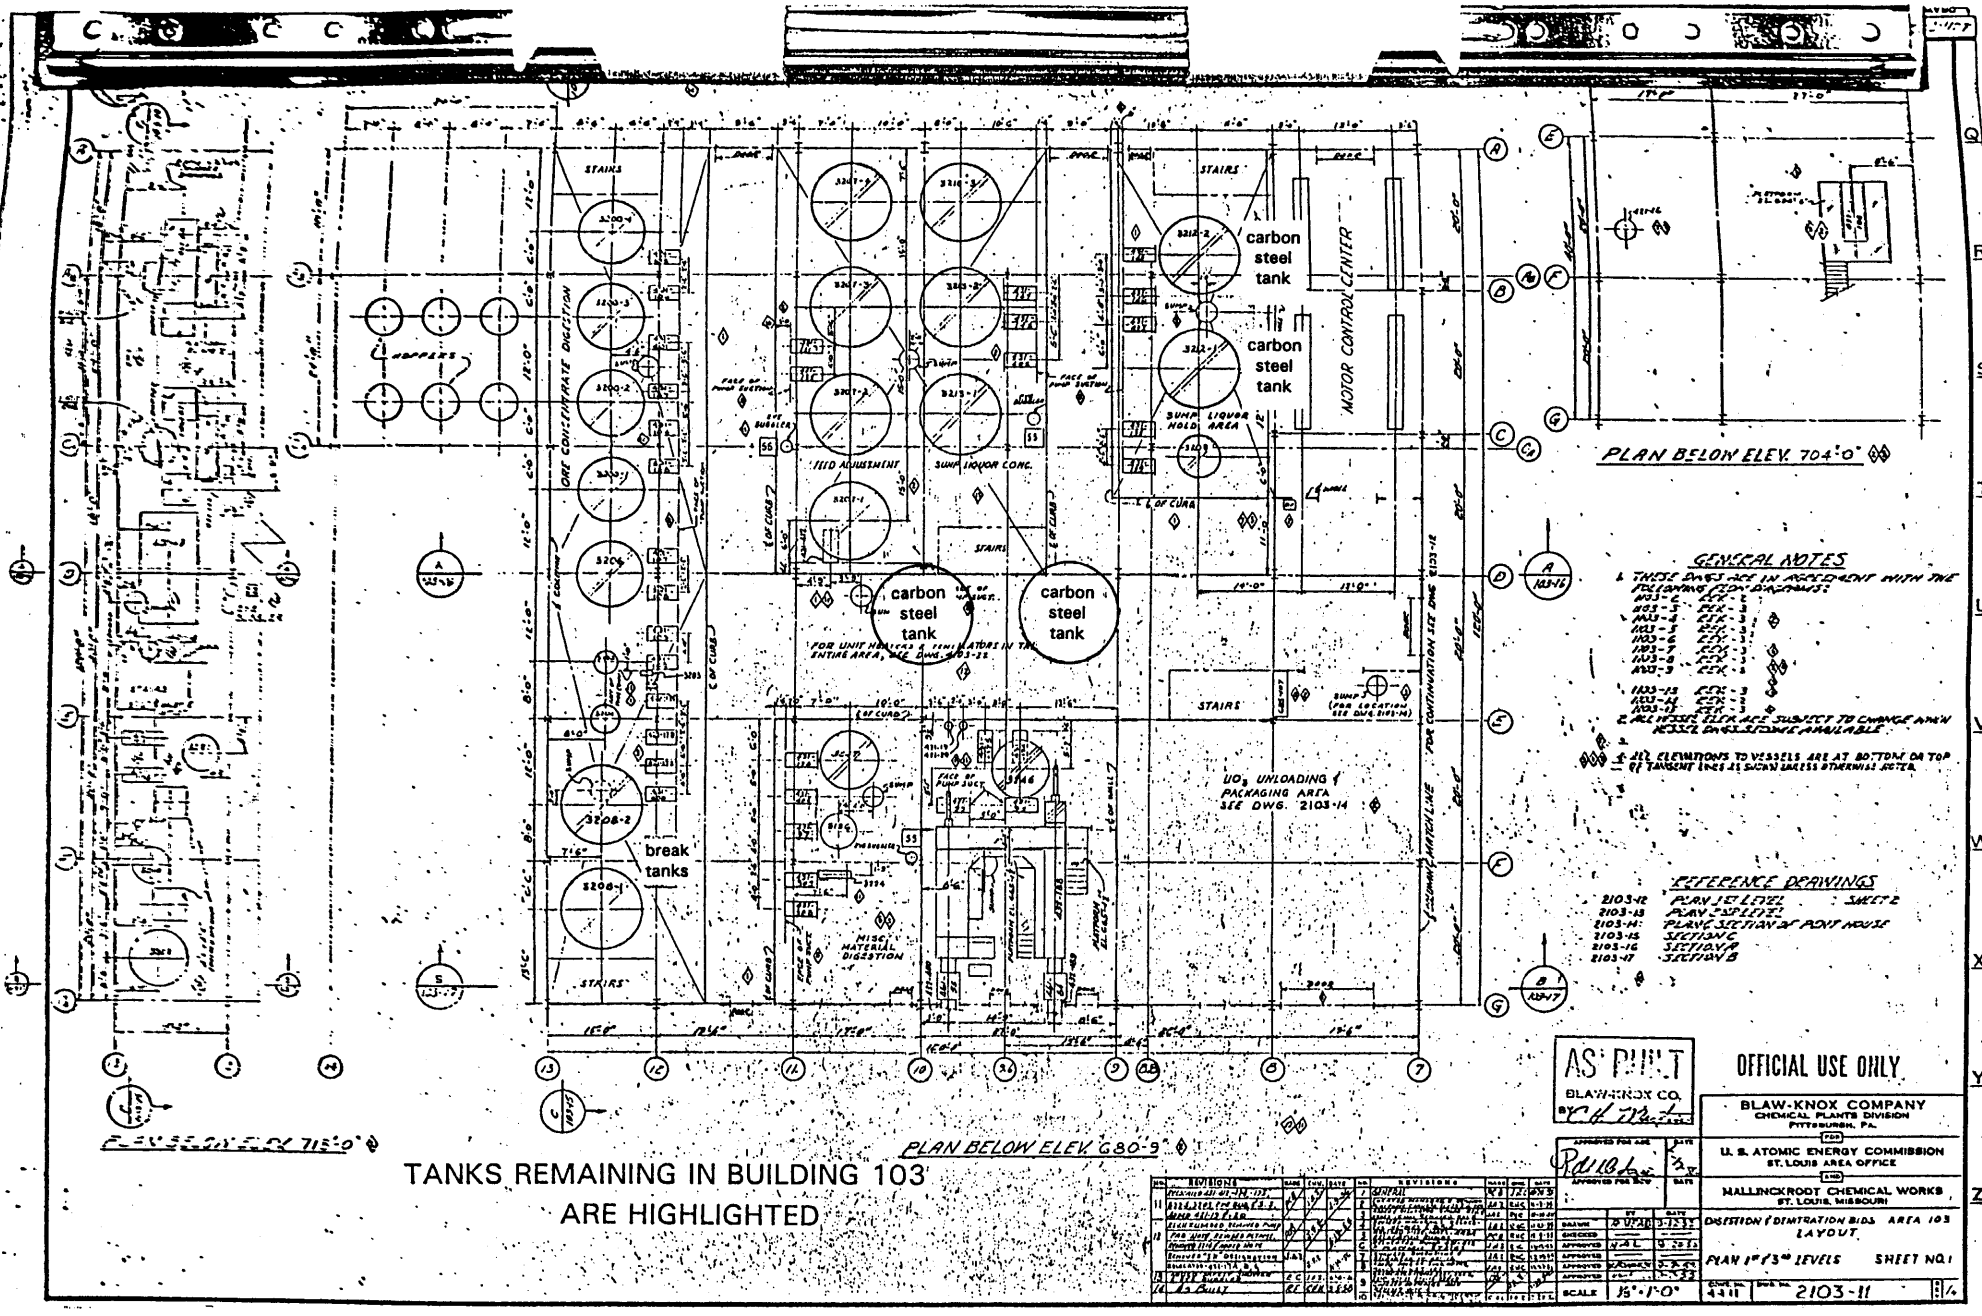
TANKS REMAINING IN BUILDING 103
ARE HIGHLIGHTED

ANALYSIS/OBSERVATIONS: A representative sample of solid lime was dissolved in water to make a 10% solution. The pH of this solution was 8. Free oils remaining in gear boxes will be removed prior to or during demolition. One oil spot in the upper level of

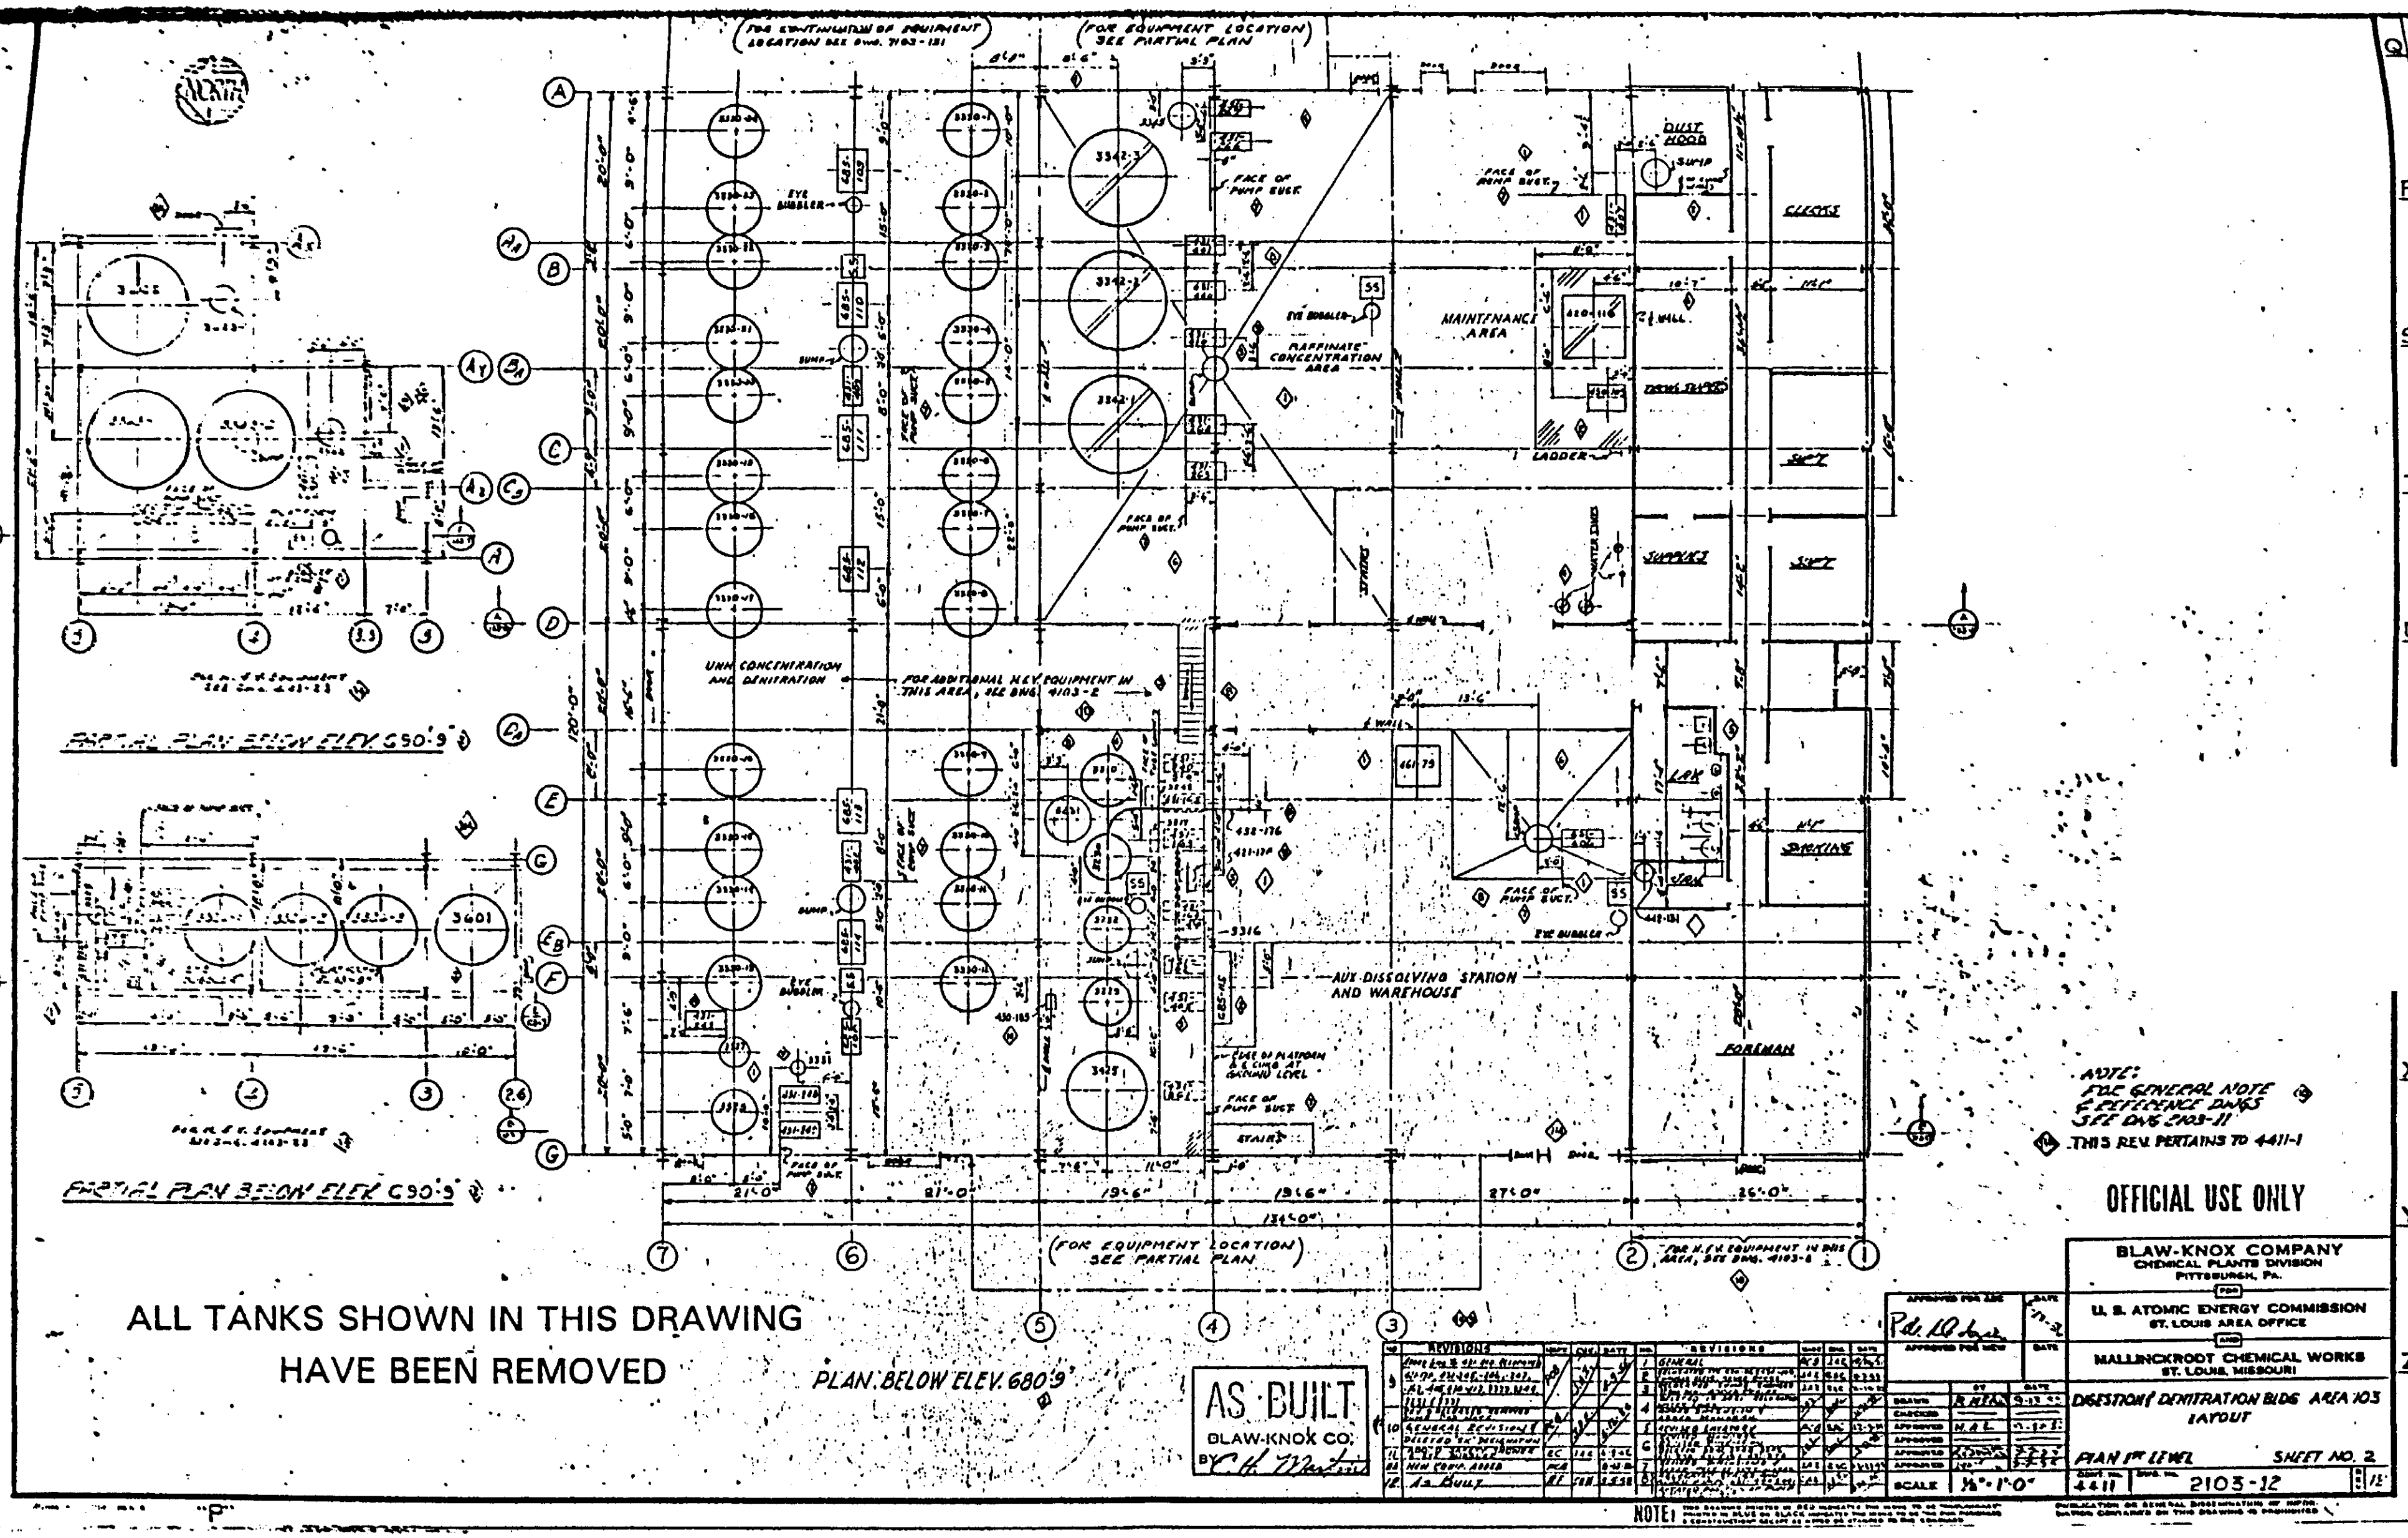
Two locations in this building were found to be in excess of the PCB cleanup threshold for low-contact restricted areas.

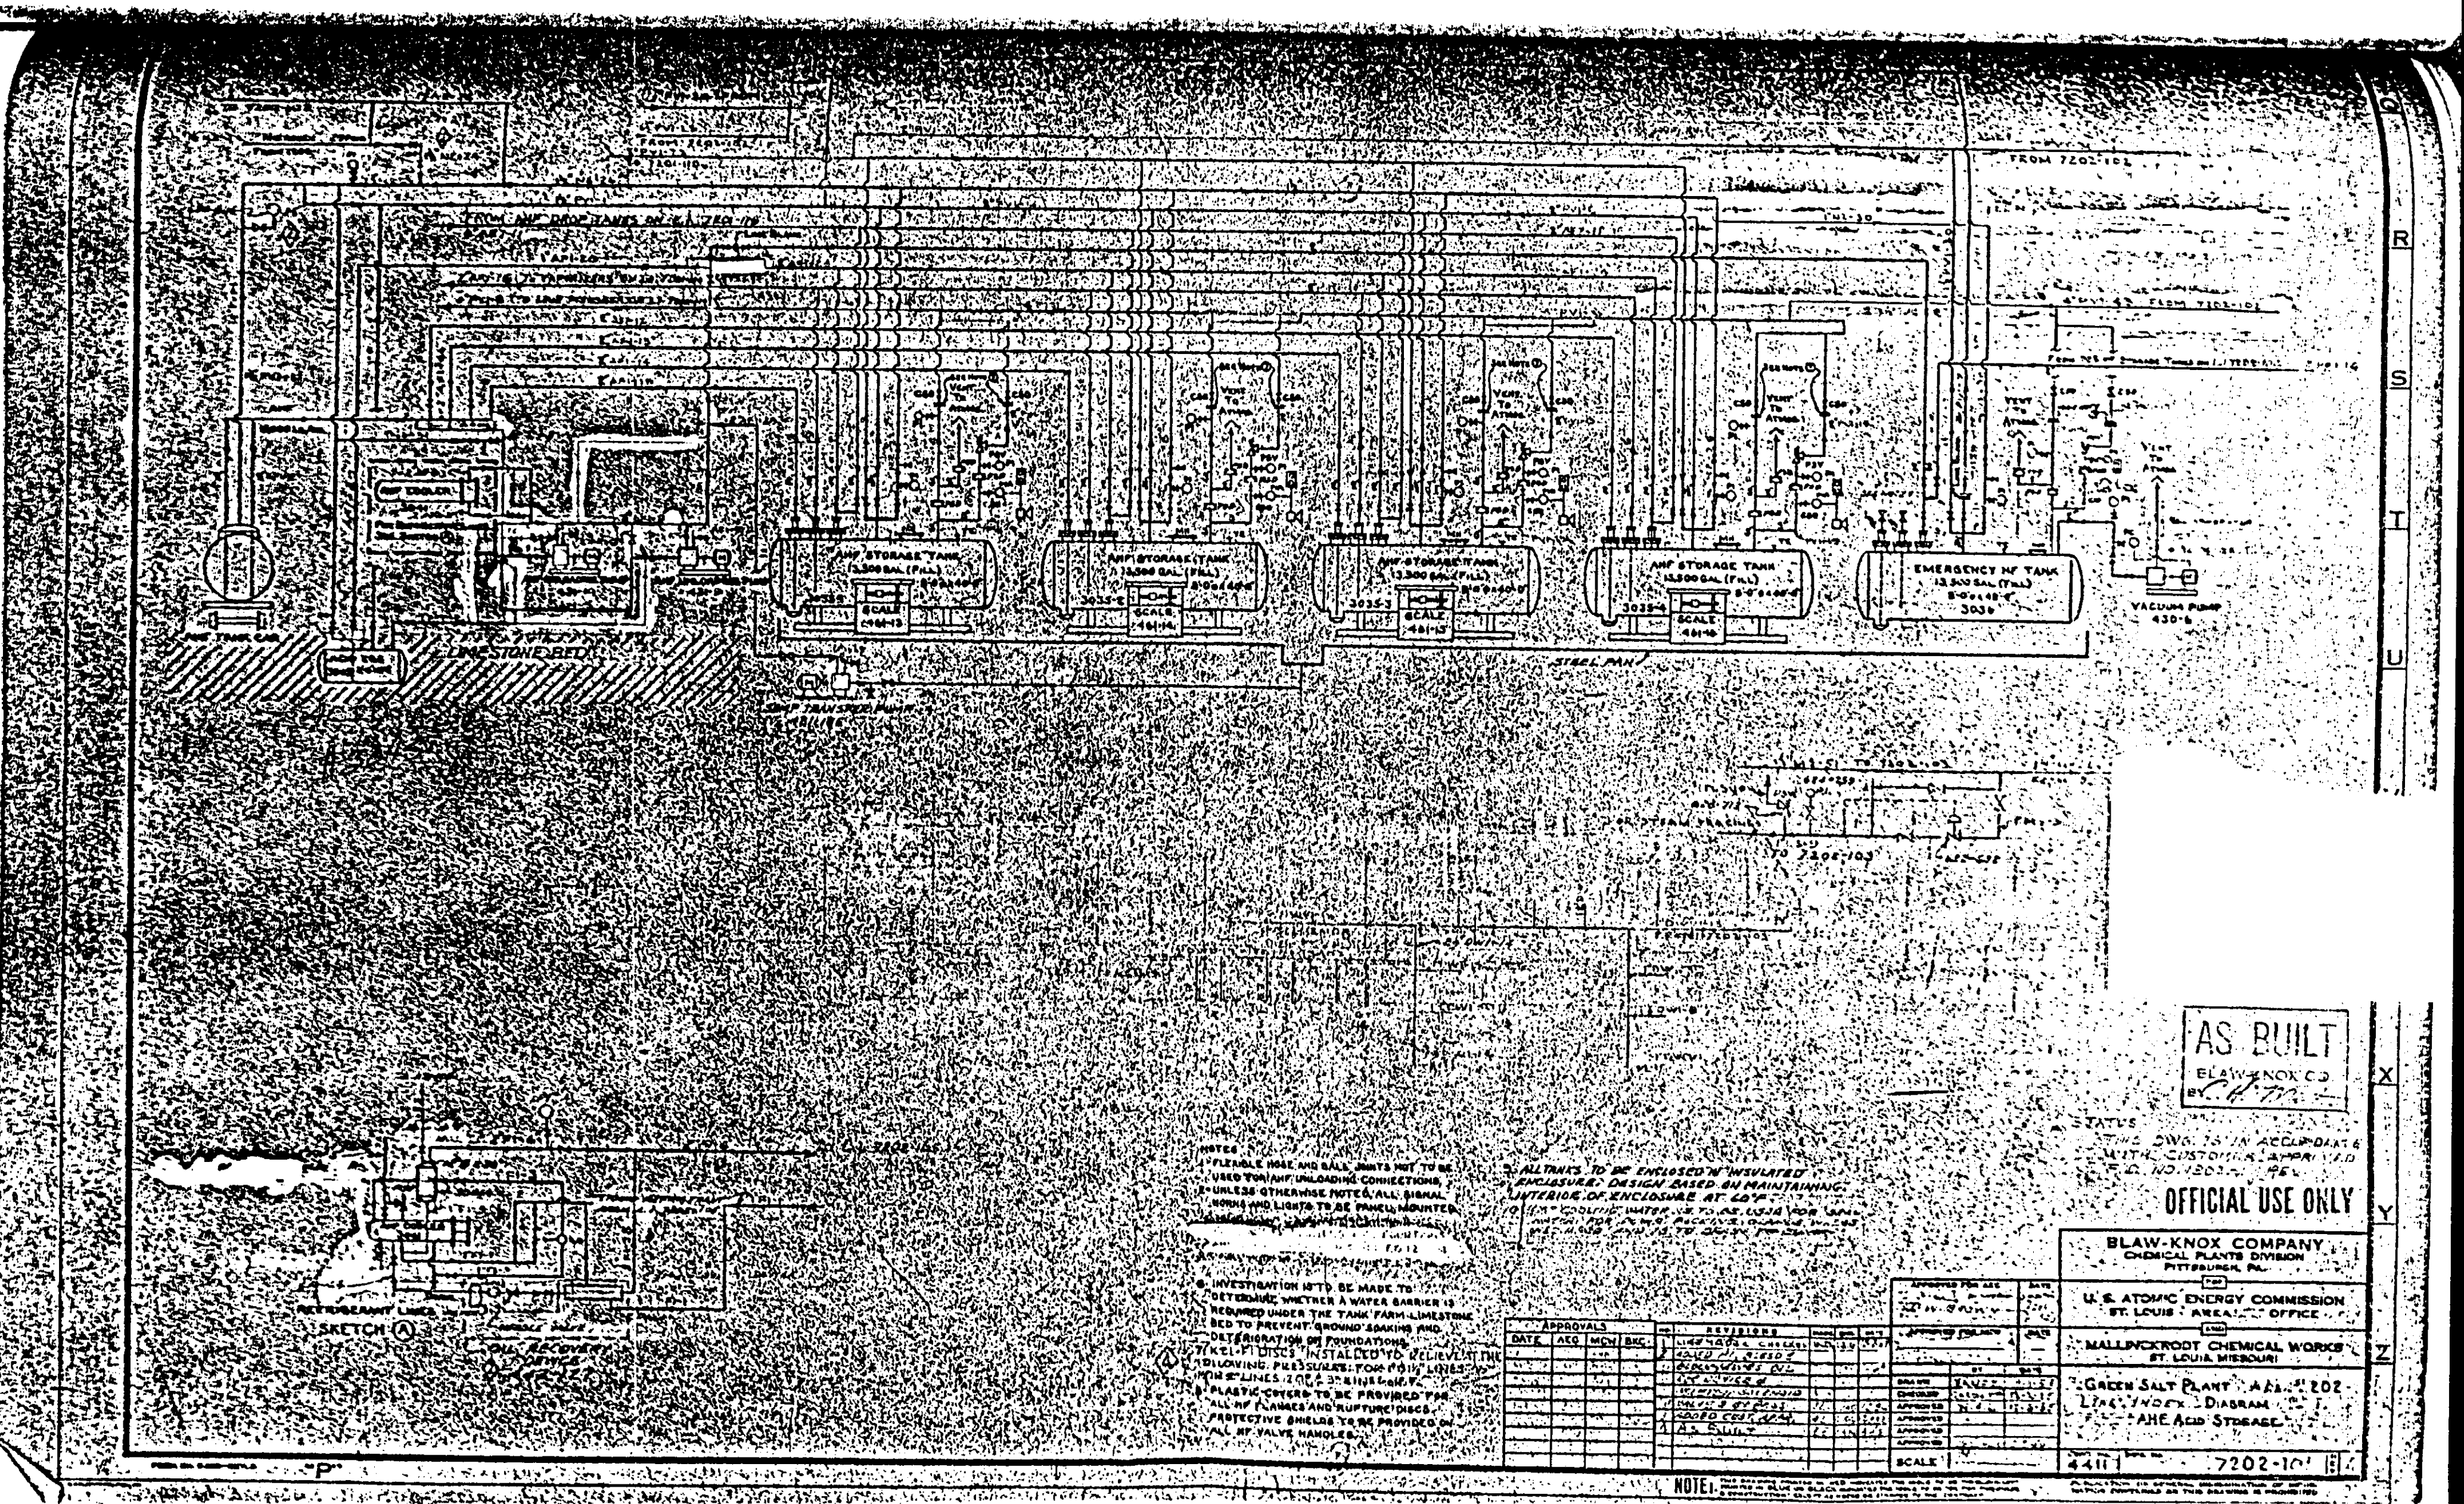
OBSERVATIONS/ANALYSIS: All eight HF/AHF tanks were opened for inspection and sampling. Six of the tanks were empty. The inner walls of these six tanks, numbers 0060, 0061, 0063, 0064, 0066, and 0067 showed a pH ranging from 4 to 7; geiger counter readings

were 3x background. Tank 0065, previously used for storage of 70% HF, has a rubber liner and contains a small amount of light green solid residue. A sample has been taken for further analysis, and the results are pending. Field analysis showed that the pH of tank 0065 is <2. Tank 0062, previously used for AHF storage, contains ~5 to 10 gal of free liquid with a pH of 10. It appears that efforts were made to neutralize this tank. A ring of suspected neutralizing agent (i.e. sodium carbonate) was observed at the bottom of the tank. All eight tanks have been vented to the atmosphere for an extended period of time - at least three years.

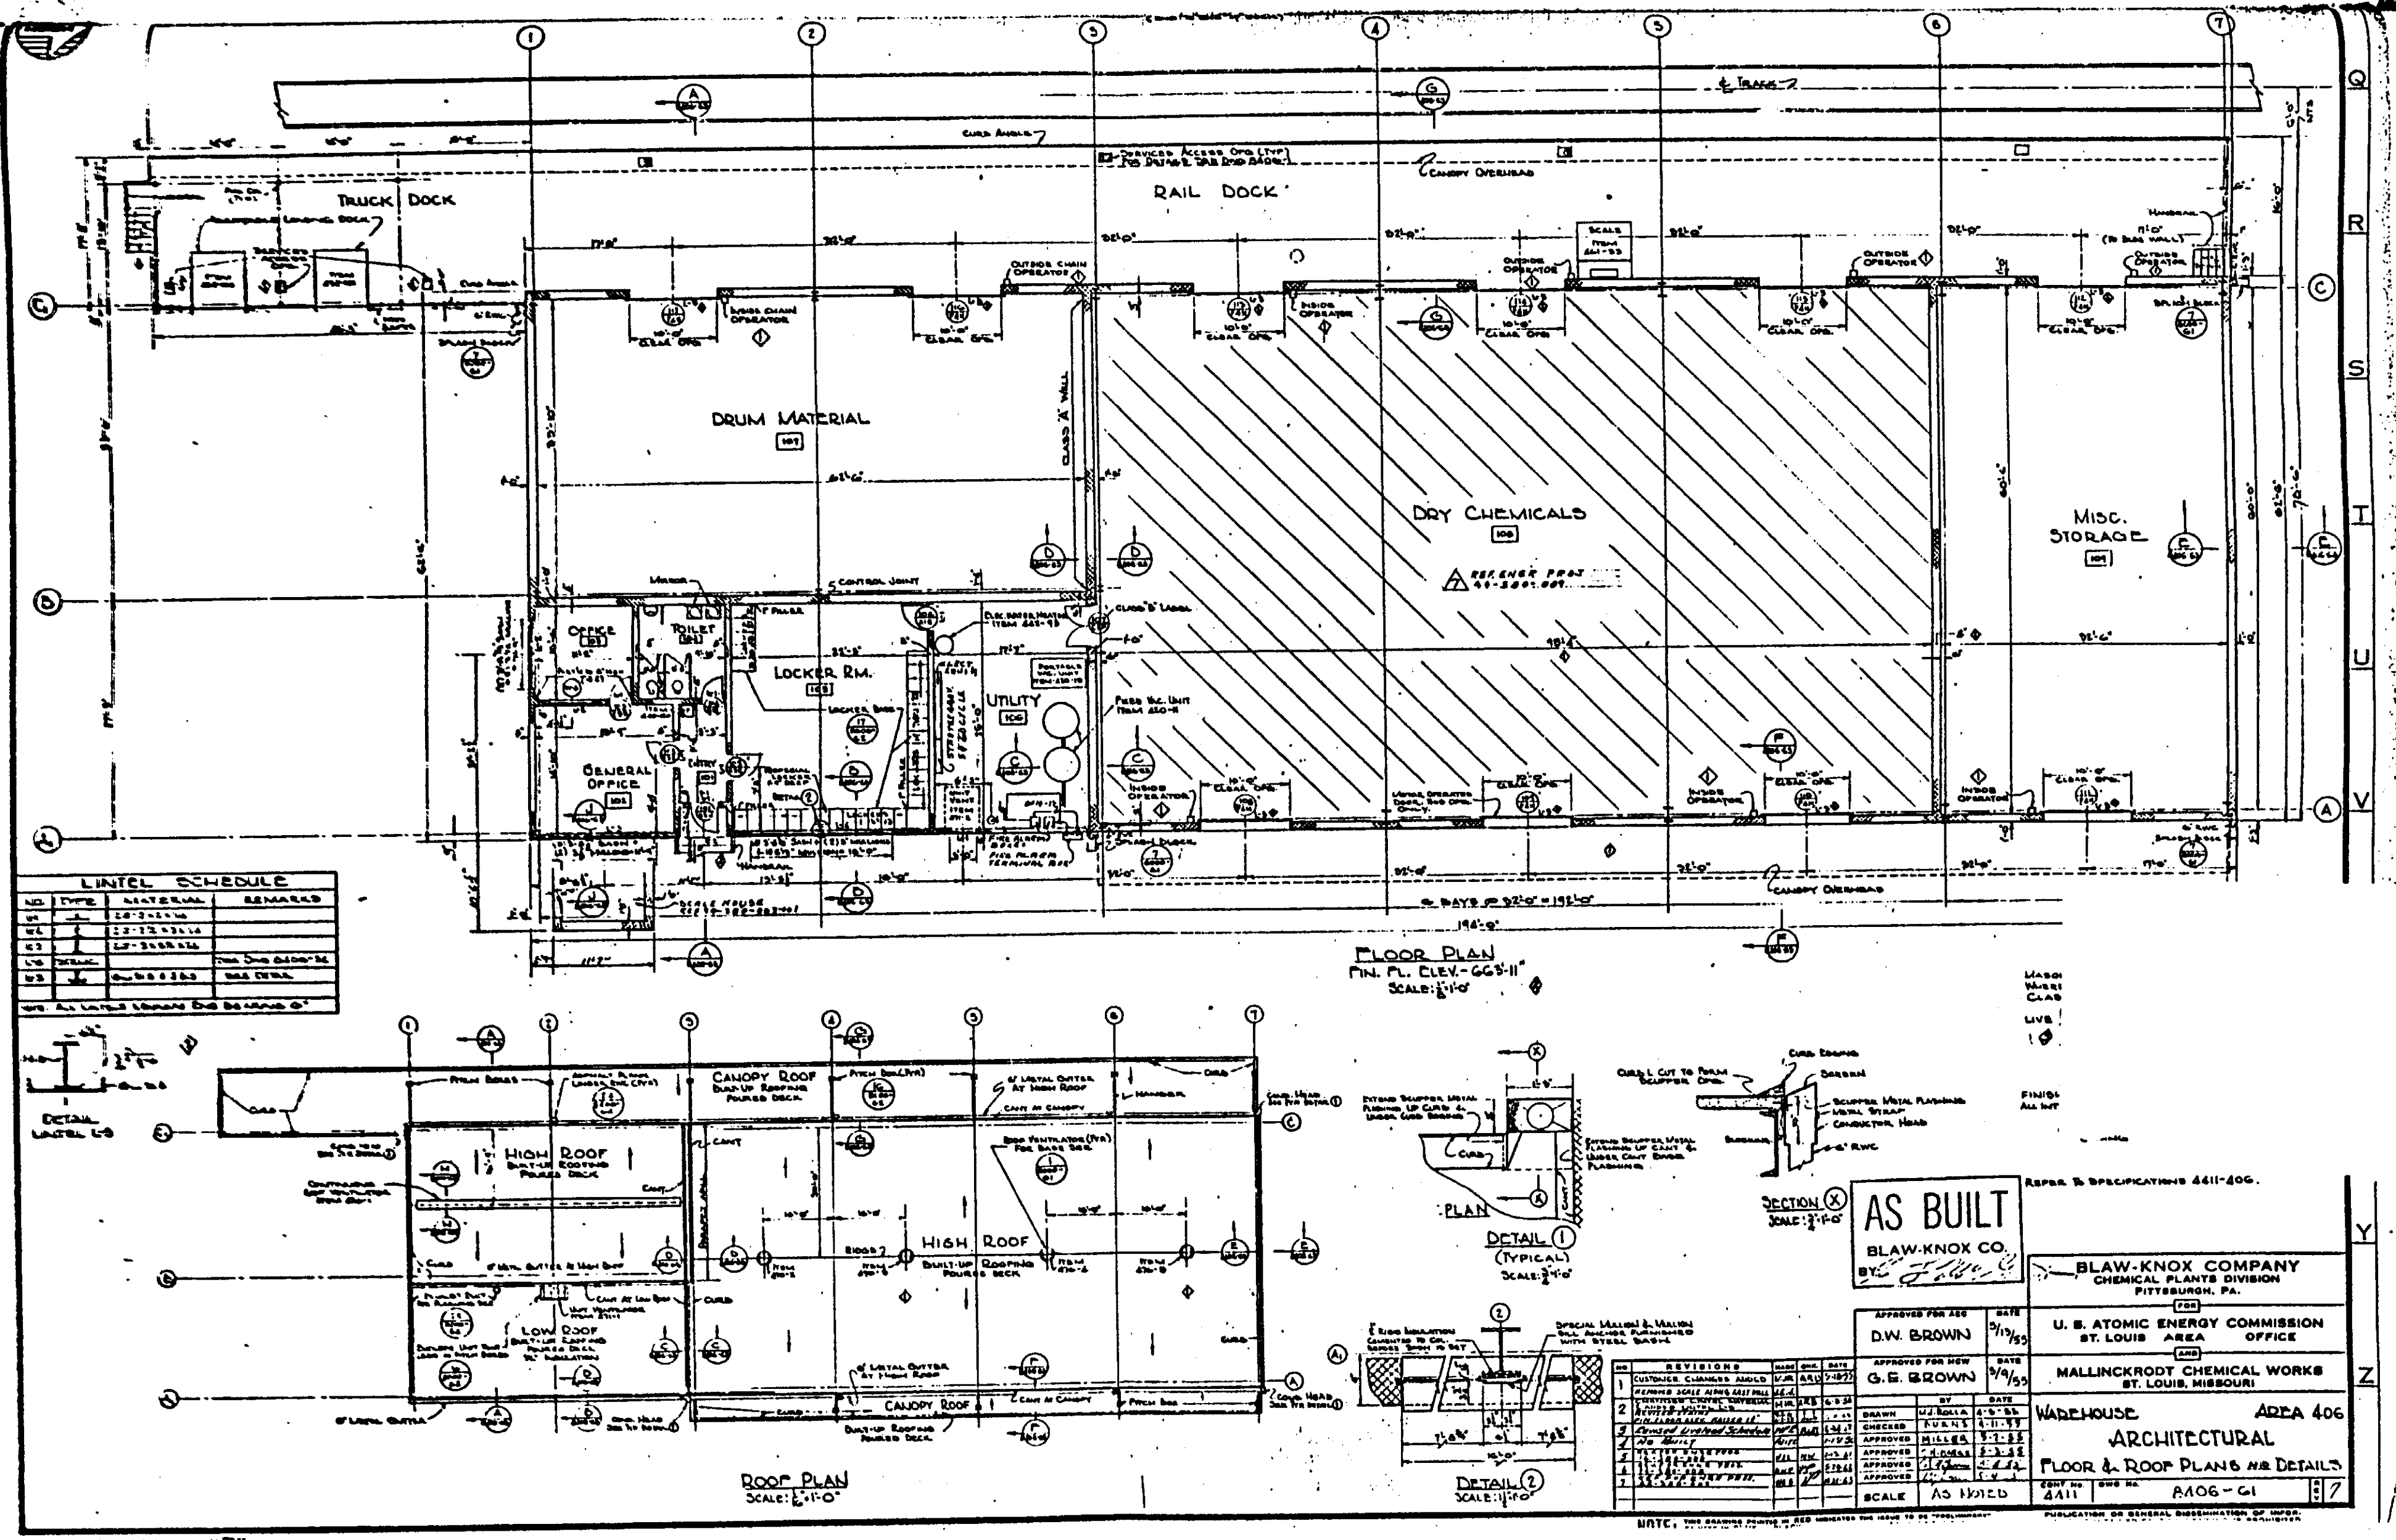
OBSERVATIONS/ANALYSIS: PCB contamination was detected on the floor in the restroom.
