DOE/OR/21548-236
CONTRACT NO. DE-AC05-86OR21548

WSSRAP BUILDINGS CHARACTERIZATION - CHEMICAL CHARACTERIZATION REPORT

Weldon Spring Site Remedial Action Project
Weldon Spring, Missouri

OCTOBER 1991 **REV. 0**

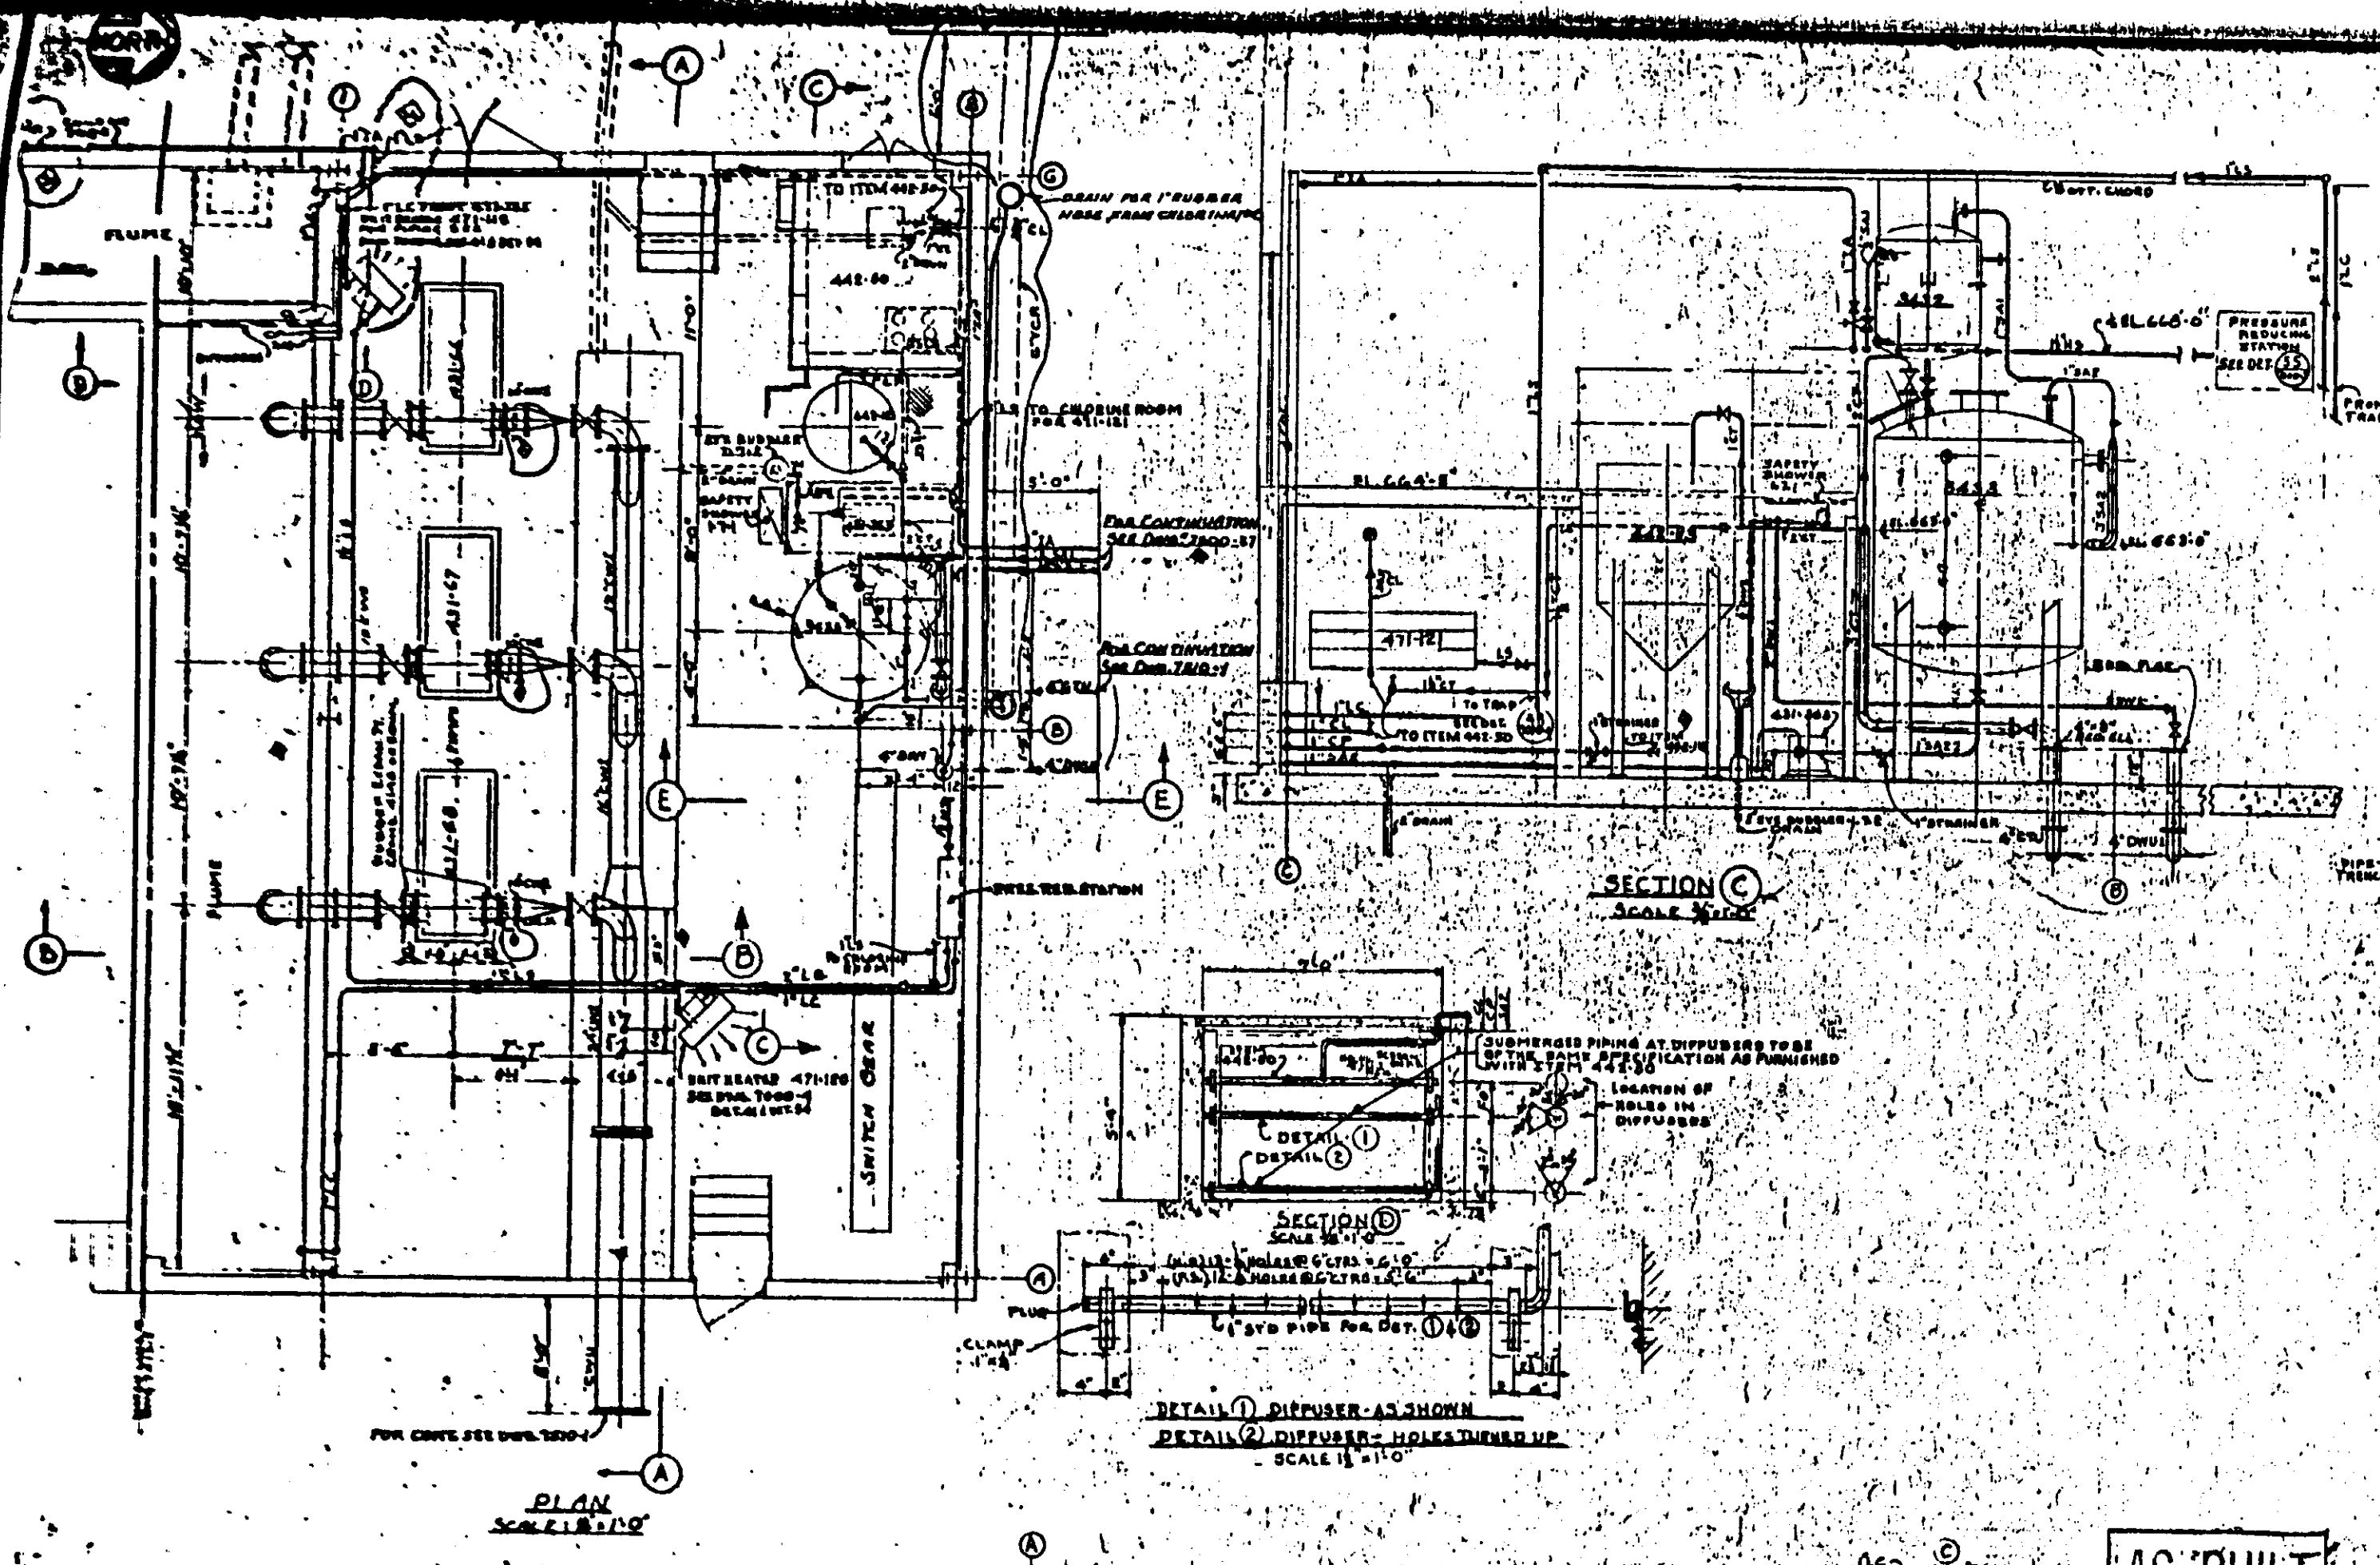
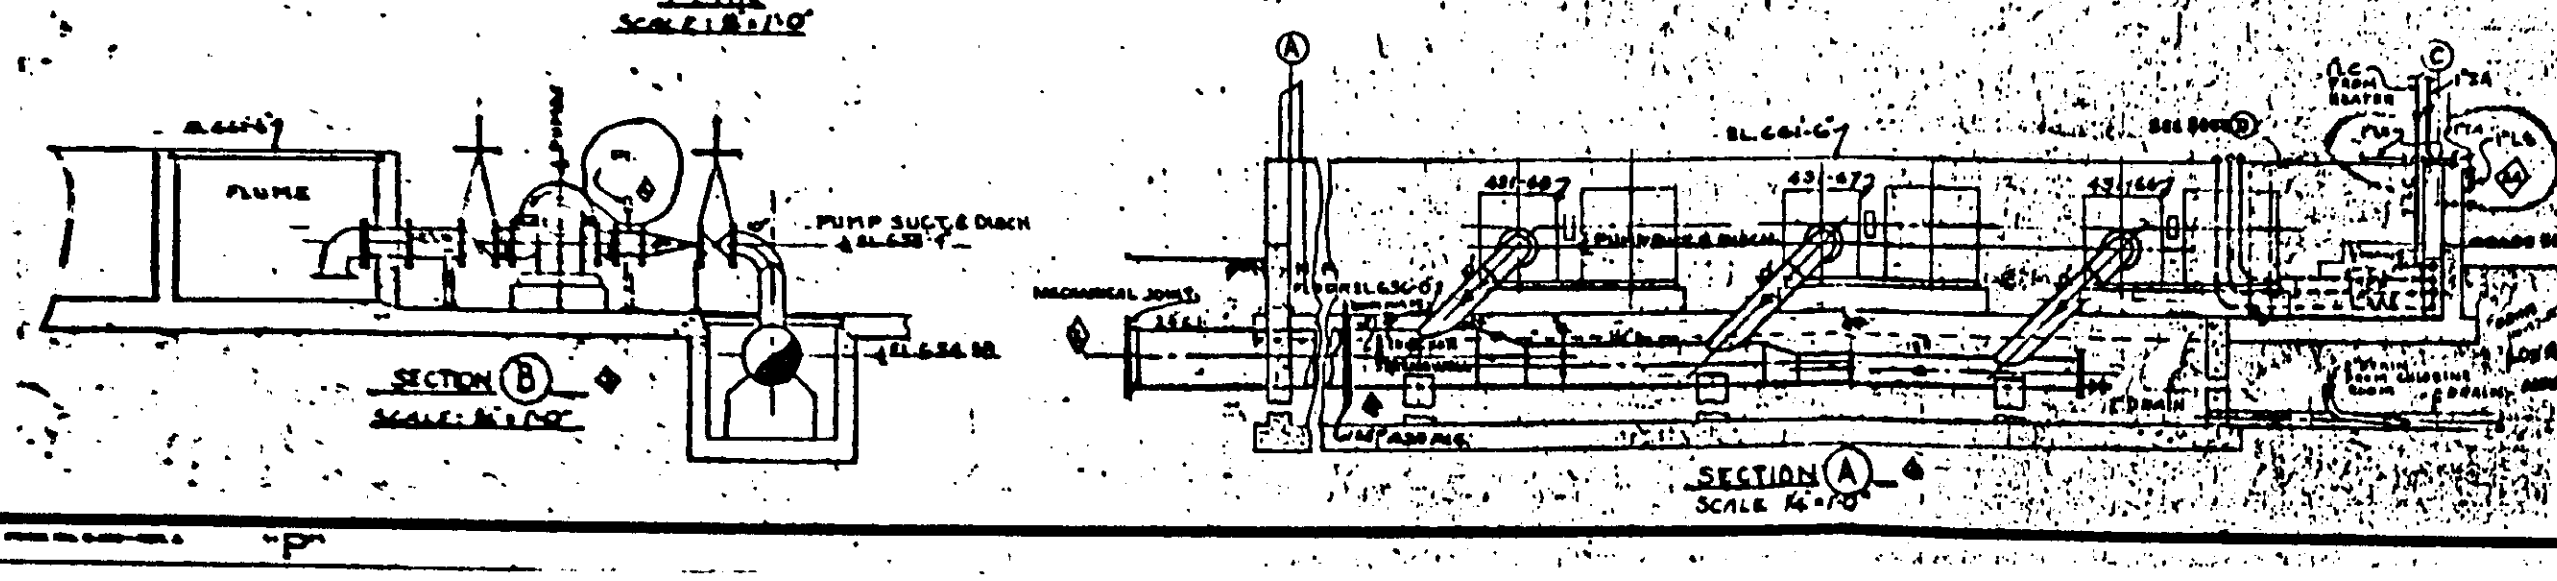
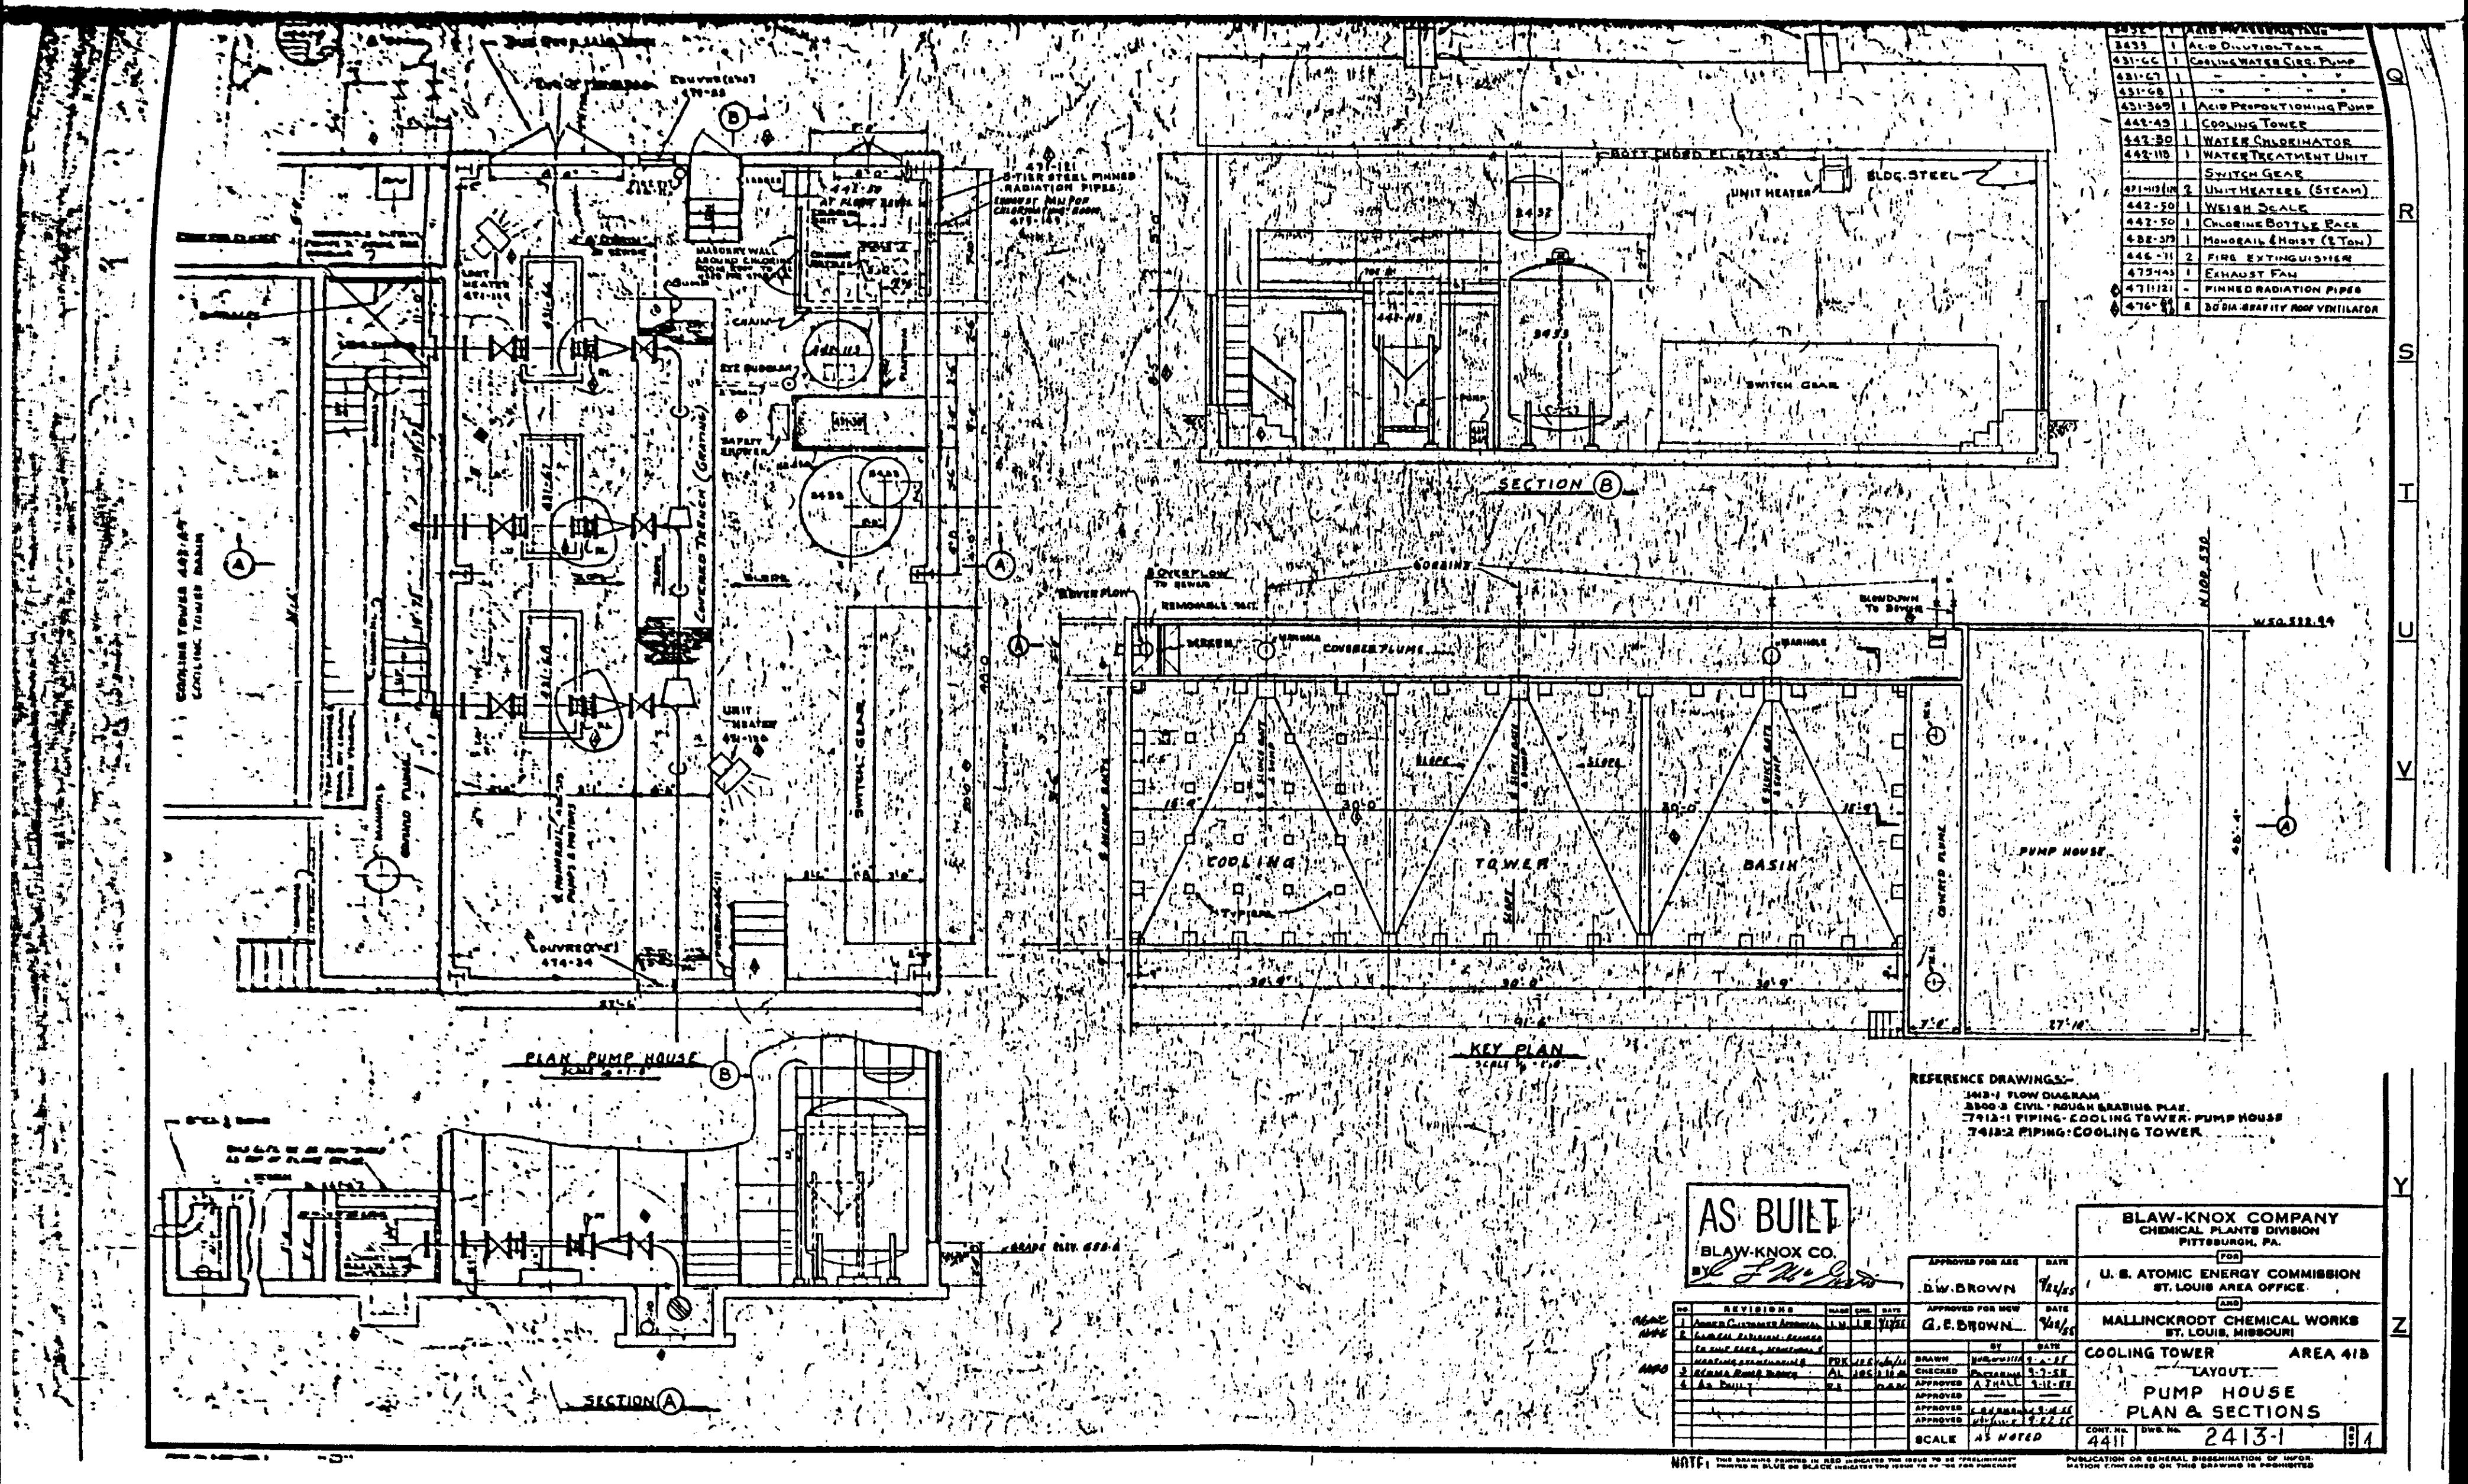
OBSERVATIONS/ANALYSIS: The acid mix tank was found to be pH neutral. One PCB wipe test location was >100 $\mu g/100\ cm^2$. The wood used to construct the cooling towers is tainted with arsenic above the toxicity characteistic leaching procedure (TCLP) extract limit, 5.0 mg/L.

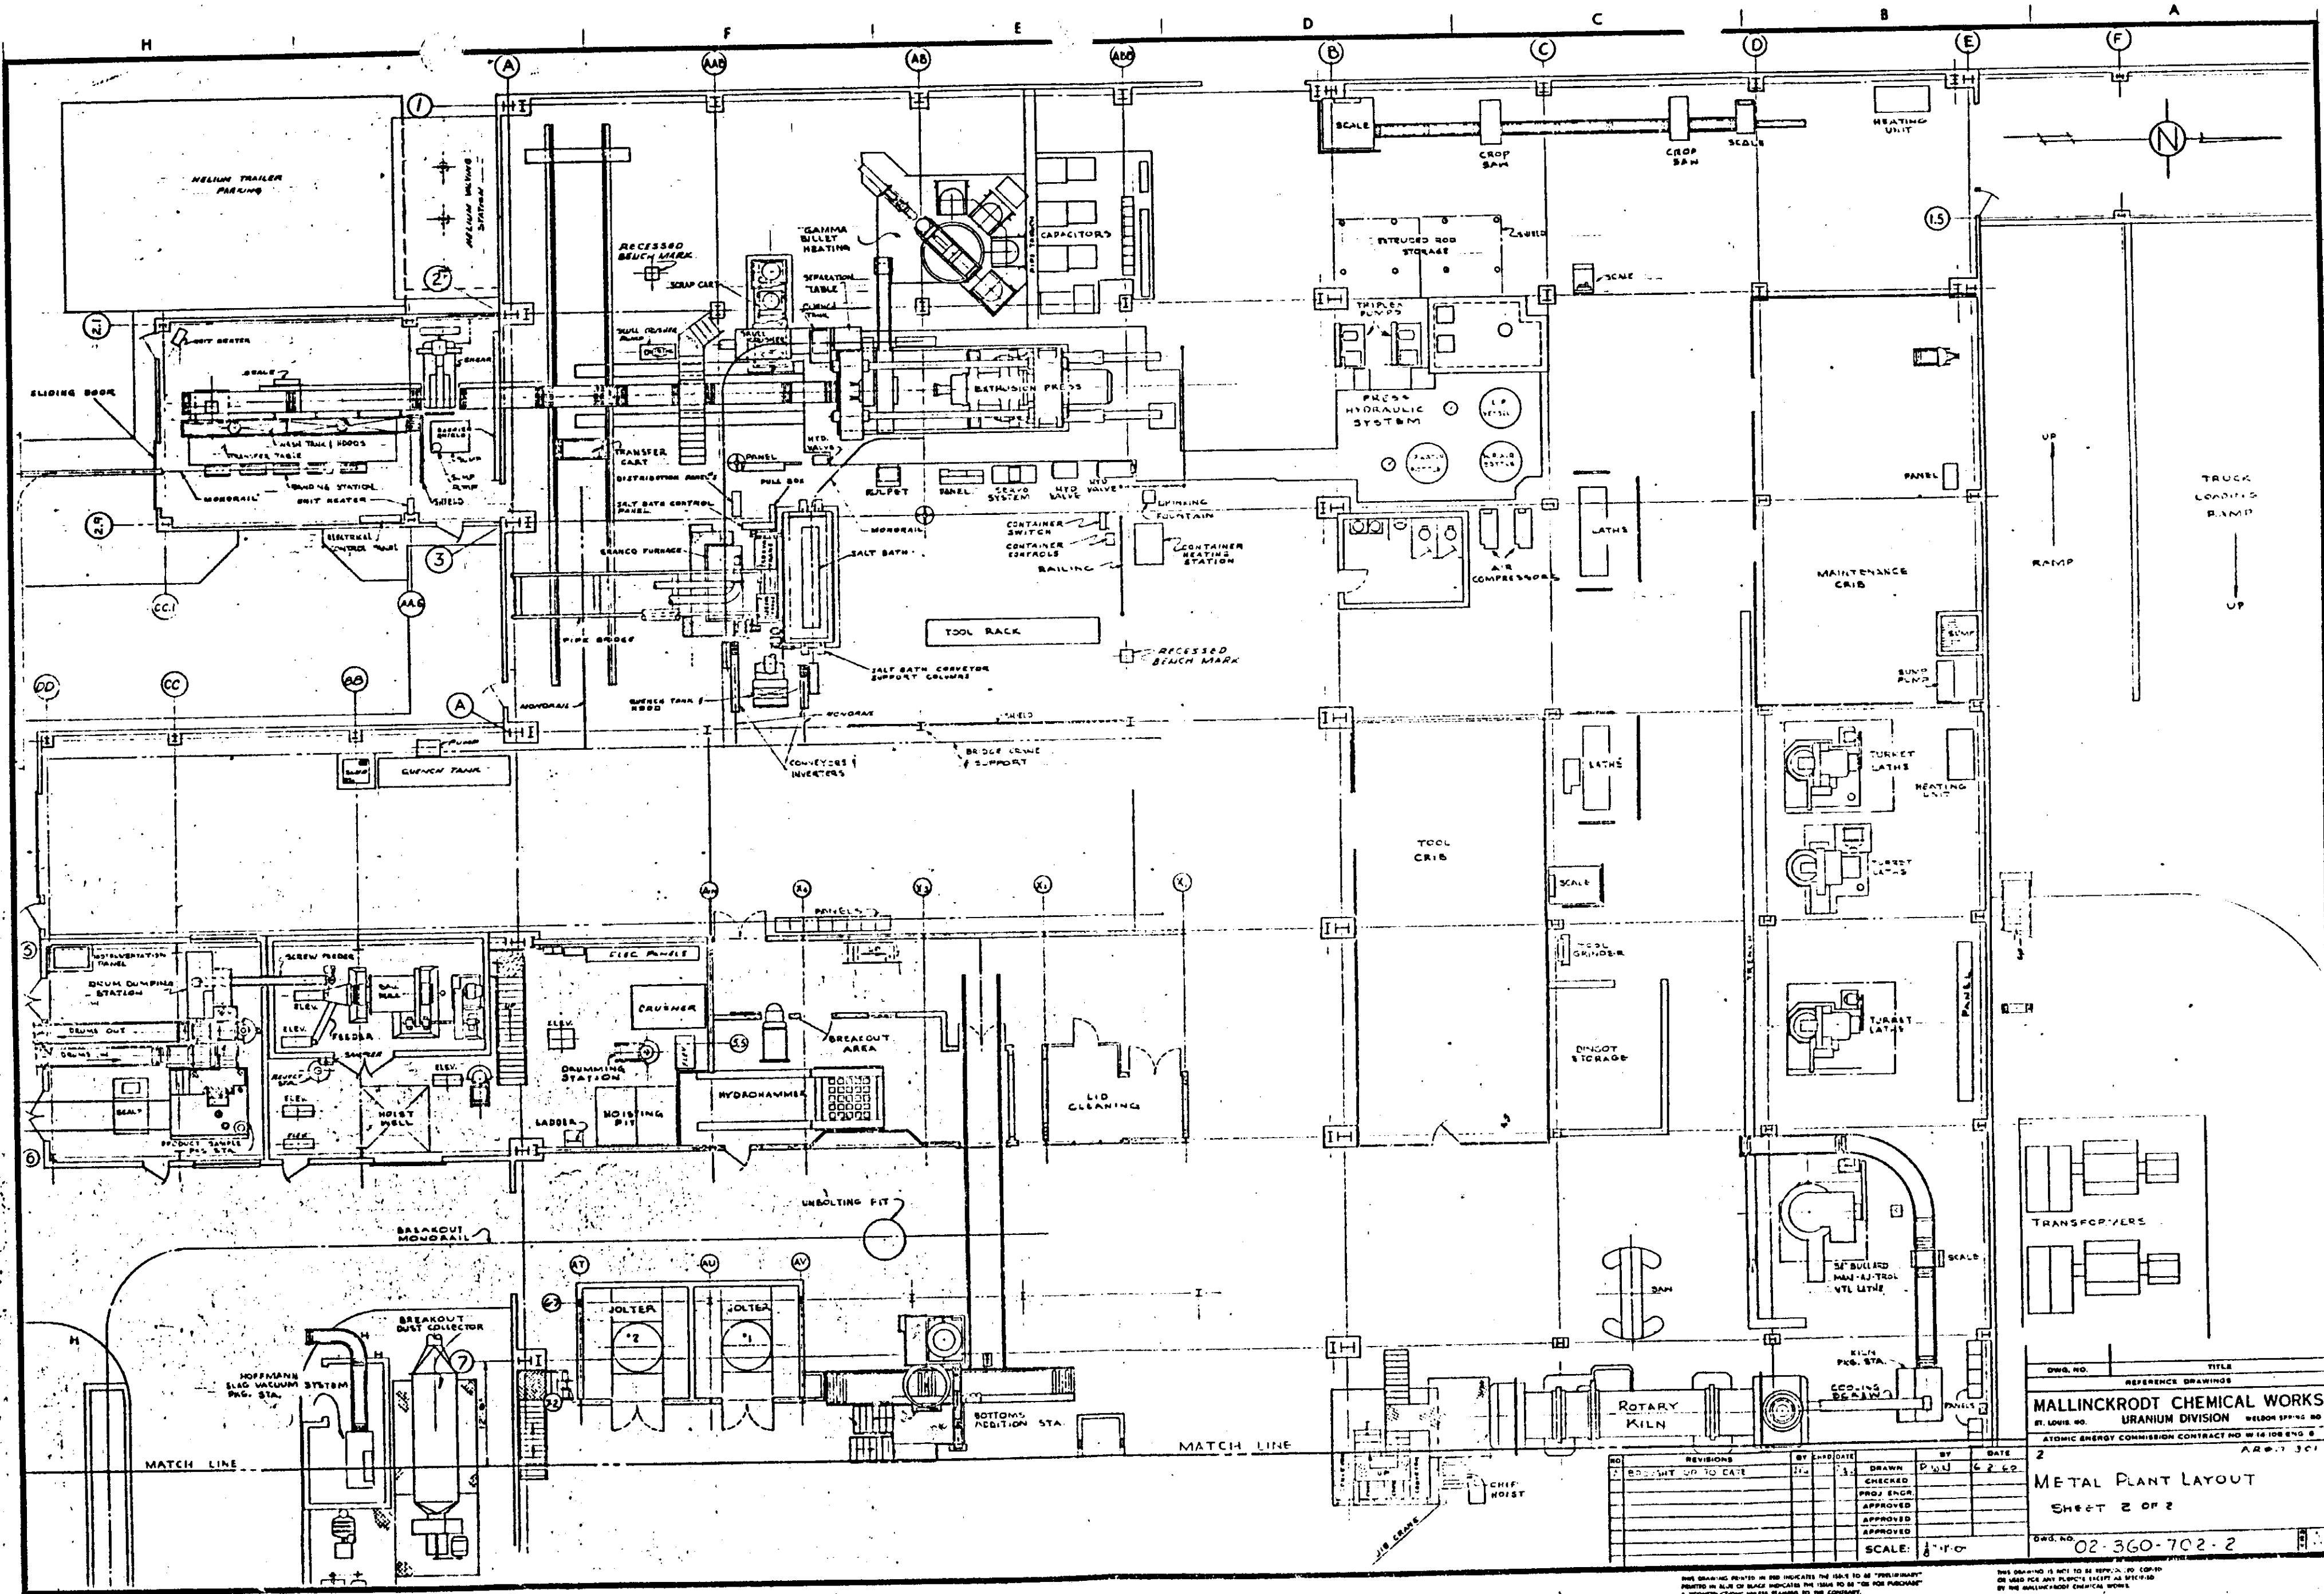
Another salt bath is present in the extrusion press and billet heater area. The salt bath in the extrusion press area was used as a receptacle for miscellaneous debris during plant shutdown. No chemical residues were observed.

PCB contamination is likely to be present in the capacitor cabinets in the billet heater area. Visible leaks were noted on many of the capacitors taken out of these cabinets.
