2002 Annual Compliance Report Burrell, Pennsylvania, Disposal Site

Compliance Summary

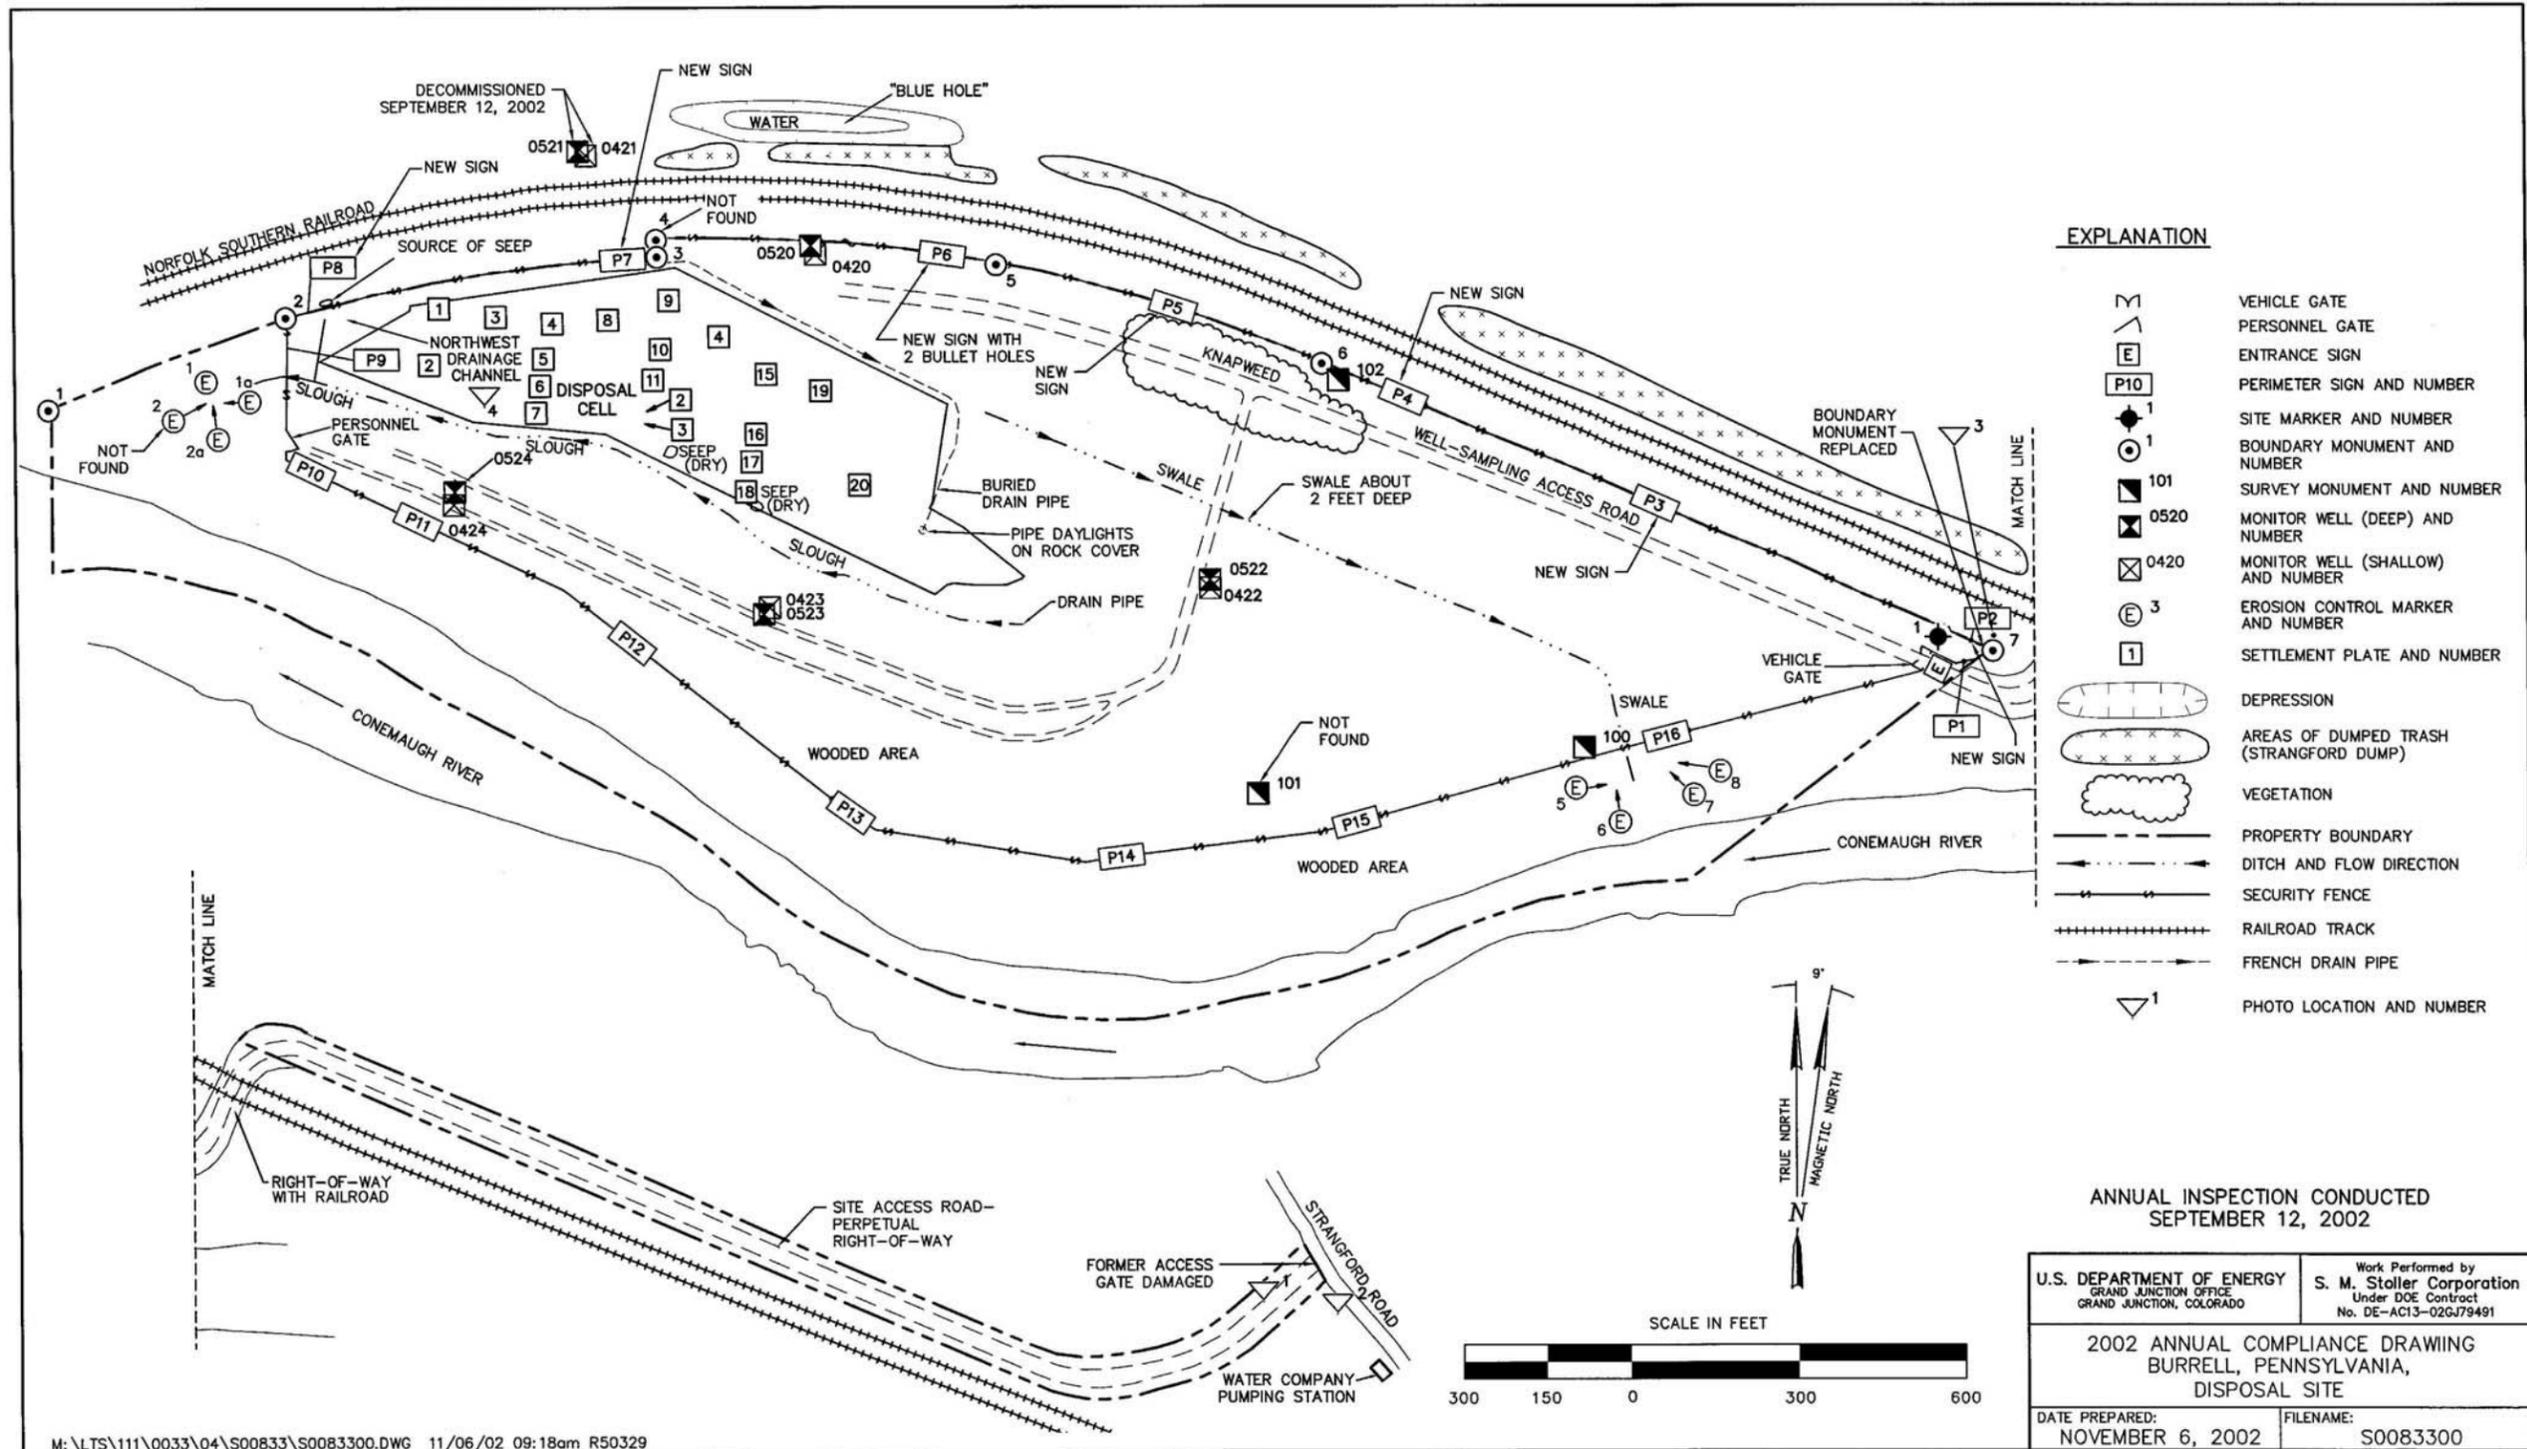
Figure 2-1. 2002 Annual Compliance Drawing for the Burrell, Pennsylvania, Disposal Site

2C The entrance sign and 17 perimeter signs are attached to the security fence. Over the past several years, inspectors noted that perimeter signs along the northern perimeter fence between perimeter sign locations P1 and P8 were progressively more damaged by gunfire to the point where, in 2001, the signs were essentially illegible. DOE replaced the damaged signs in December 2001. Inspectors found the new signs in reasonably good condition, although perimeter sign P6 already had two bullet holes in it. Because access to the other side of the site is more difficult, the remaining perimeter signs were in good condition.

2D The site has three survey monuments (SM-100, SM-101, and SM-102) and seven boundary monuments (BM-1 through BM-7). Because of dense vegetation, inspectors could not locate survey monument SM-1 or boundary monument BM-4. Remaining markers and monuments were undisturbed and in excellent condition. The cap on boundary monument BM-7, found sheared off in 2001, was replaced in December 2001 (PL-3).

DOE replaced damaged perimeter signs, repaired a boundary monument, and cleared vegetation from fence lines and monitor well access routes.
