2002 Annual Compliance Report Rifle, Colorado, Disposal Site

Figure 14-1. 2002 Annual Compliance Drawing for the Rifle, Colorado, Disposal Site

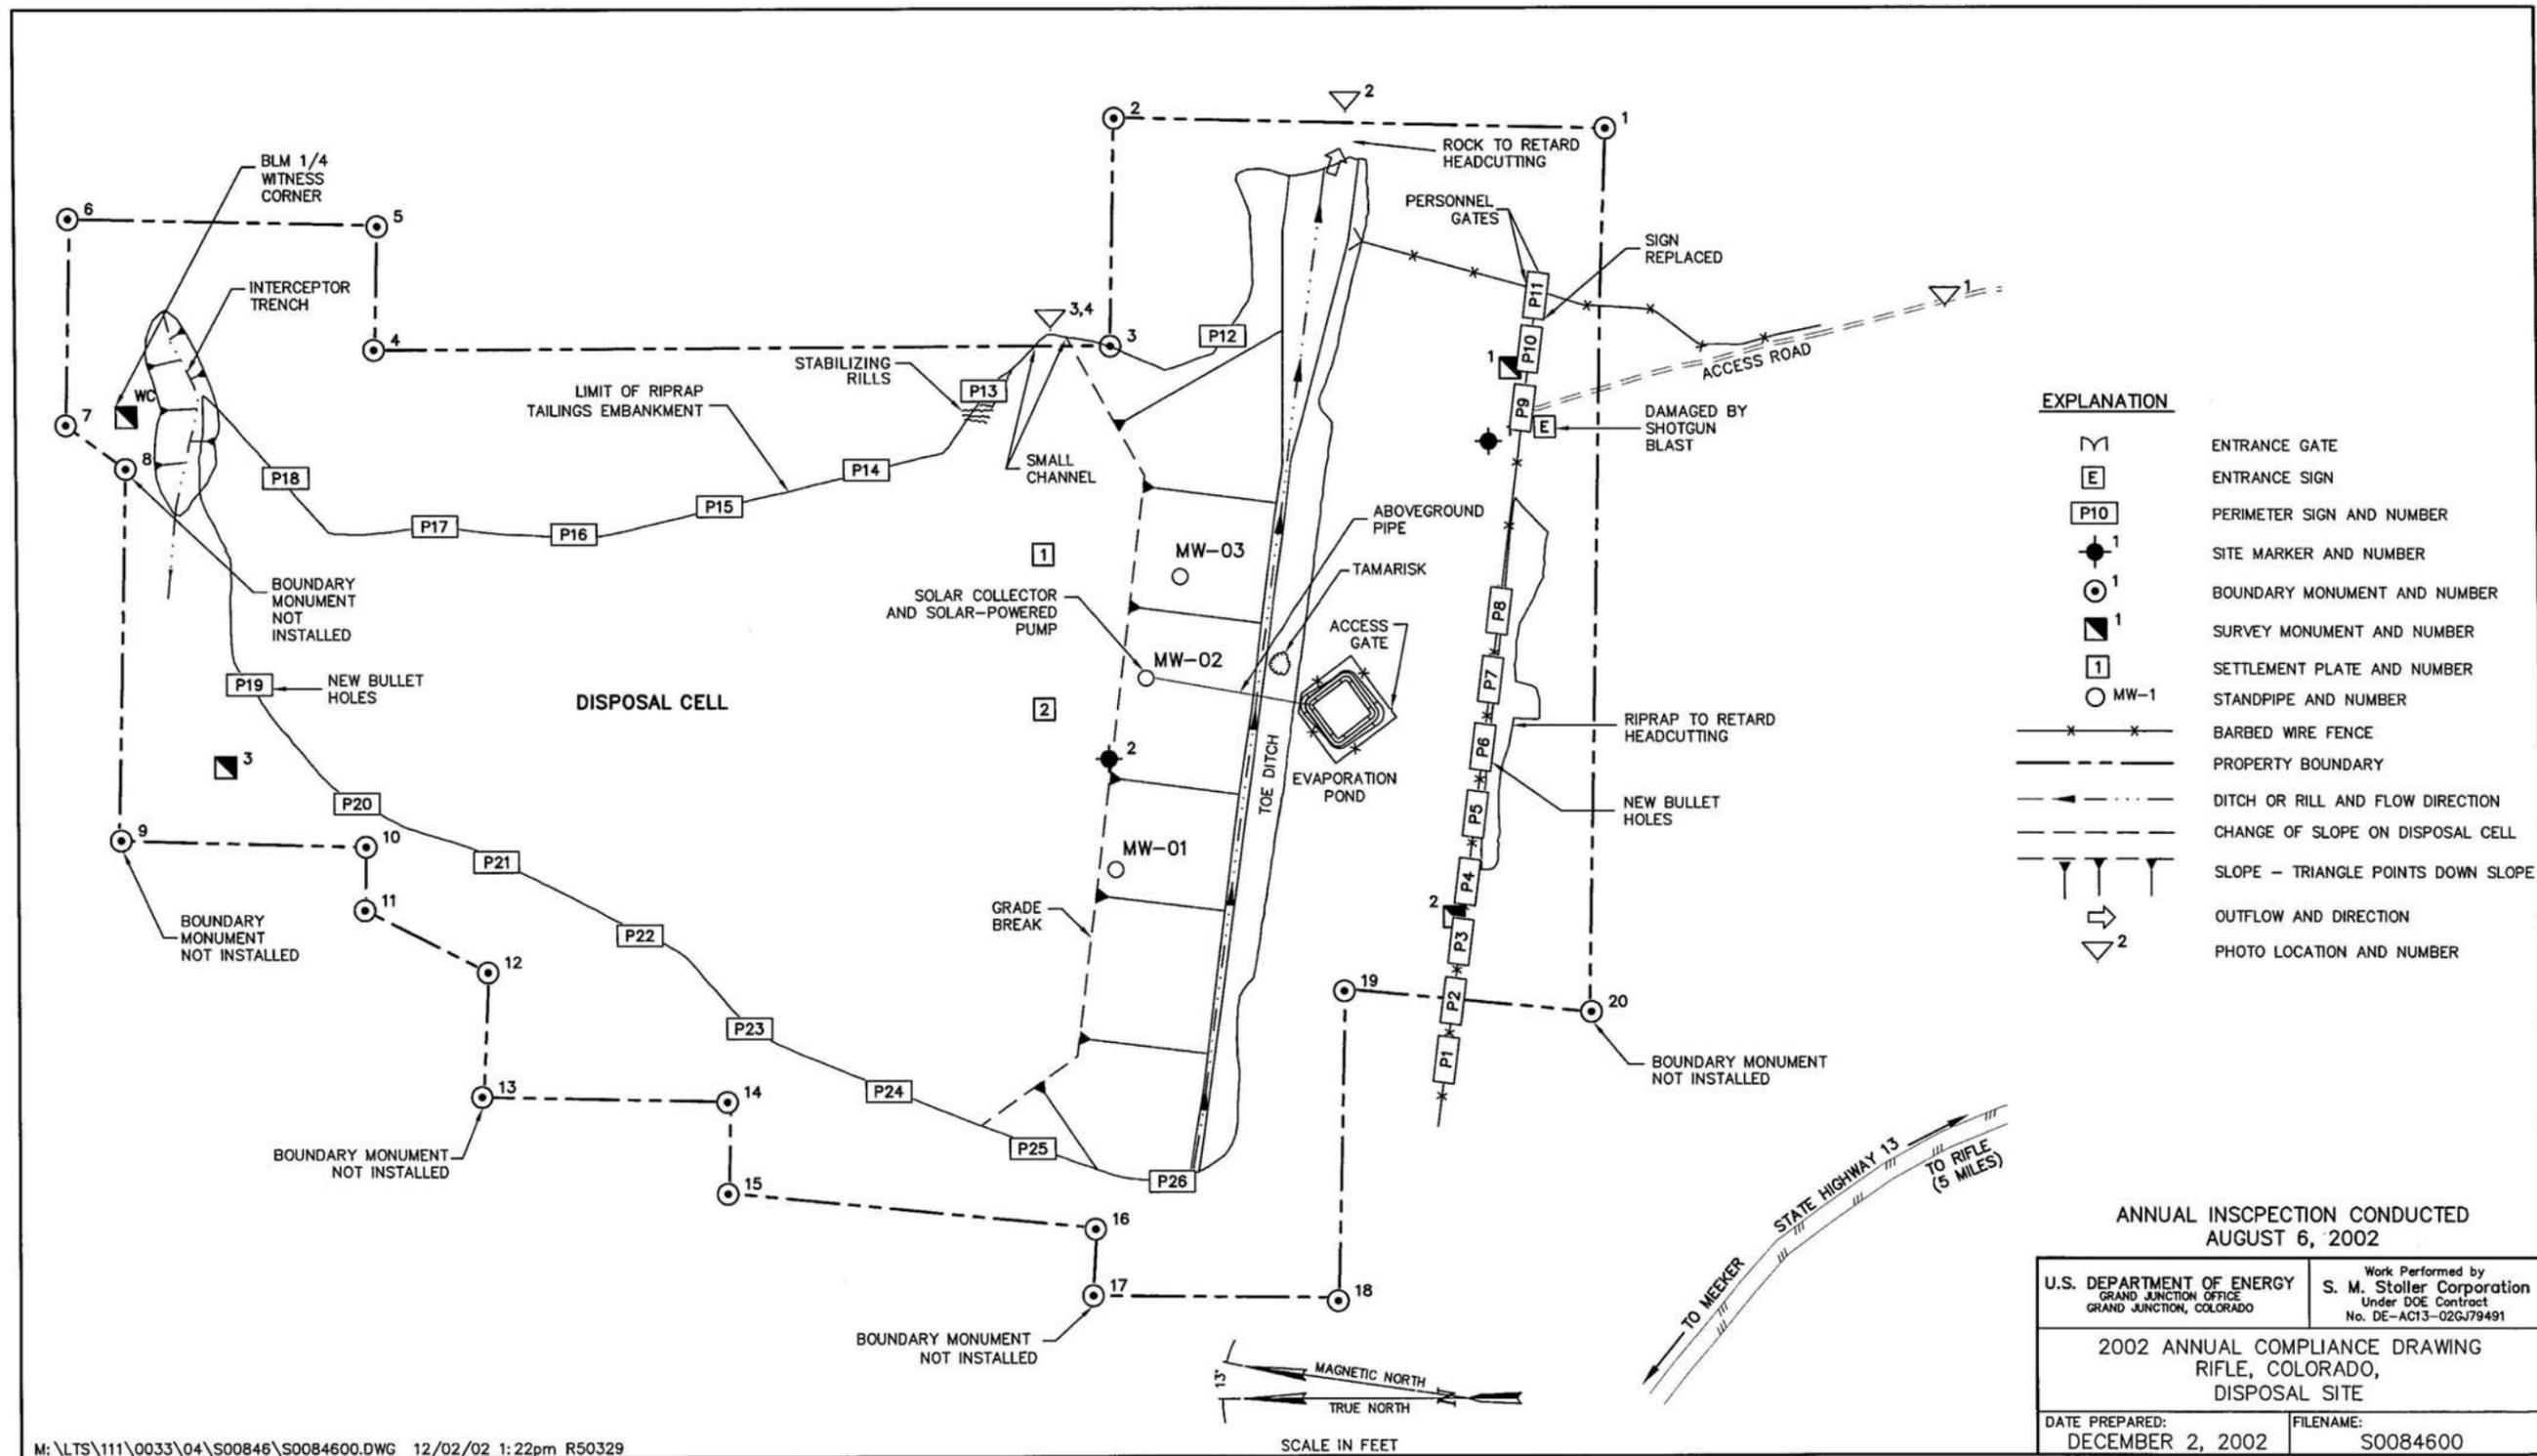
The site, north of Rifle, Colorado, was inspected on August 6, 2002. Results of the inspection are described below. Features and photograph locations (PLs) mentioned in this report are shown on Figure 14–1. Numbers in the left margin of this report refer to items summarized in the Executive Summary table.
