2002 Annual Compliance Report Salt Lake City, Utah, Disposal Site

Compliance Summary

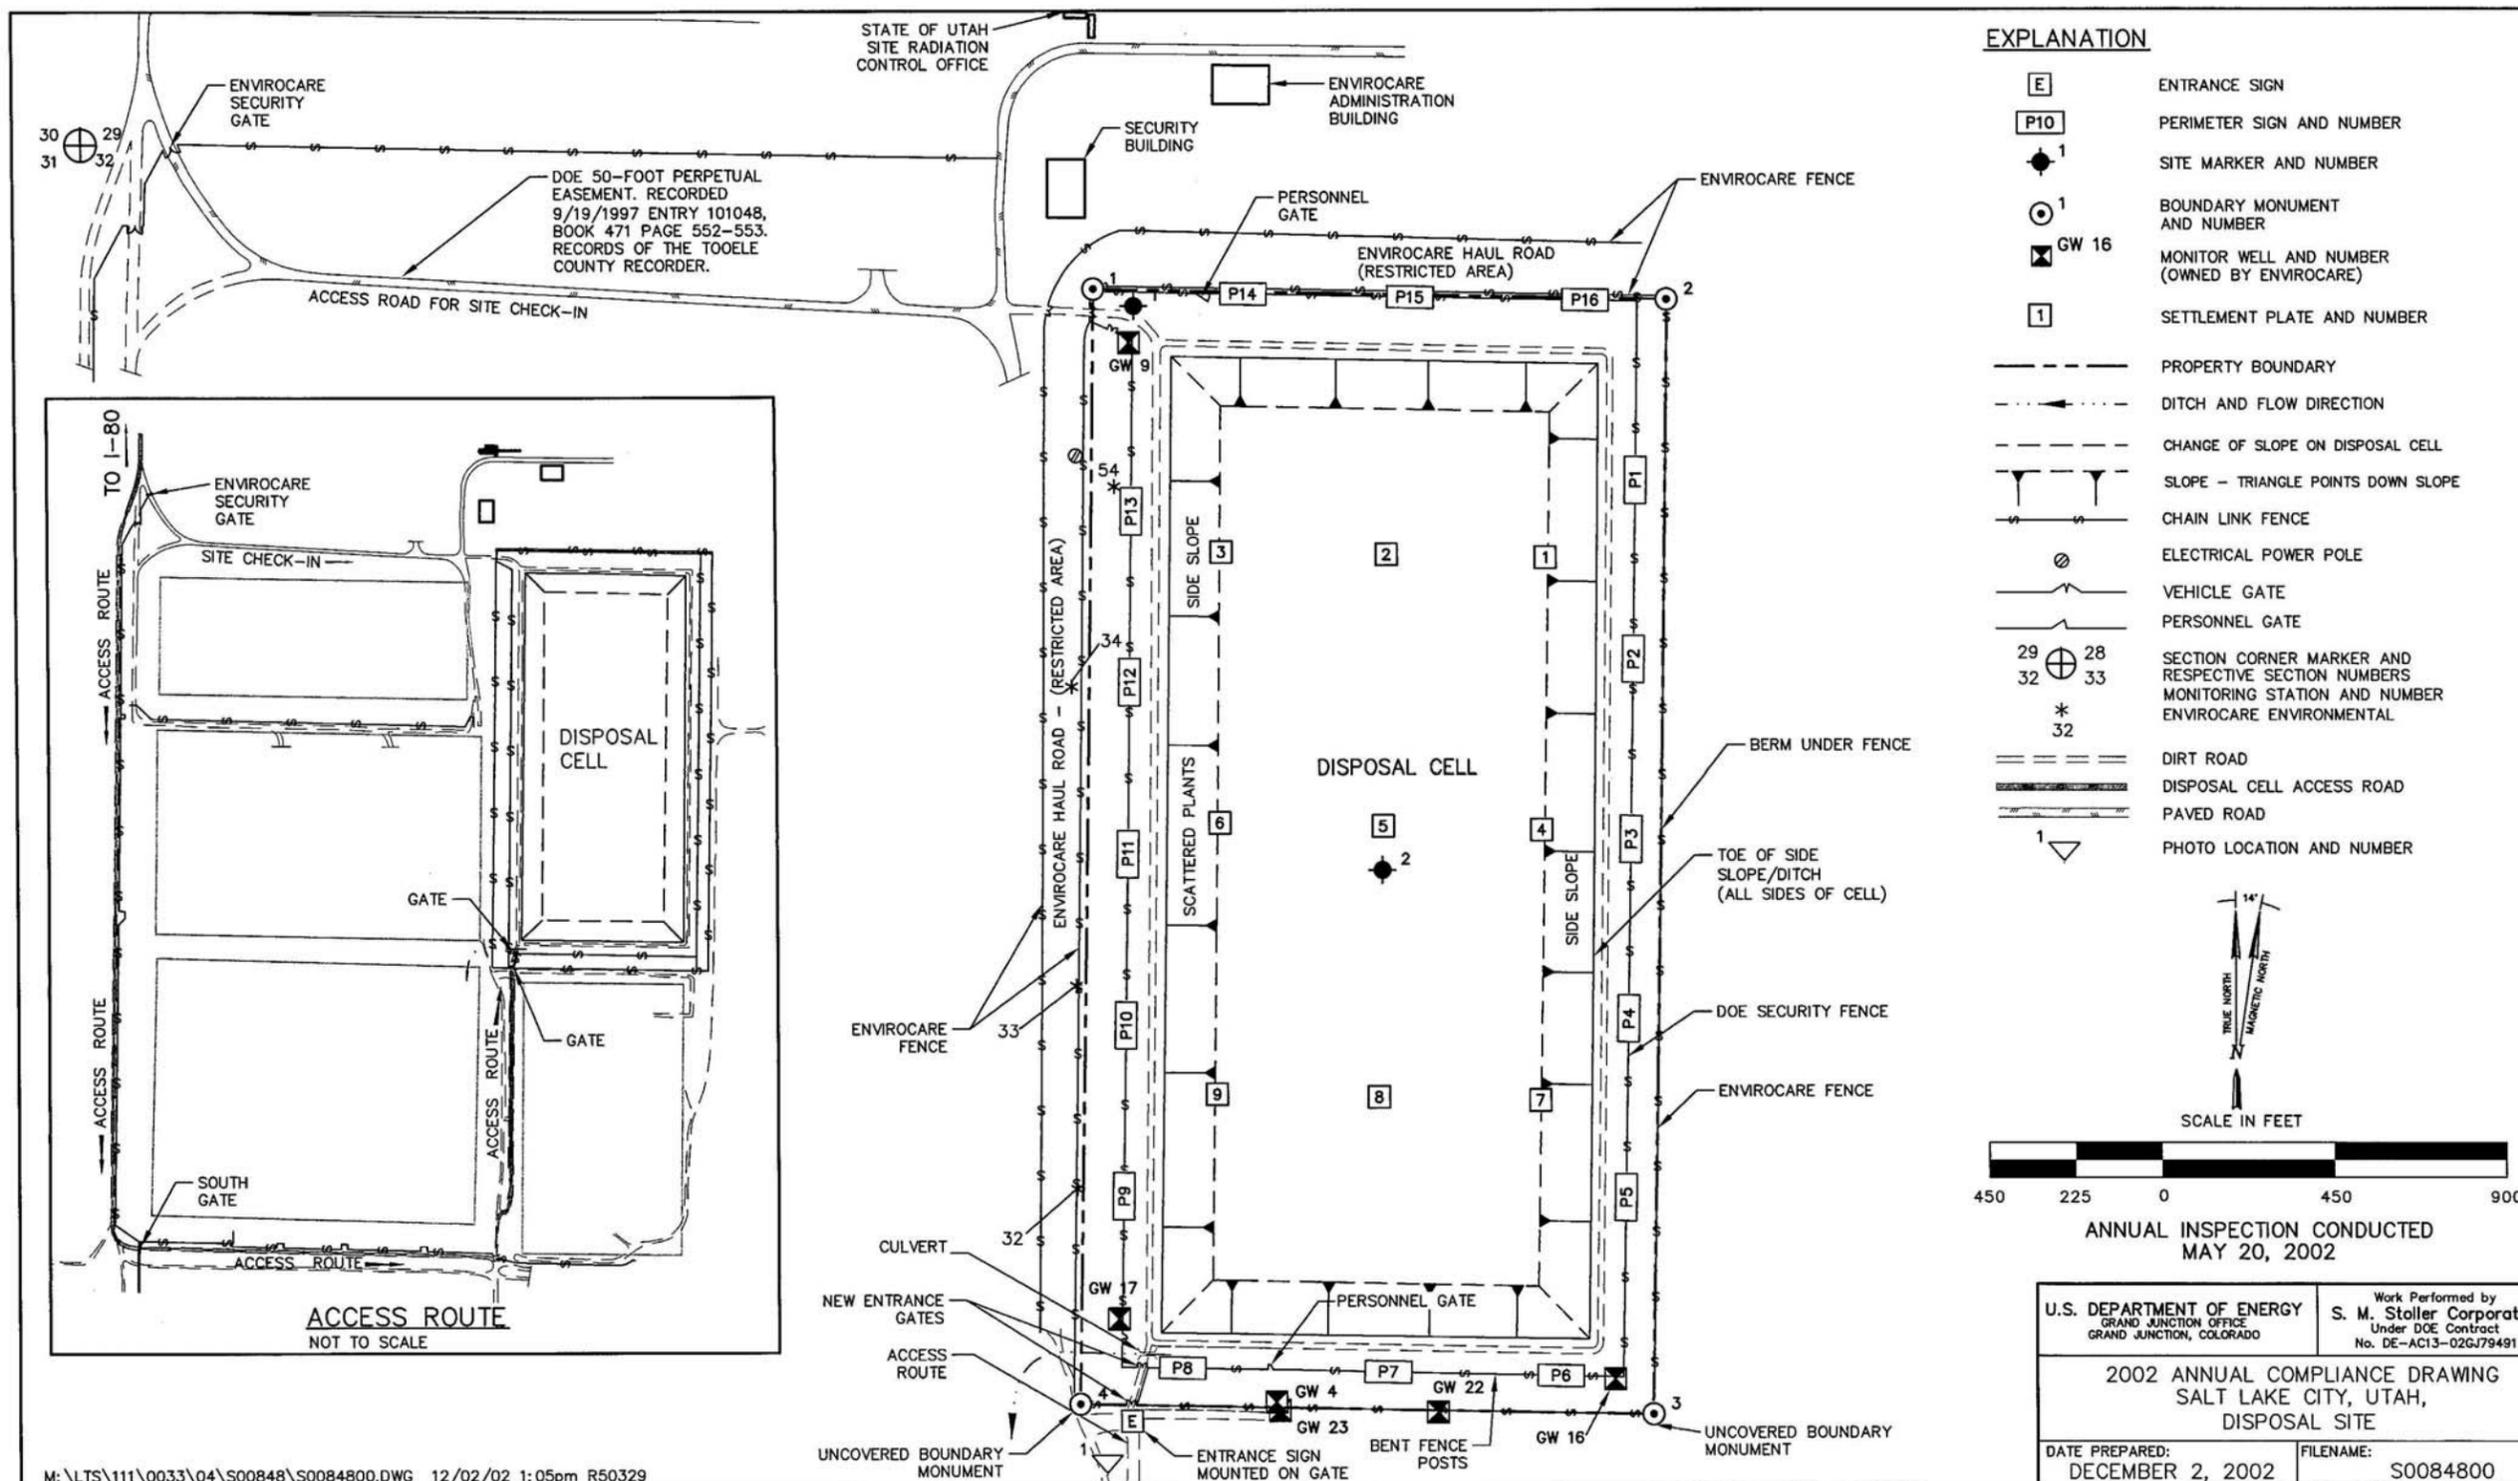
Figure 15-1. 2002 Annual Compliance Drawing for the Salt Lake (South Clive), Utah, Disposal Site

The site, 85 miles west of Salt Lake City, Utah, was inspected on May 20, 2002. Results of the inspection are described below. Features and the photograph location (PL) mentioned in this report are shown on Figure 15-1. Numbers in the left margin of this report refer to items summarized in the Executive Summary table.

The entrance sign was relocated by Envirocare from the former entrance gate to the new entrance gate (PL-1). All perimeter signs were present and in good condition.
