DOE/OR/21548-066
(CONTRACT NO. DE-AC05-86OR21548)

REMEDIAL INVESTIGATIONS FOR QUARRY BULK WASTES

For The :
Weldon Spring Site Remedial Action Project
Weldon Spring, Missouri

Prepared By MK-Ferguson Company & Jacobs Engineering Group
DECEMBER 1989 REV. 1

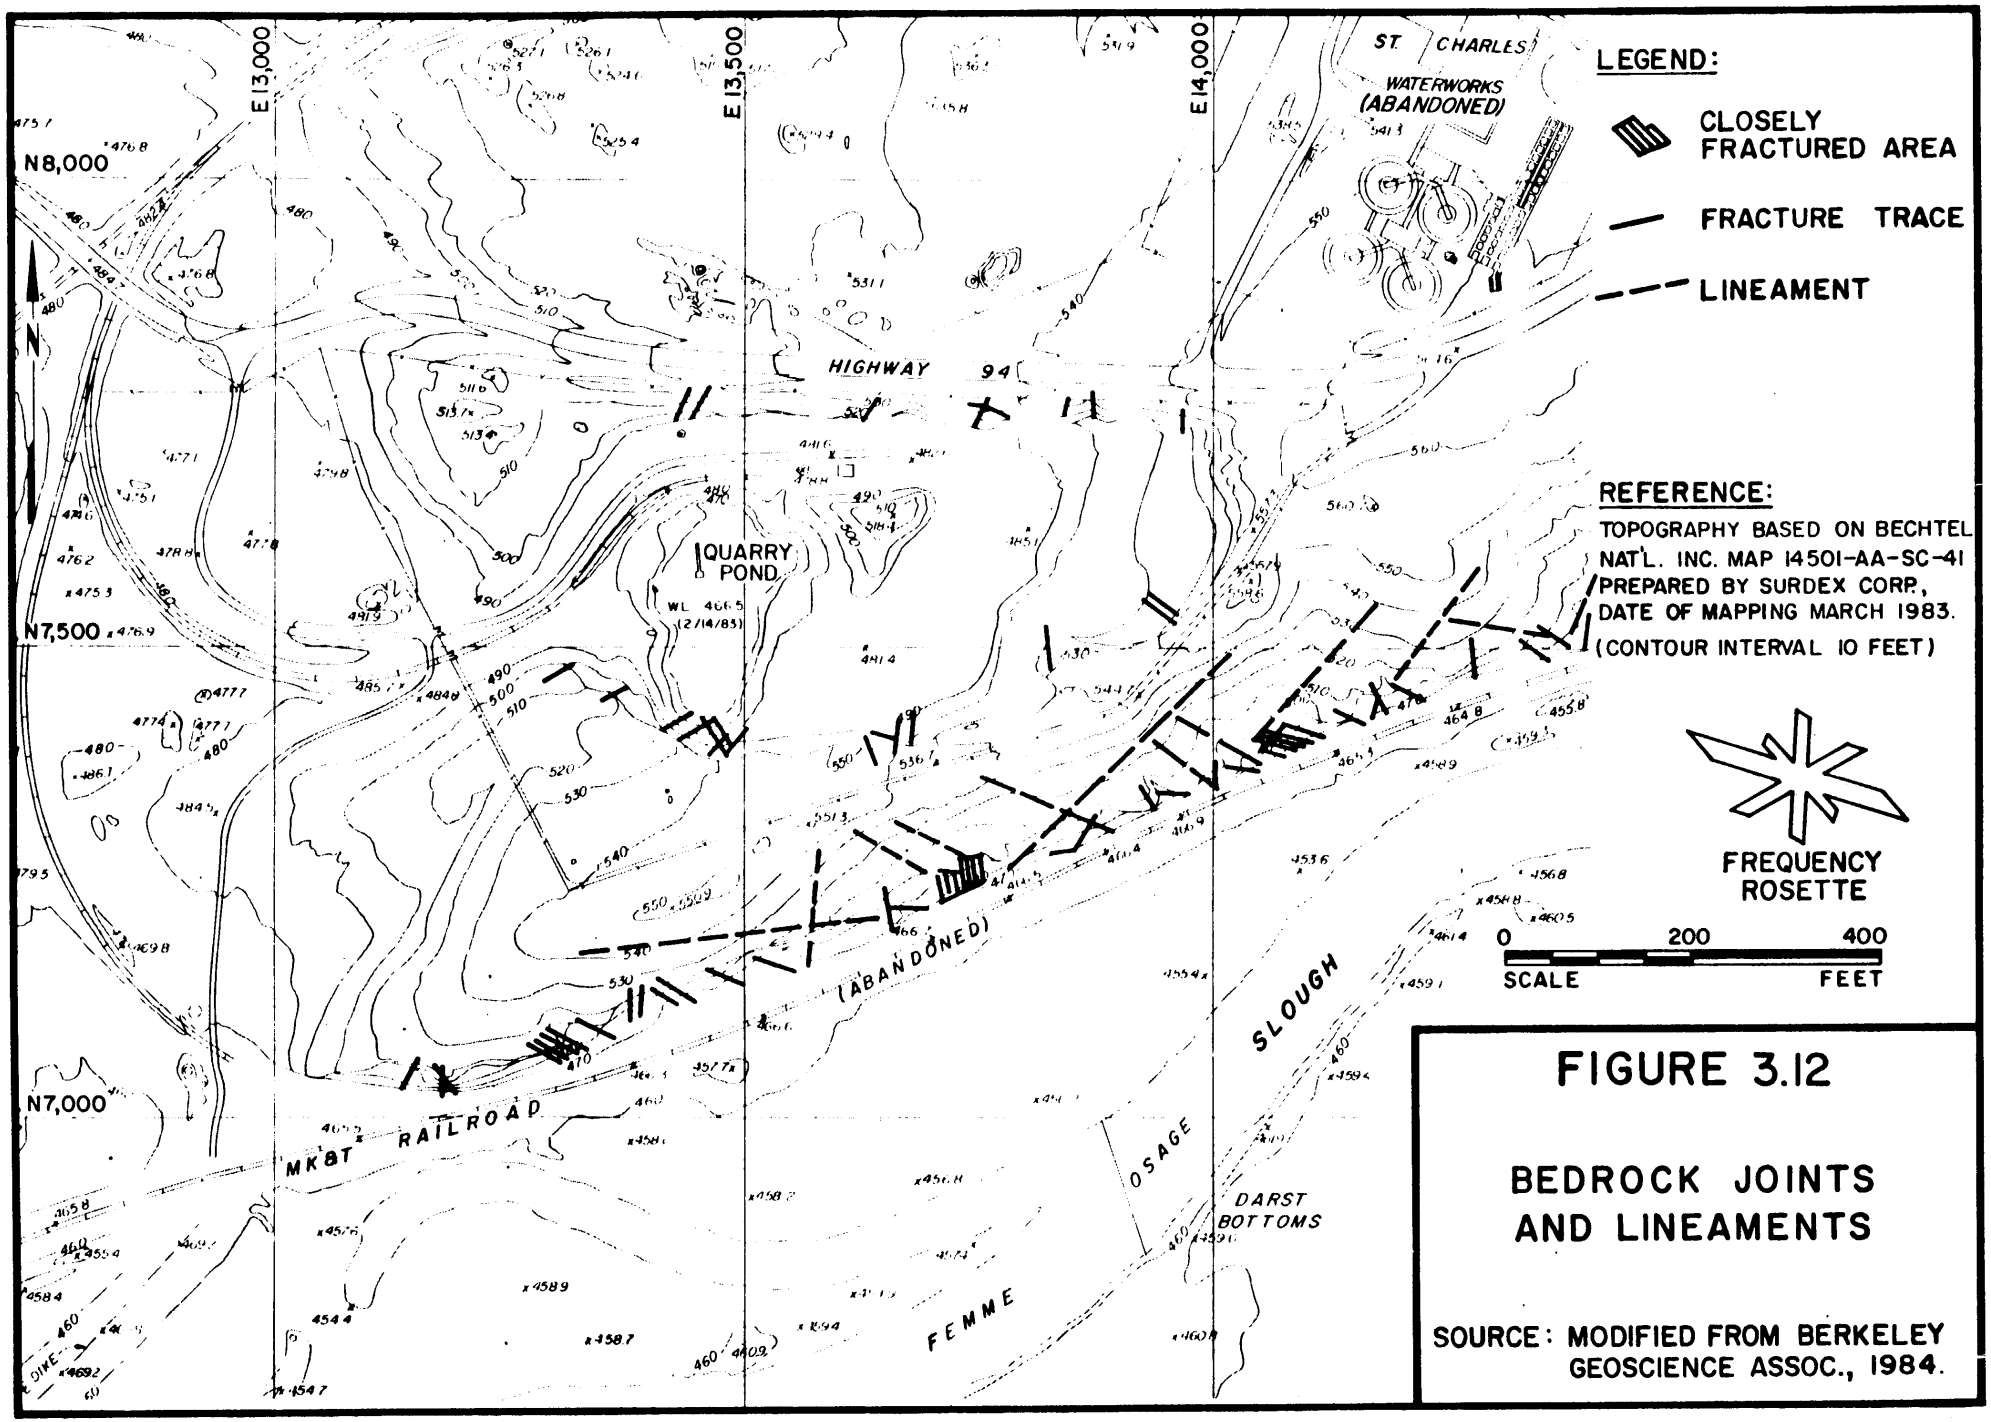
FIGURE 3.12

The results of fracture and lineament mapping investigations performed by LBL are shown in Figure 3.12. Fracture and joint orientations are summarized in the rosette diagram, which shows that the predominant set is oriented about N 70° W. Joints in this set are vertical and have an average spacing of about 30 feet along the limestone bluffs facing the slough (BGA, 1984). Two secondary vertical joint sets are also present; their orientations are N 60° E and north-south.

As part of the fracture mapping program, LBL also identified potential conduits for fluid flow in the quarry limestone. Most of the joints are open with apertures that vary from 1 inch to several feet. Clay fillings are present in many of the joints. Three zones of closely spaced fractures south and east of the quarry are indicated on Figure 3.12. These zones coincide with gullies in the bluffs and probably represent areas of more intense weathering and solution activity. The joint surfaces along the bluff and on the quarry walls are typically etched with patterns which indicate that most of the joints have been in contact with groundwater at some time (BGA, 1984). Field observations and borehole infiltration tests indicate that the joints become increasingly tighter as the Kimmswick/Decorah contact is approached from the surface.

BEDROCK JOINTS AND LINEAMENTS

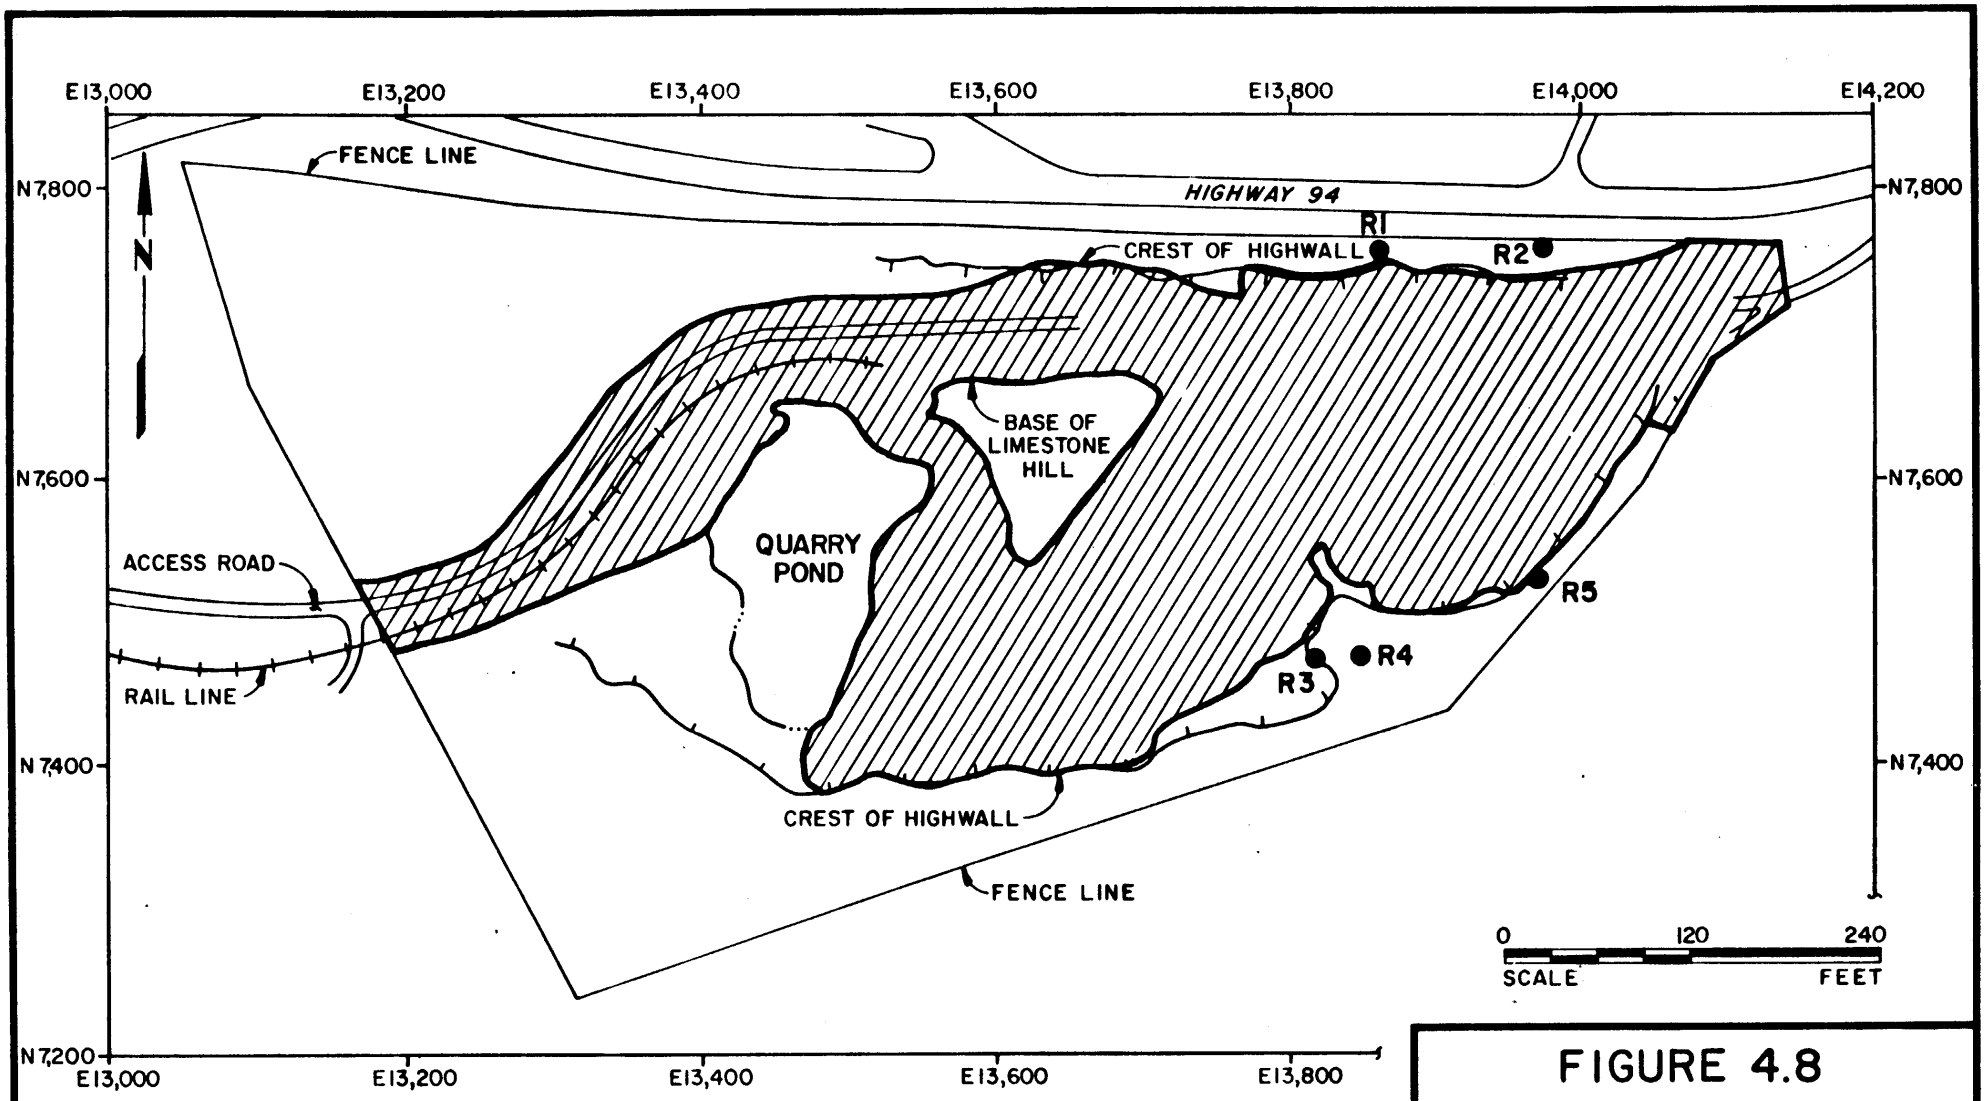
FIGURE 4.8

CONFIRMED SURFACE RADIOLOGICAL CONTAMINATION 0 TO 0.5 FOOT DEPTH

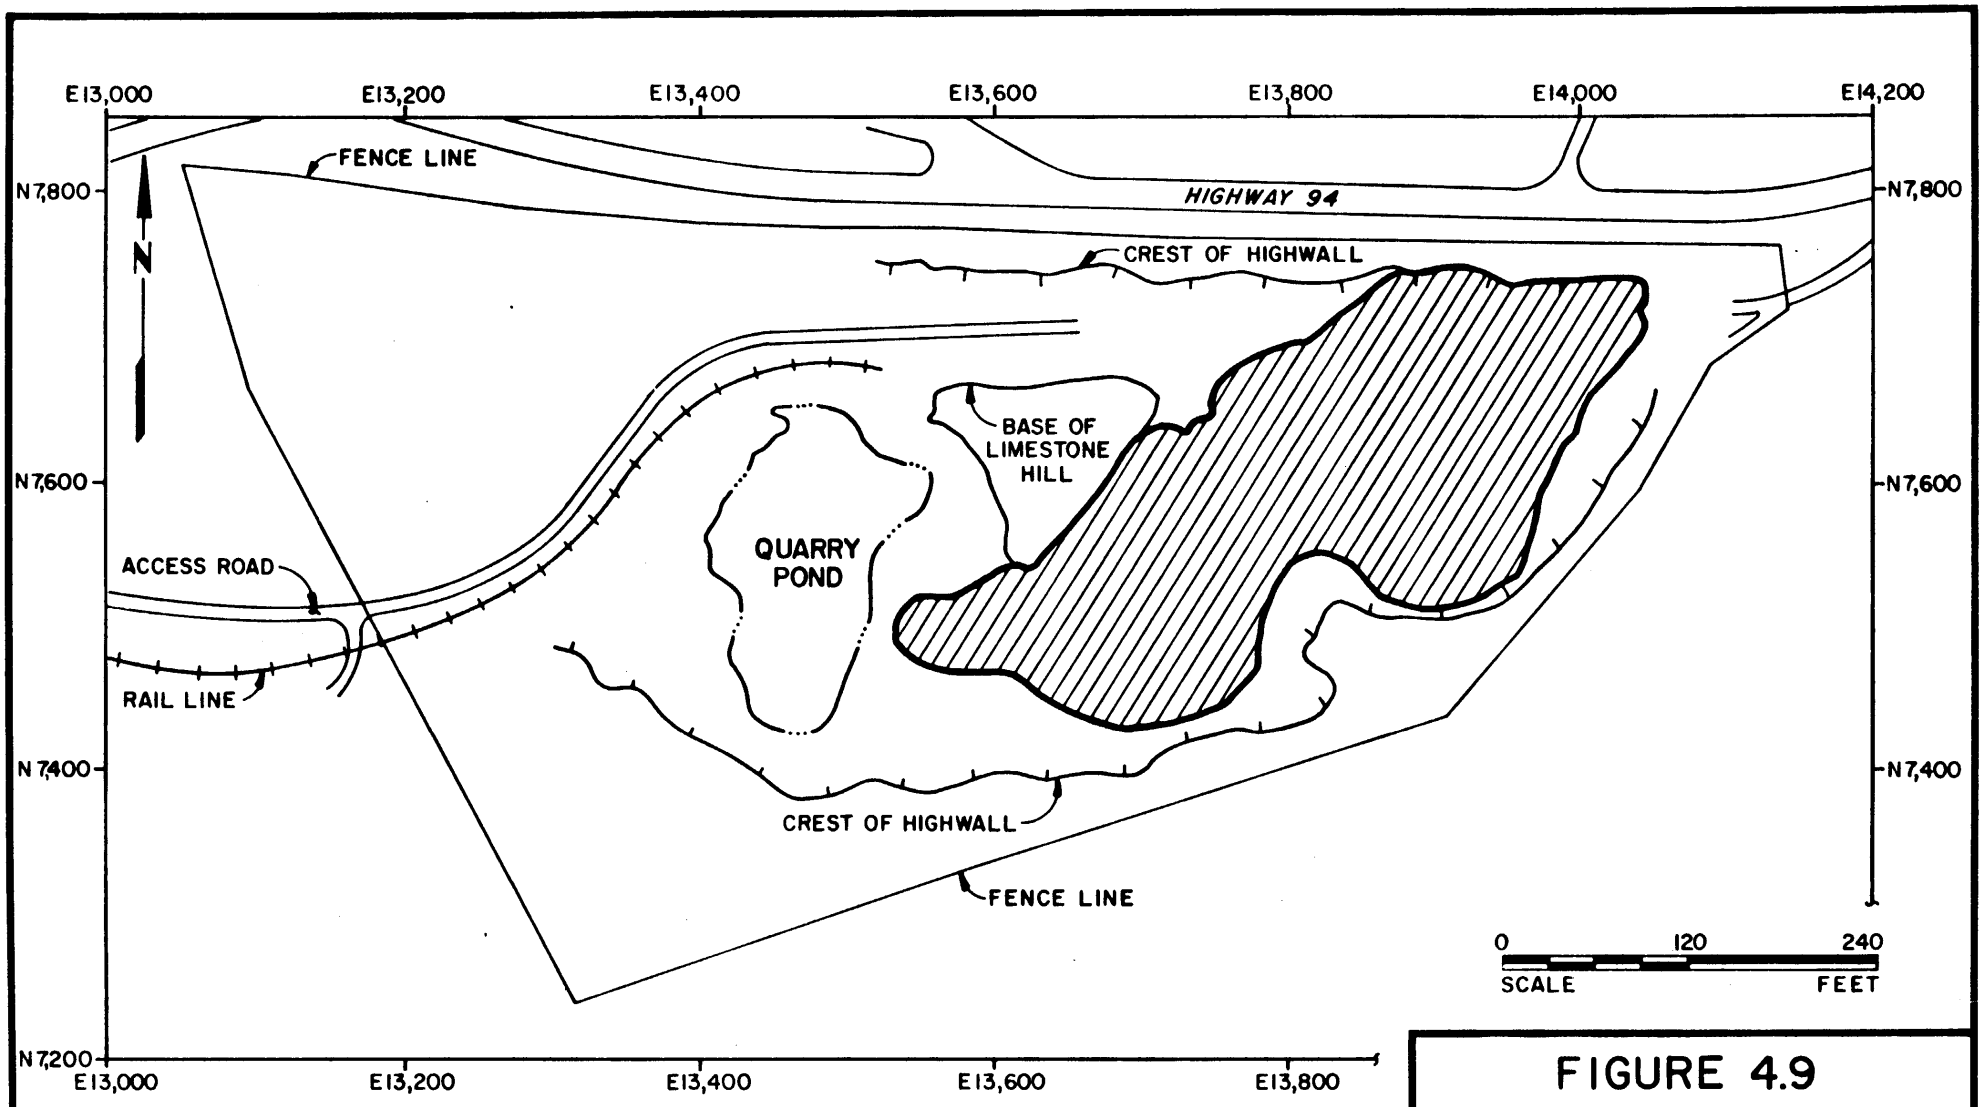
FIGURE 4.9

CONFIRMED SUBSURFACE RADIOLOGICAL CONTAMINATION 0.5 TO 5 FOOT DEPTH

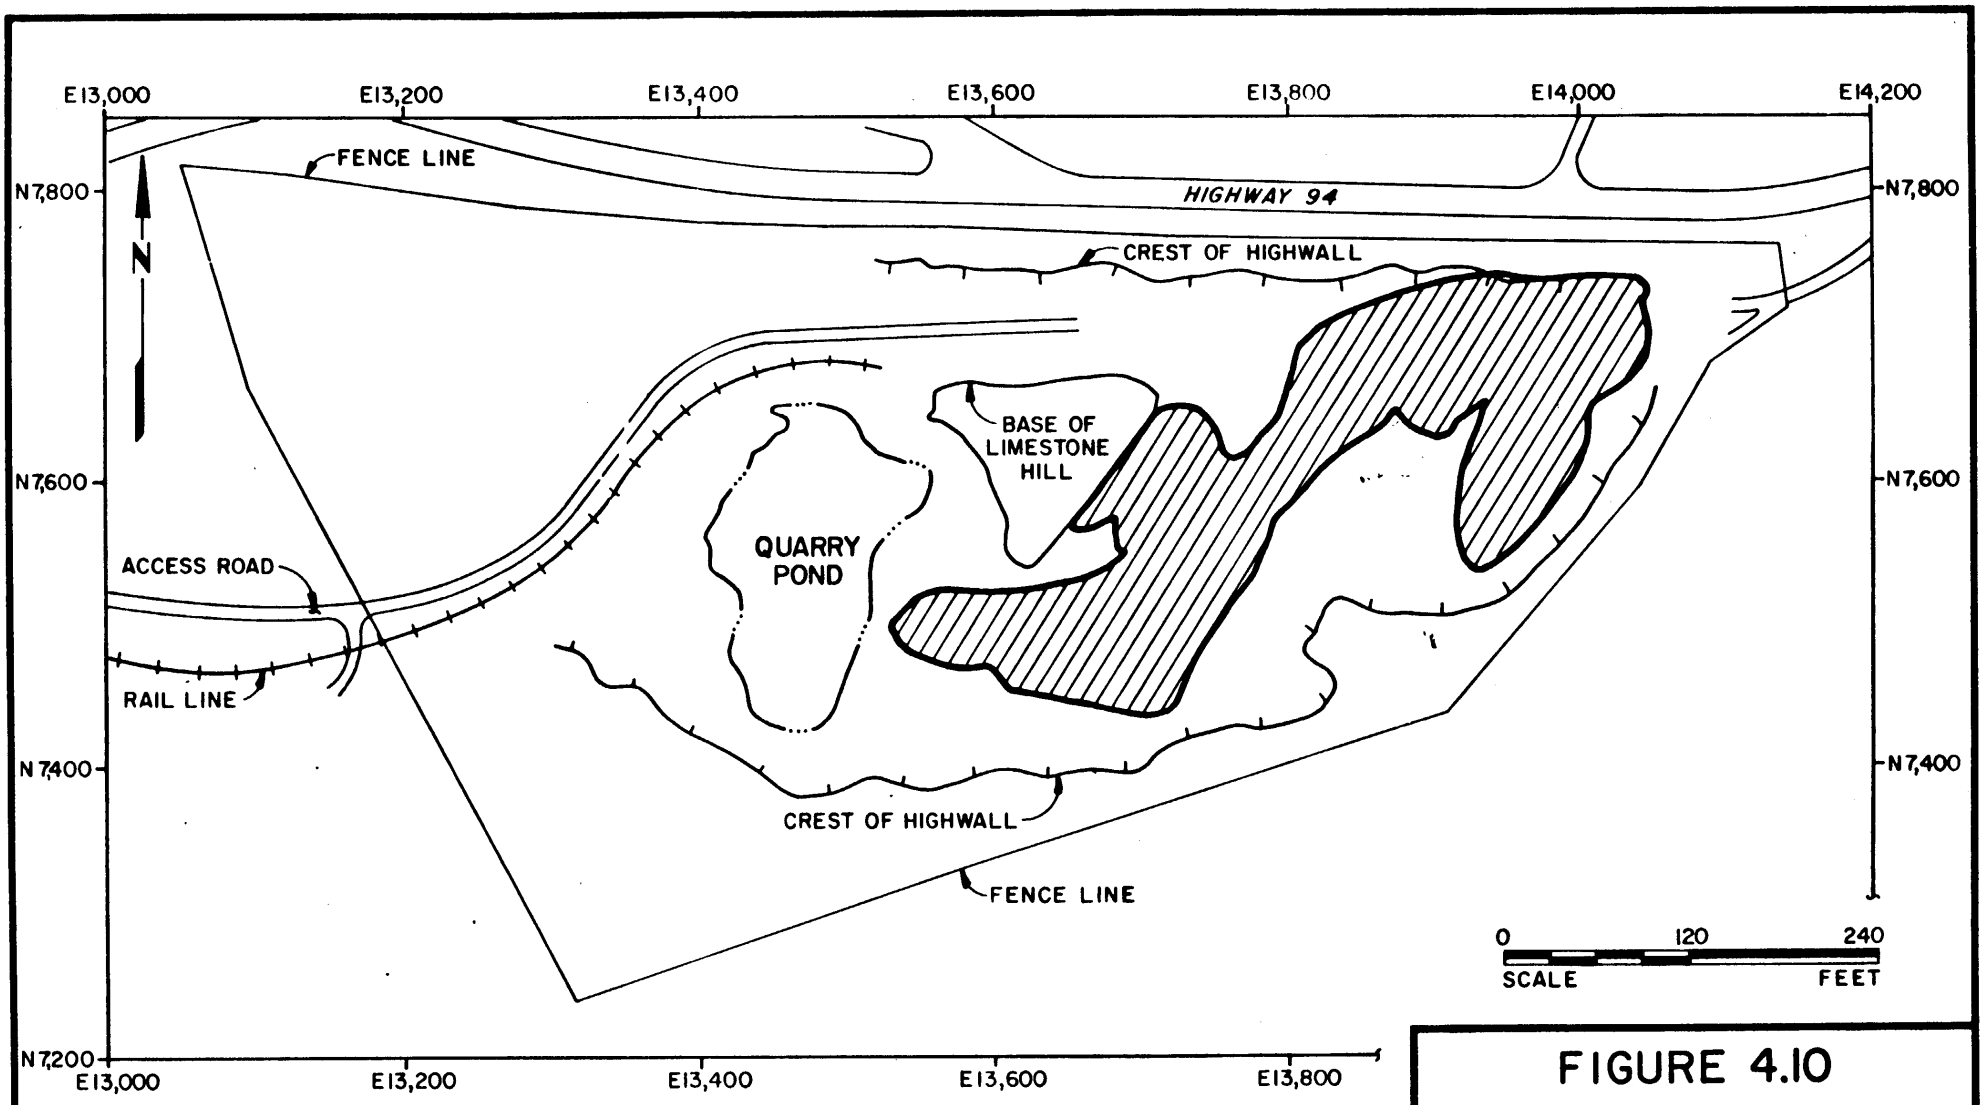
FIGURE 4.10

CONFIRMED SUBSURFACE RADIOLOGICAL CONTAMINATION 5 TO 10 FOOT DEPTH

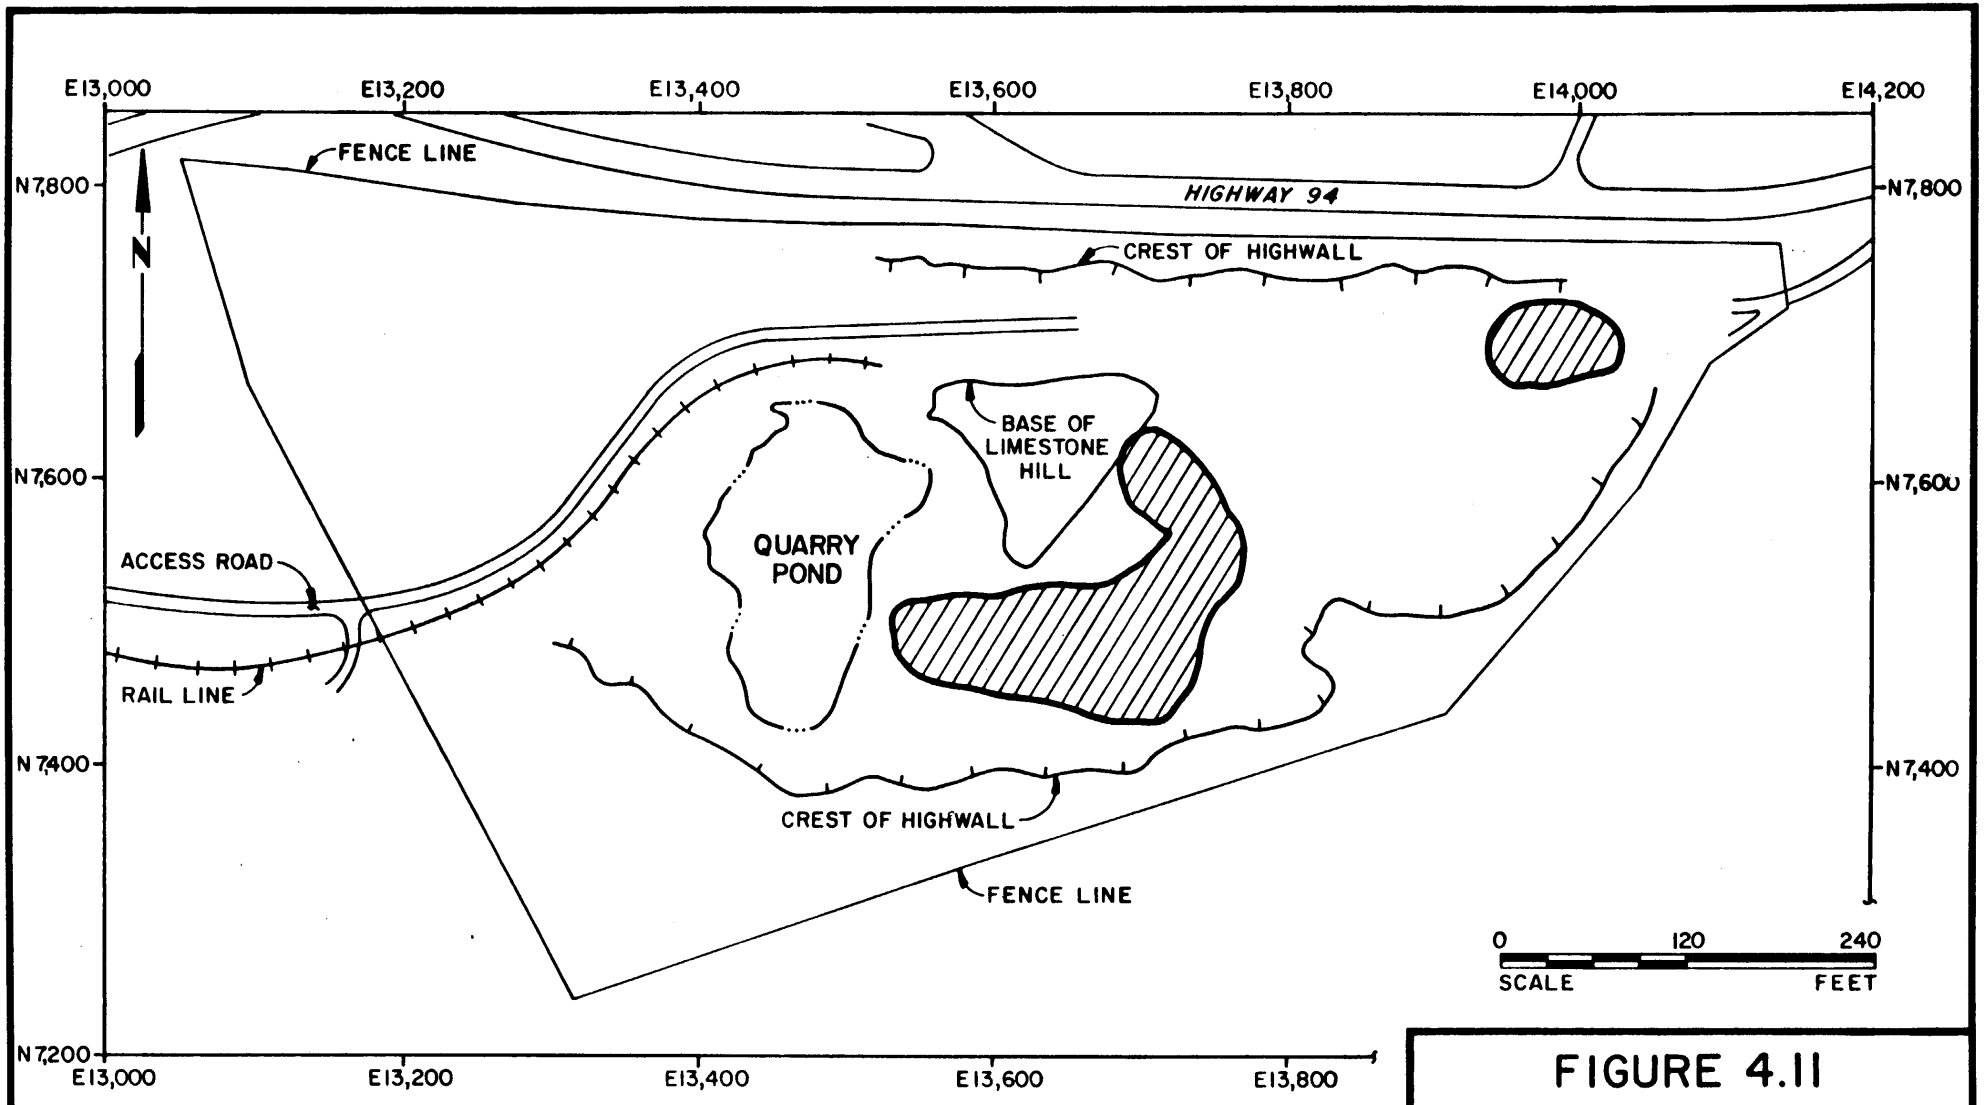
FIGURE 4.11

CONFIRMED SUBSURFACE RADIOLOGICAL CONTAMINATION 10 TO 15 FOOT DEPTH

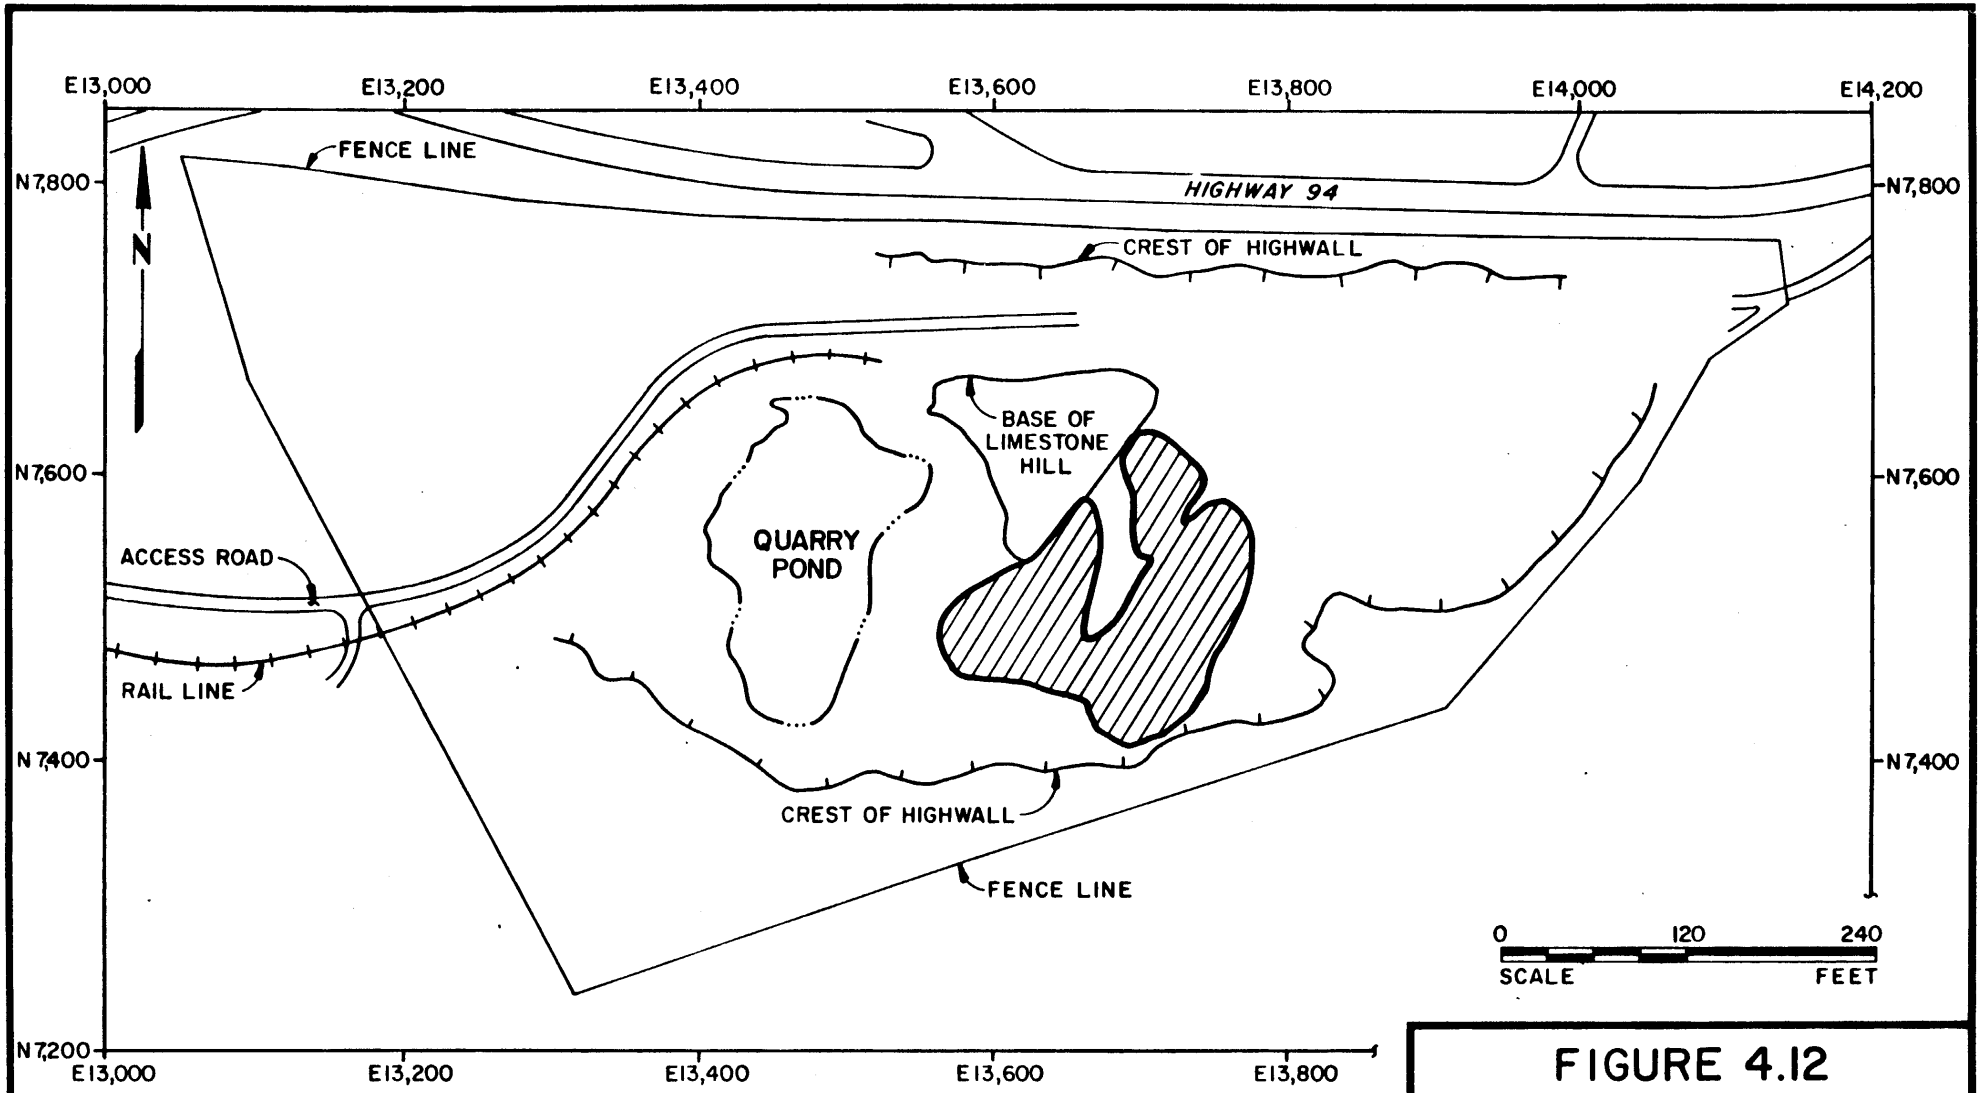
FIGURE 4.12

CONFIRMED SUBSURFACE RADIOLOGICAL CONTAMINATION 15 TO 20 FOOT DEPTH

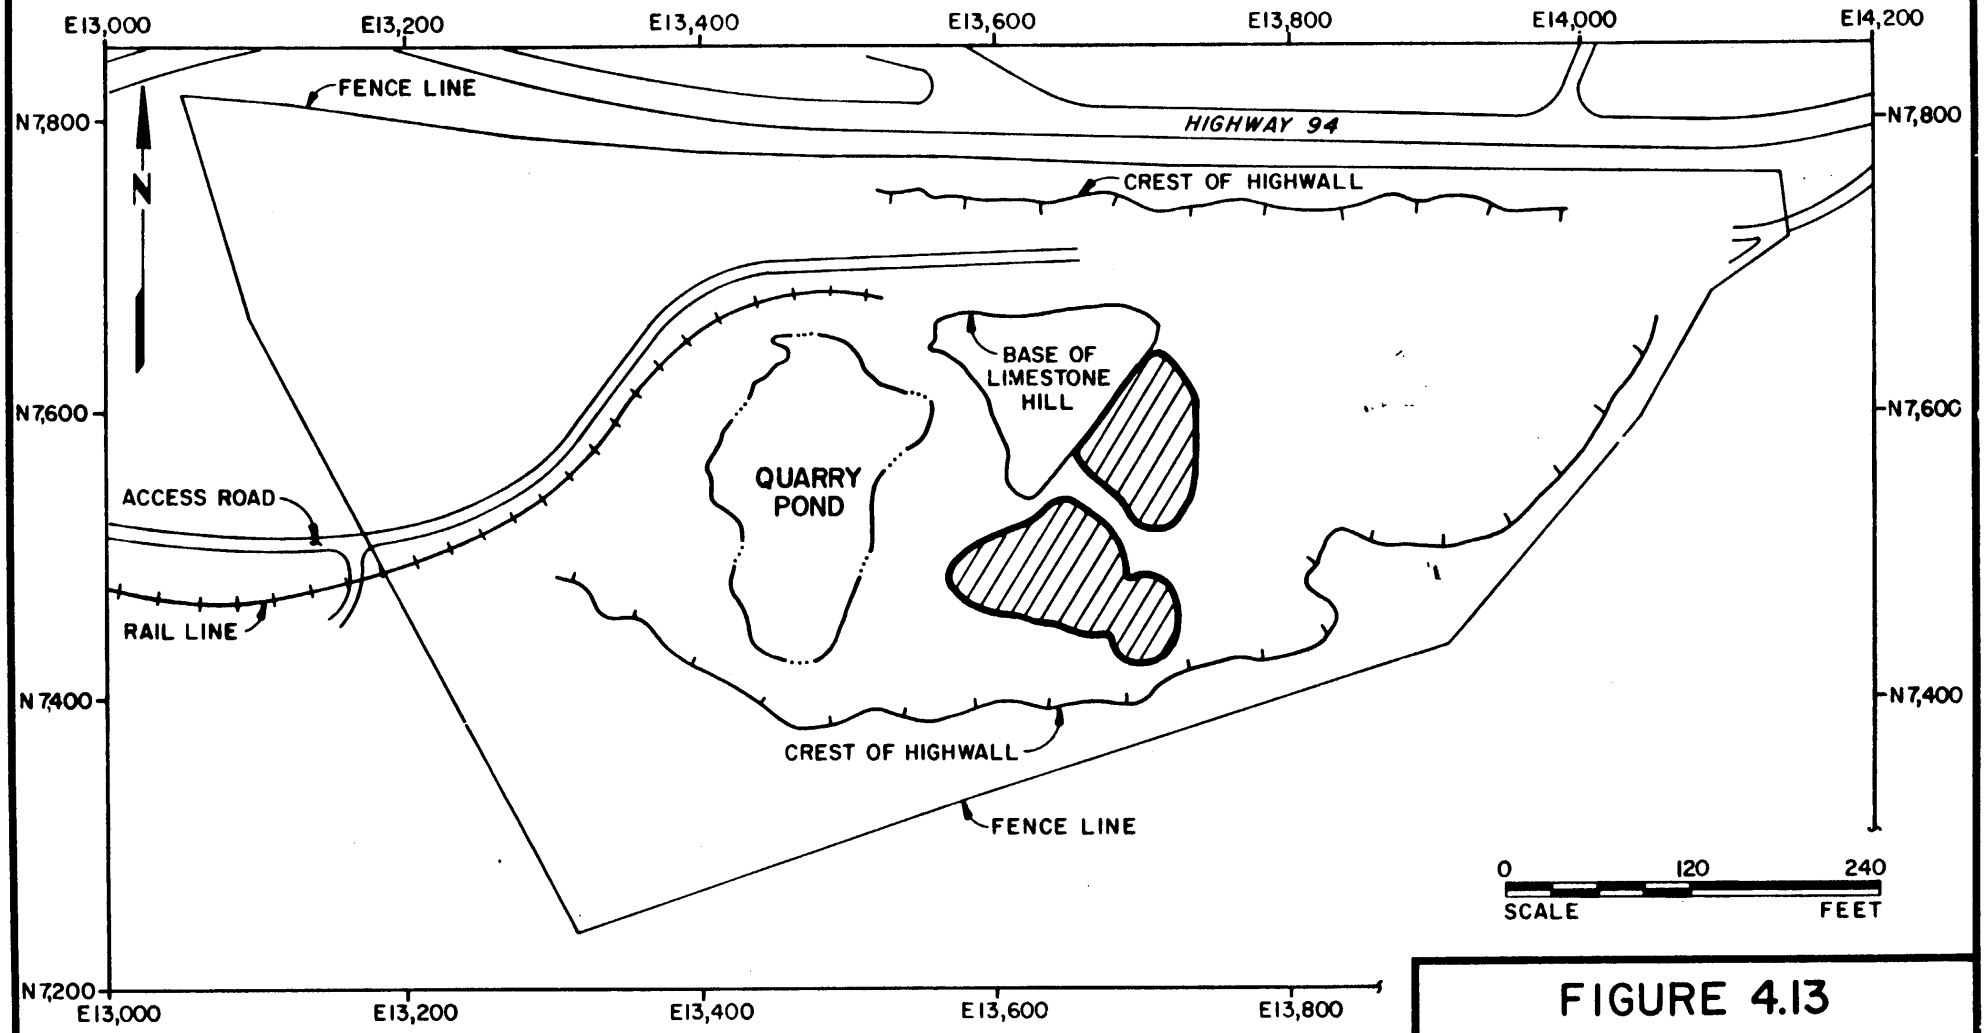
FIGURE 4.13

CONFIRMED SUBSURFACE RADIOLOGICAL CONTAMINATION 20 TO 25 FOOT DEPTH

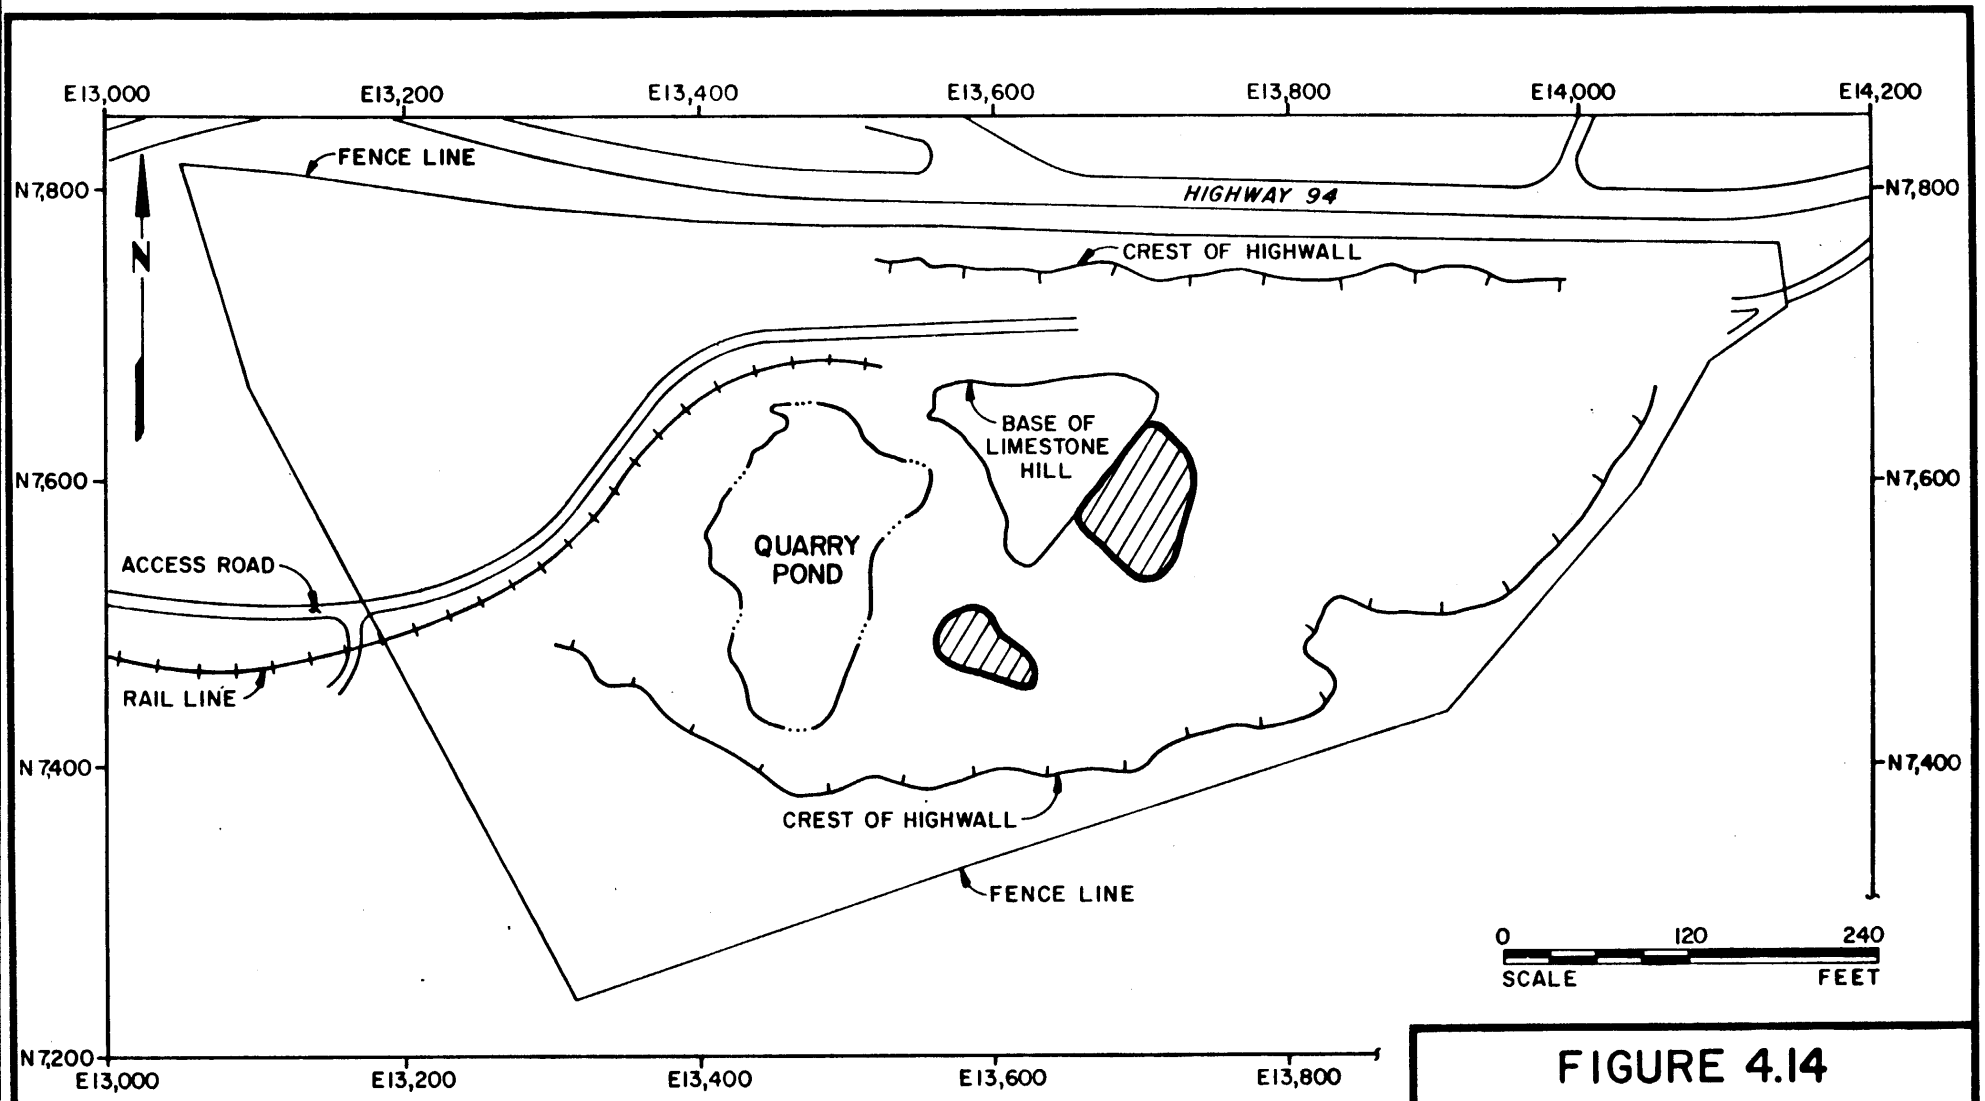
FIGURE 4.14

CONFIRMED SUBSURFACE RADIOLOGICAL CONTAMINATION 25 TO 30 FOOT DEPTH

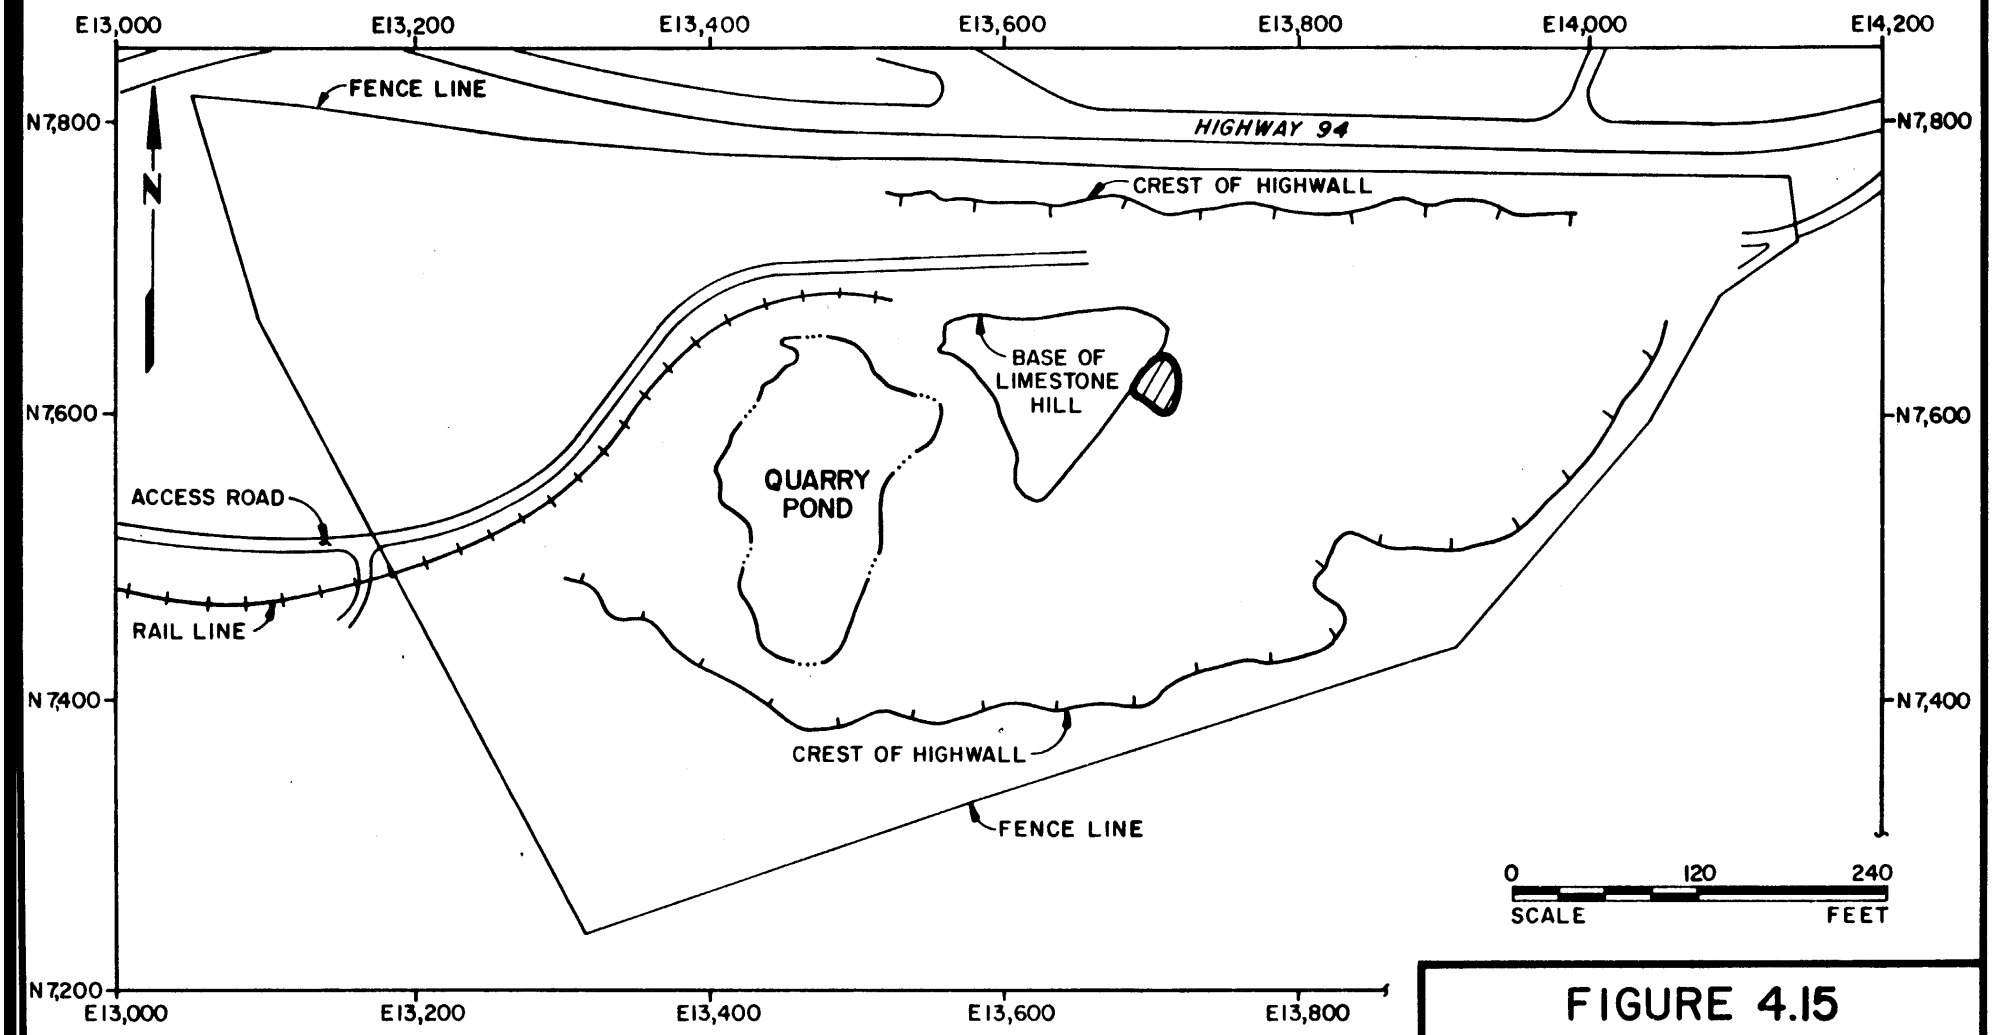
FIGURE 4.15

CONFIRMED SUBSURFACE RADIOLOGICAL CONTAMINATION 30 TO 35 FOOT DEPTH

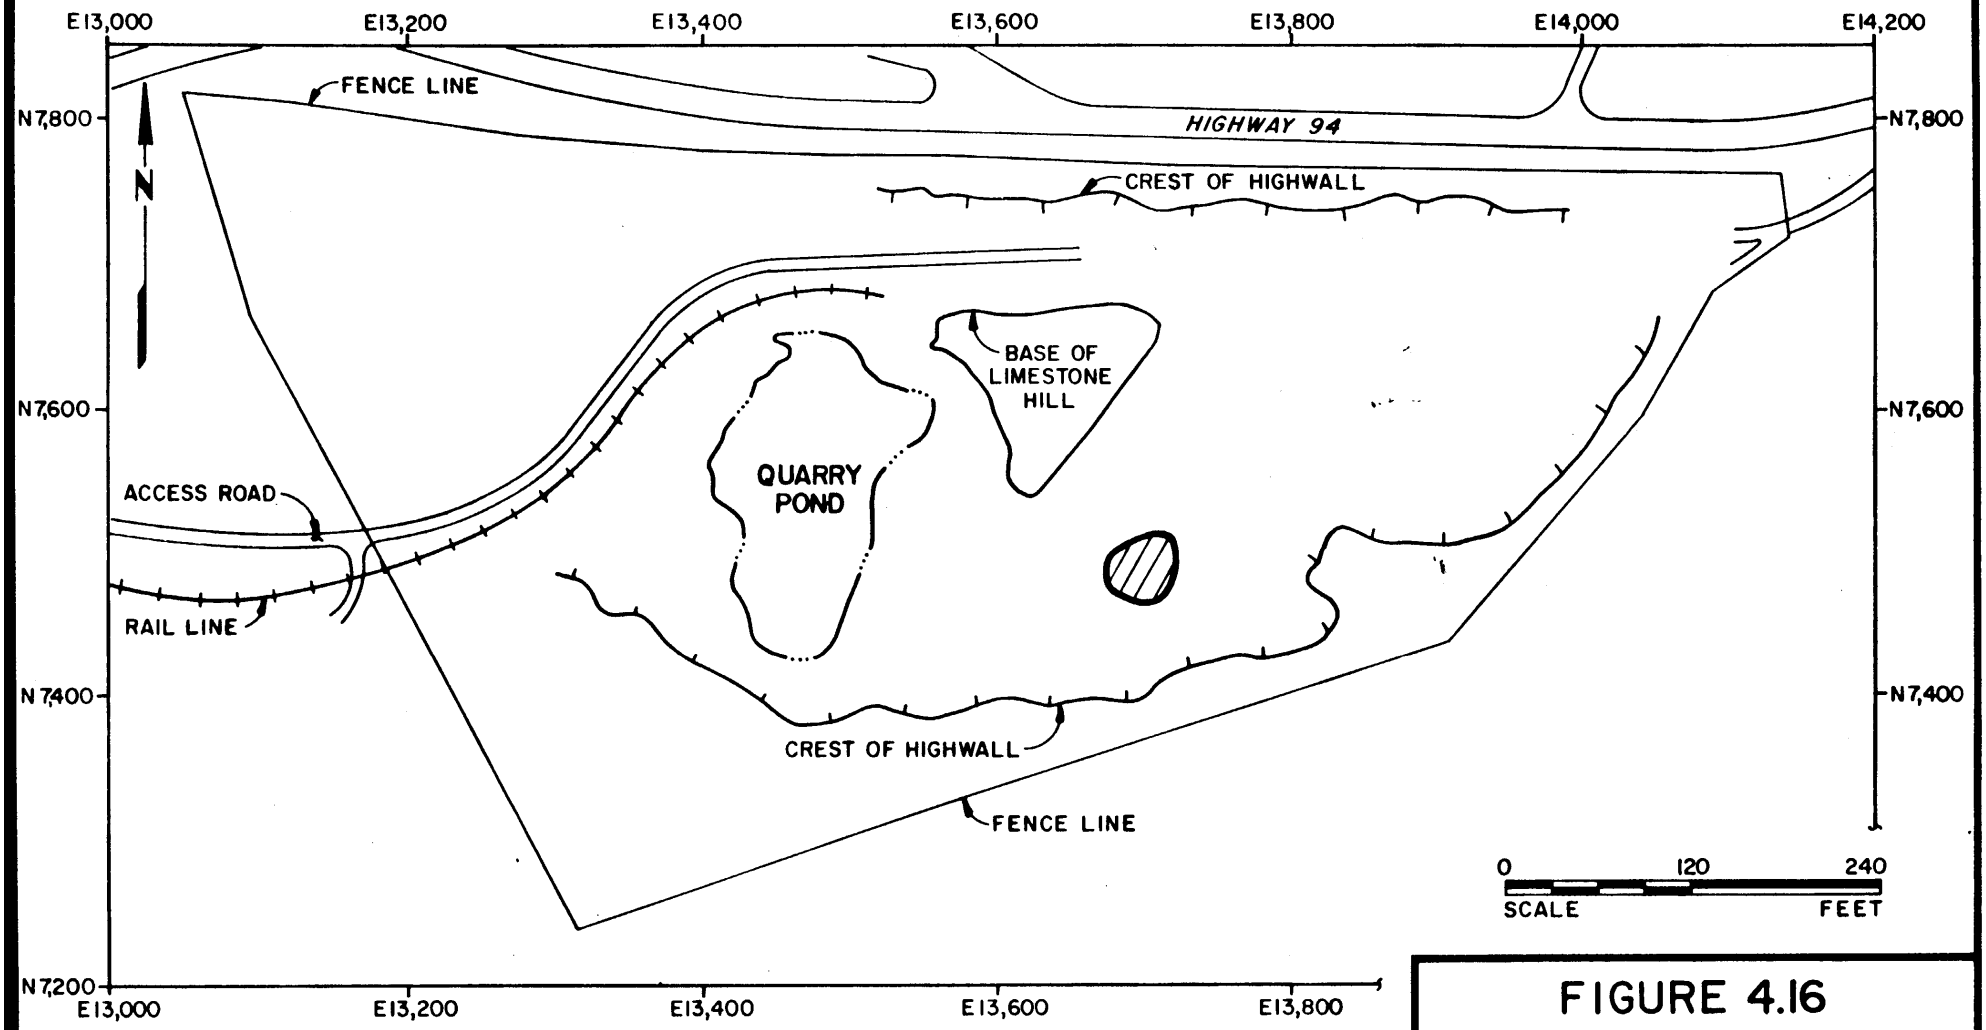
FIGURE 4.16

CONFIRMED SUBSURFACE RADIOLOGICAL CONTAMINATION 35 TO 40 FOOT DEPTH
