DOE/OR/21548-066
(CONTRACT NO. DE-AC05-86OR21548)

REMEDIAL INVESTIGATIONS FOR QUARRY BULK WASTES

For The :
Weldon Spring Site Remedial Action Project
Weldon Spring, Missouri

Prepared By MK-Ferguson Company & Jacobs Engineering Group
DECEMBER 1989 REV. 1

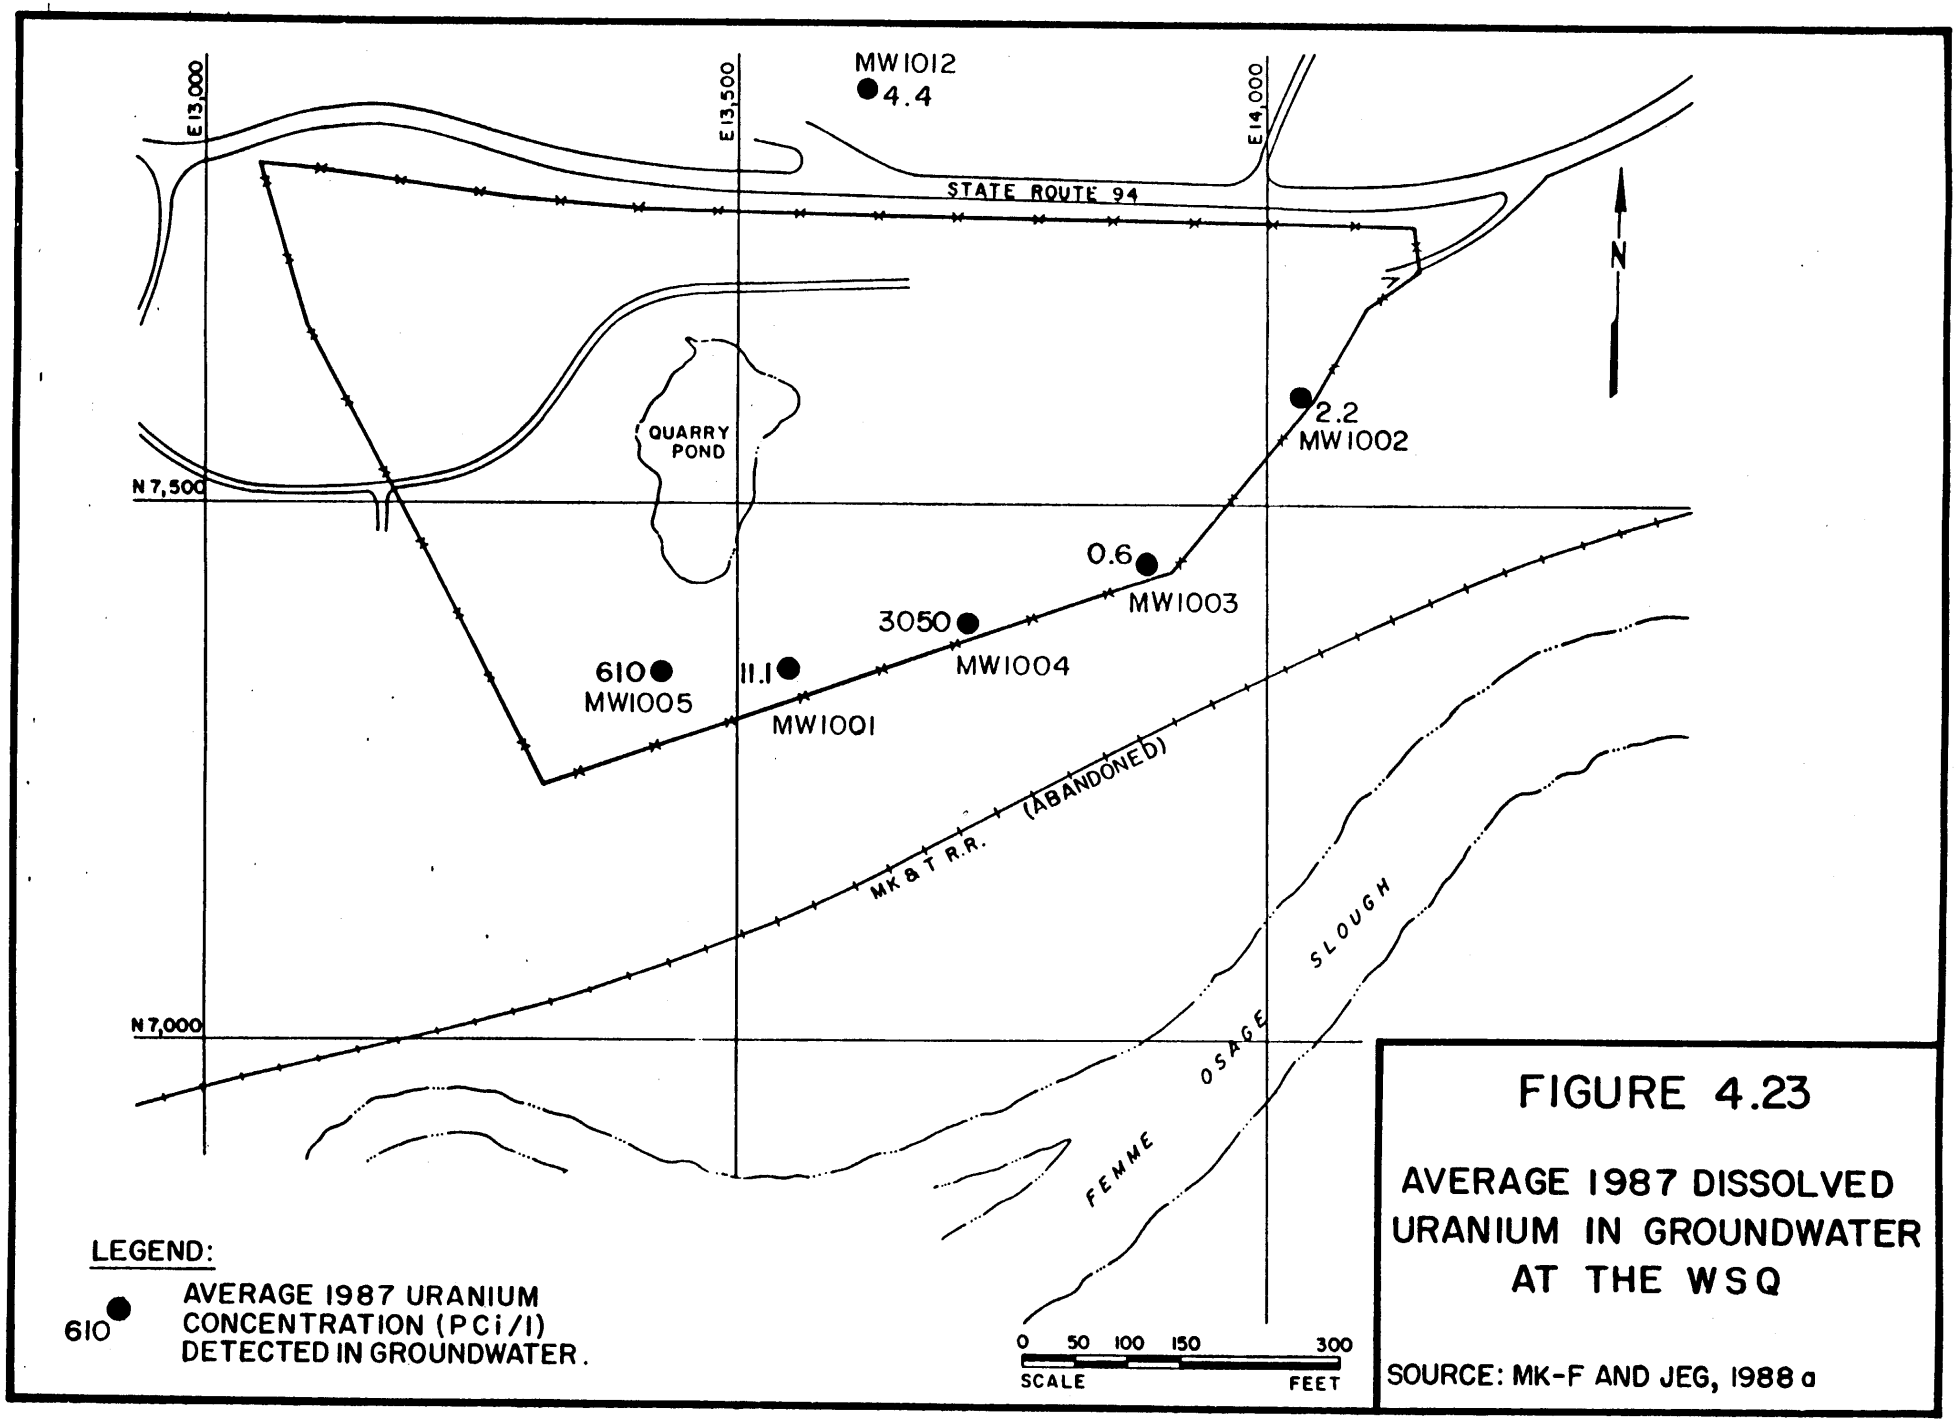
FIGURE 4.23

AVERAGE 1987 DISSOLVED URANIUM IN GROUNDWATER AT THE WSQ
